# 2019 Annual Inspection Report Inactive CCR Surface Impoundment

City of Ames Steam Electric Plant

Report Number 27219426.00 | April 2020

Subject: 2019 Coal Combustion Residuals (CCR) Inactive Surface Impoundment Inspection

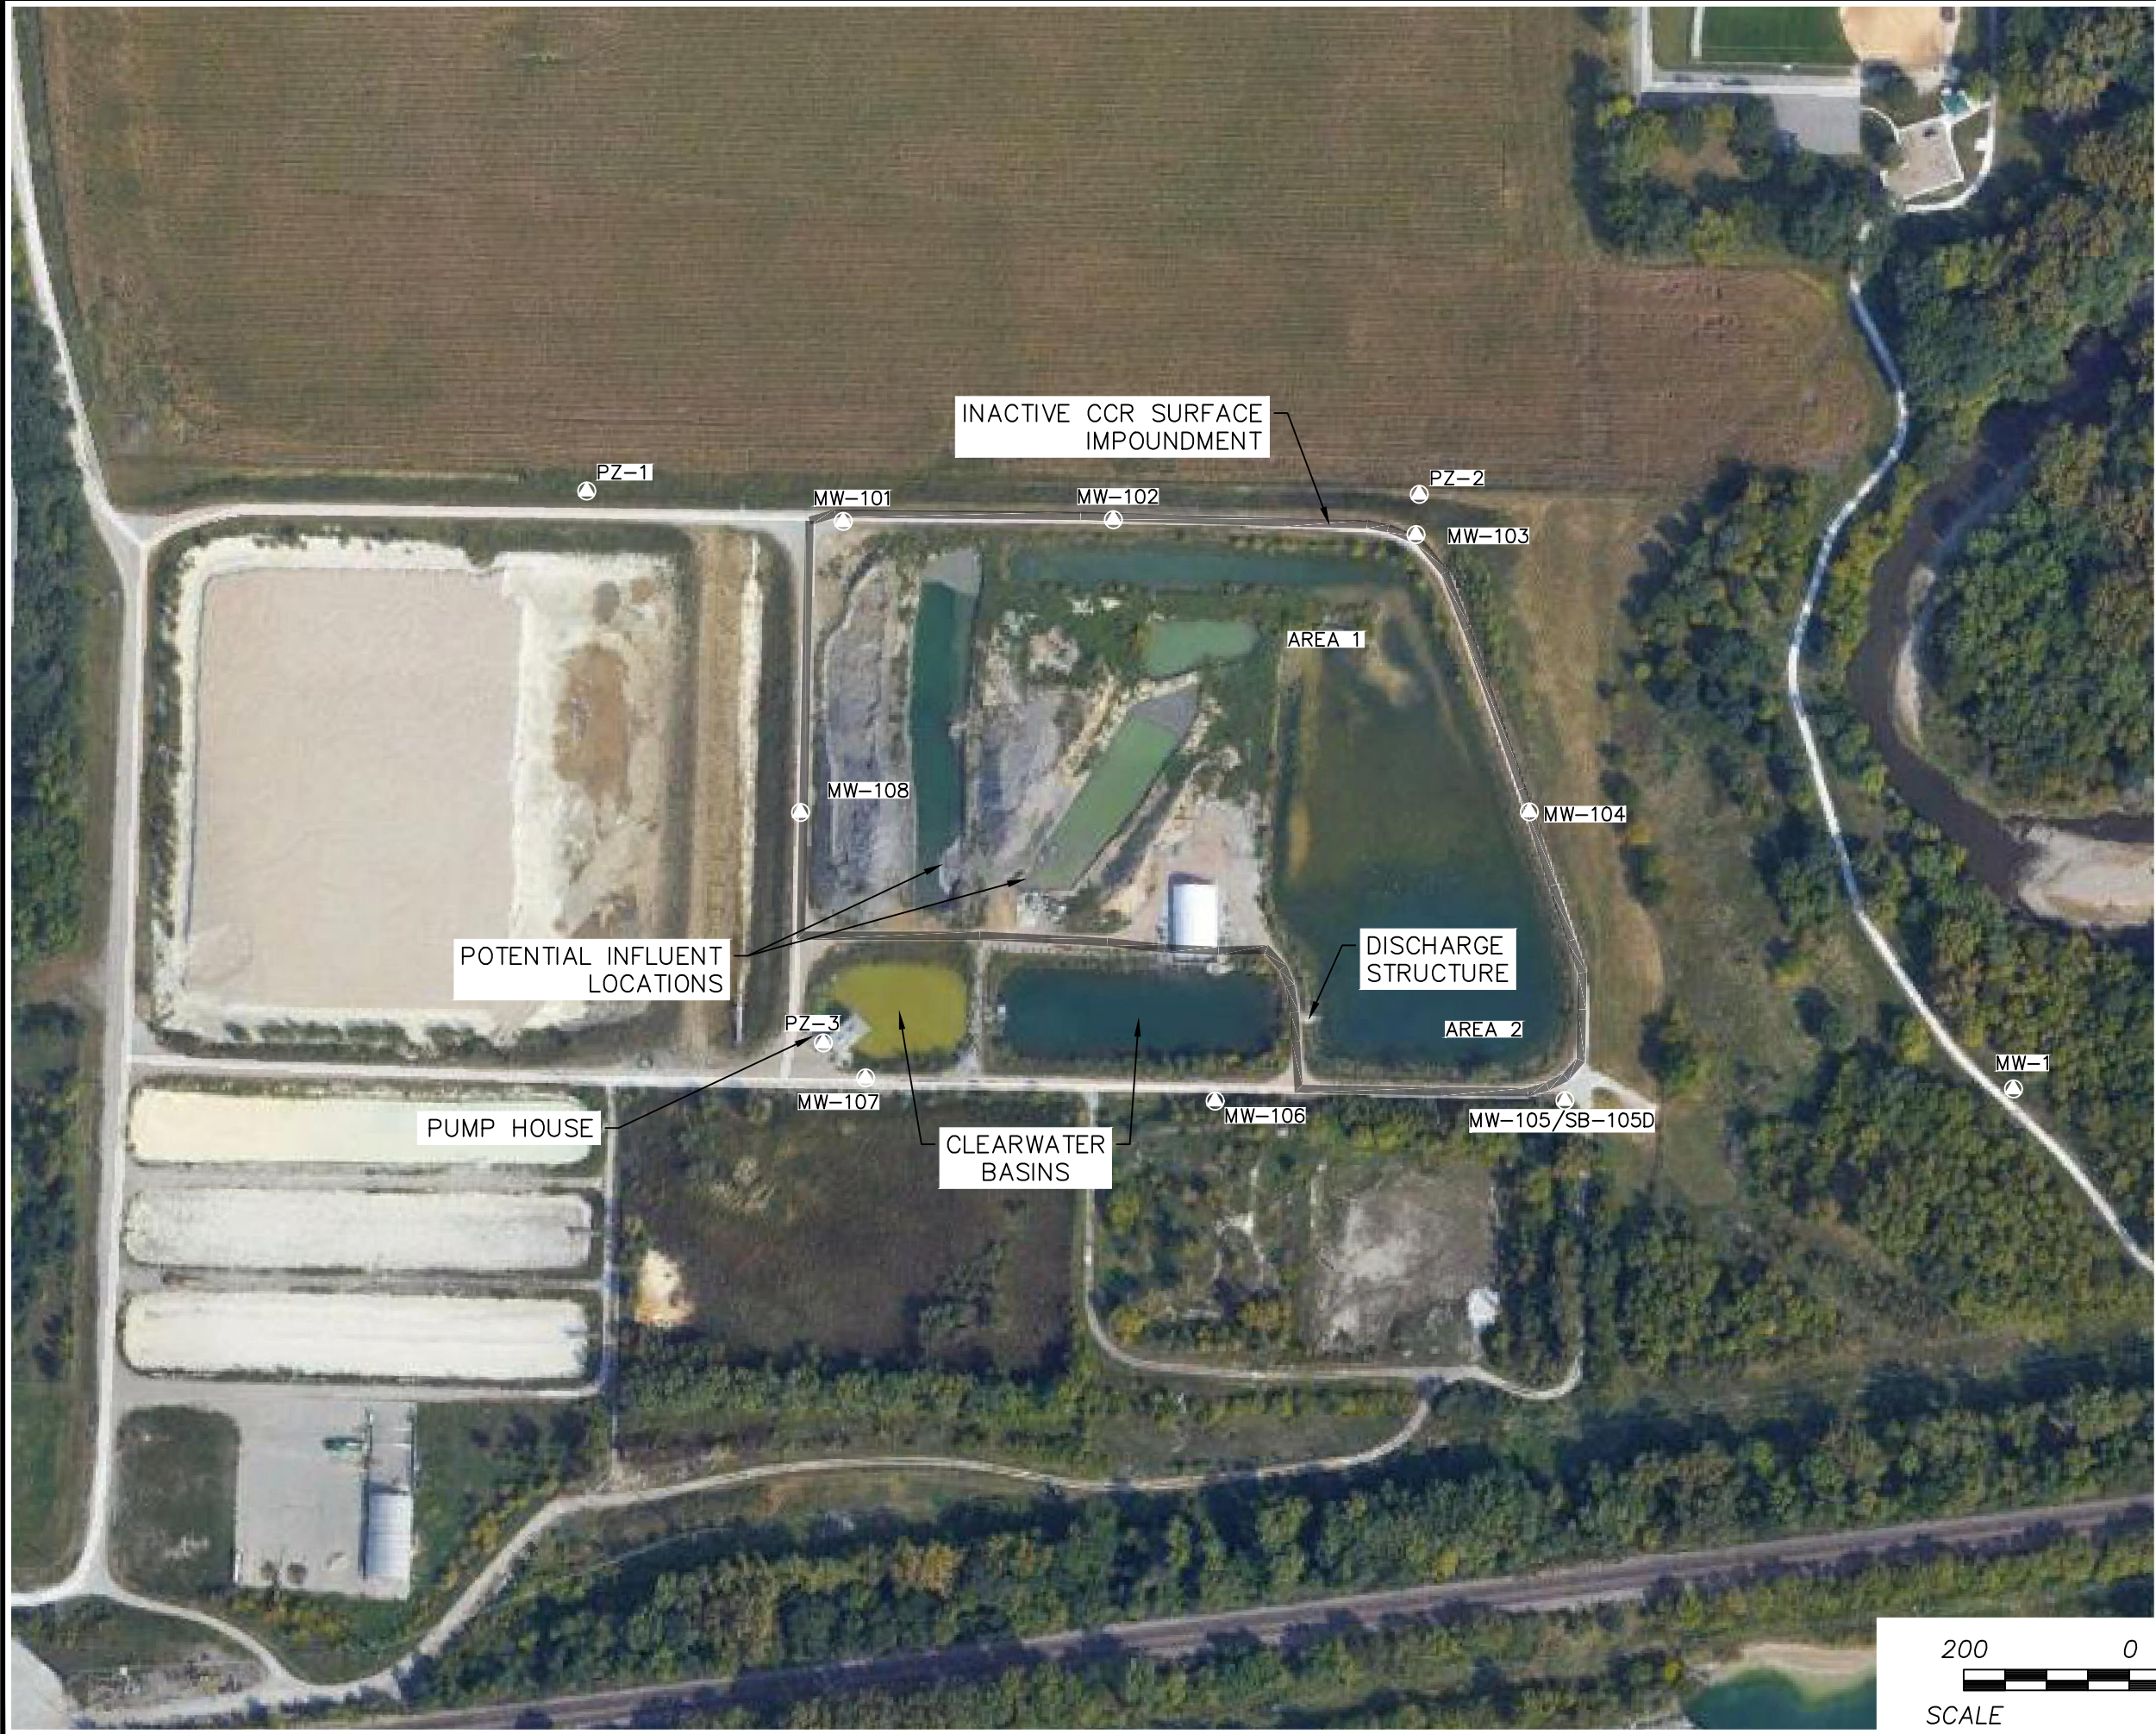
2.	Are there any brush, trees, or other unwanted vegetation? Multiple locations	X		
3.	Are there any slumps or eroded areas? See Figure 1 Area 2	X		
4.	Are animal burrows present? Beavers have been observed in the impoundment and have built nest on the <b>interior</b> portion of the impoundment (See Figure 1 Area 1)		X

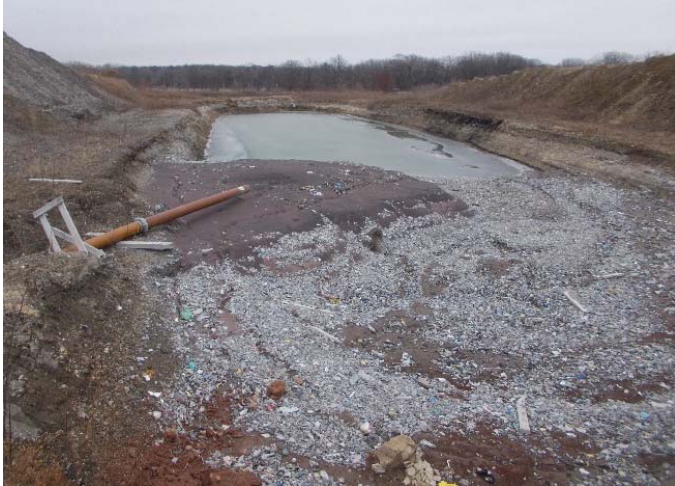
**Photo 1: 2018 East Ash sluice pipe to Ash Pond Receiving Ditch**

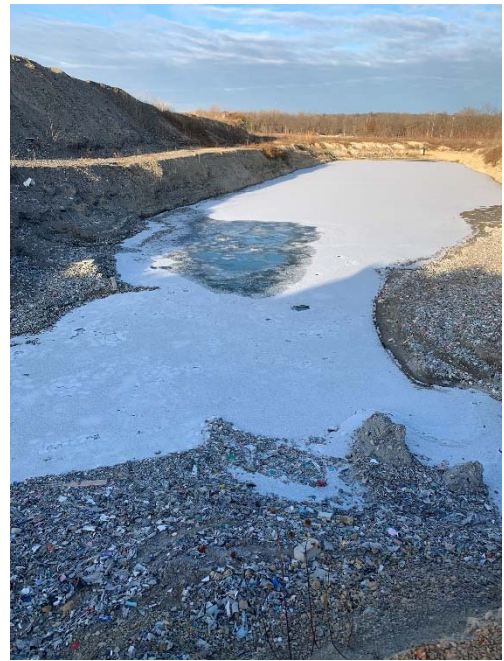
**Photo 2: 2019 East Ash sluice pipe to Ash Pond Receiving Ditch**

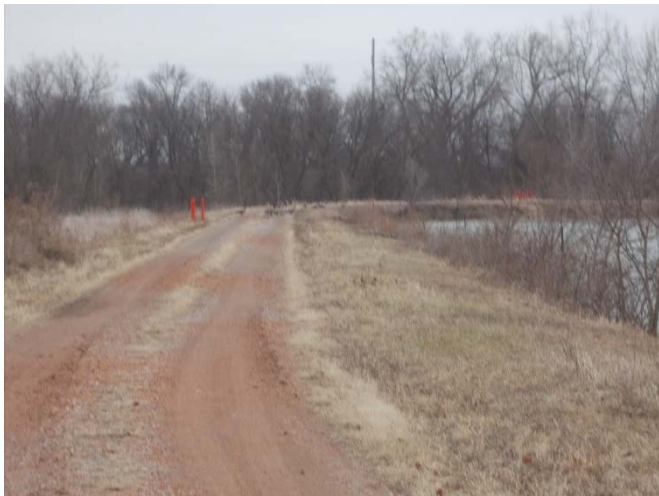
**Photo 3: 2018 North dike crest view east along Ash Pond**

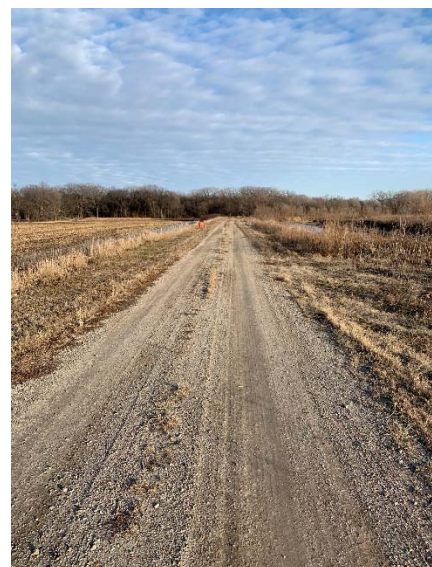
**Photo 4: 2019 North dike crest view east along Ash Pond**

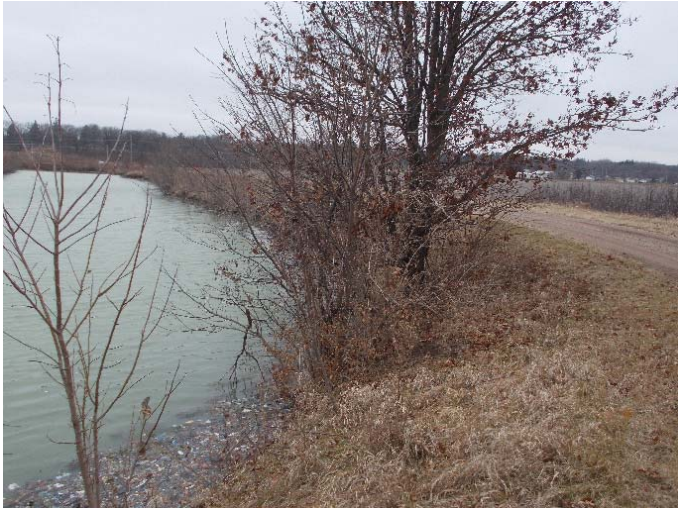
**Photo 5: 2018 North dike interior slope view west along ash pond**

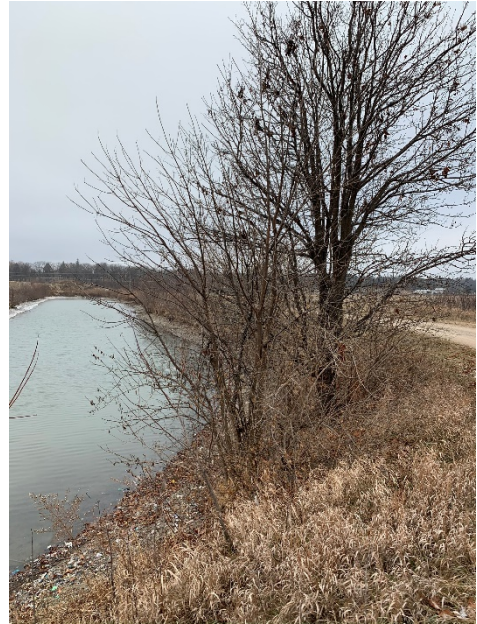
**Photo 6: 2019 North dike interior slope view west along ash pond**

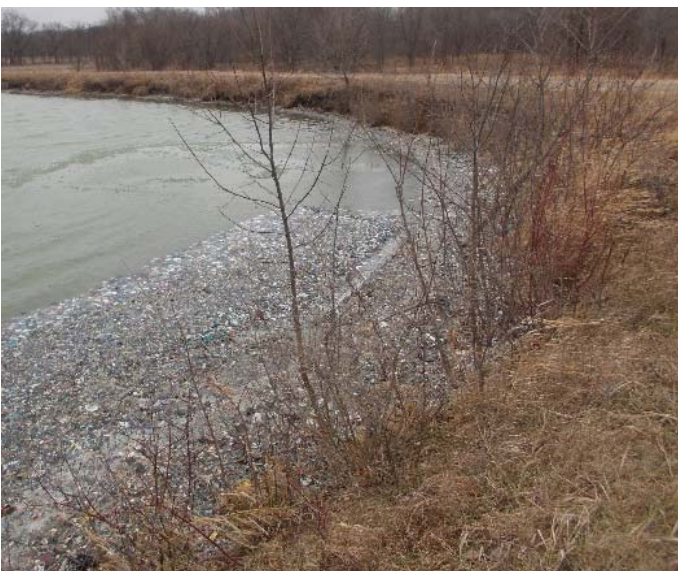
**Photo 7: 2018 Erosion along inside slope south embankment**

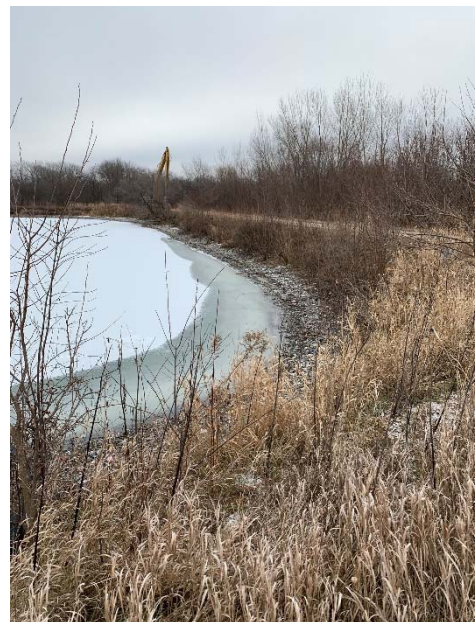
**Photo 8: 2019 Erosion along inside slope south embankment**

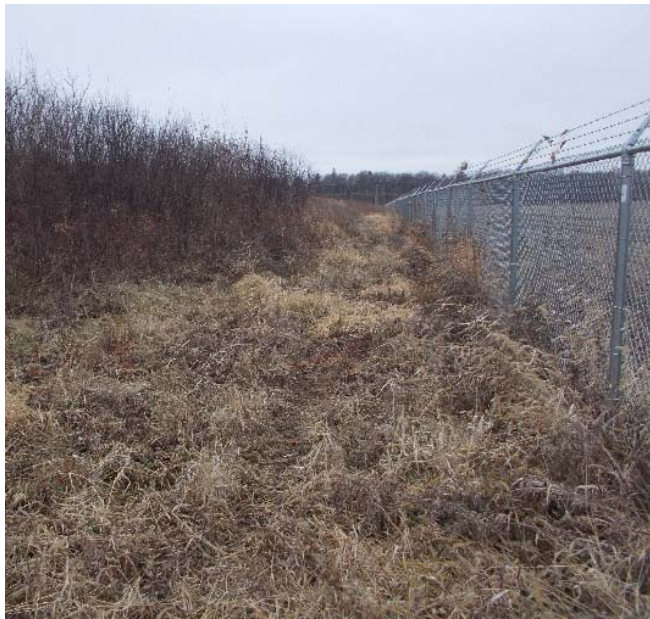
**Photo 9: 2018 Outside slope north embankment viewing west. New fence and vegetation needing removal.**

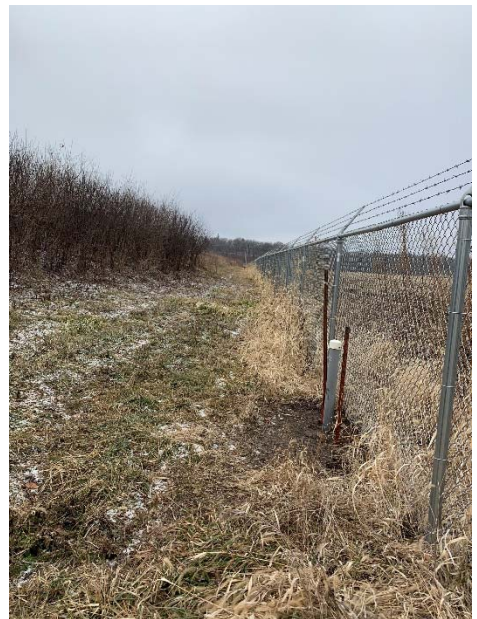
**Photo 10: 2019 Outside slope north embankment viewing west.**

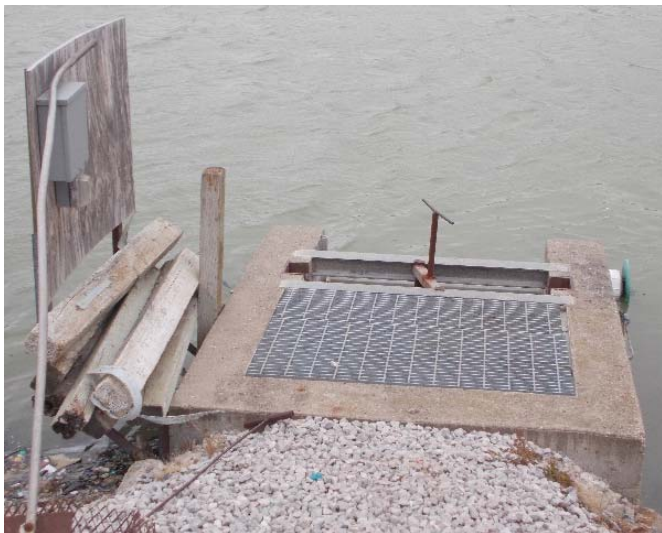
**Photo 11: 2018 Ash pond outlet structure**

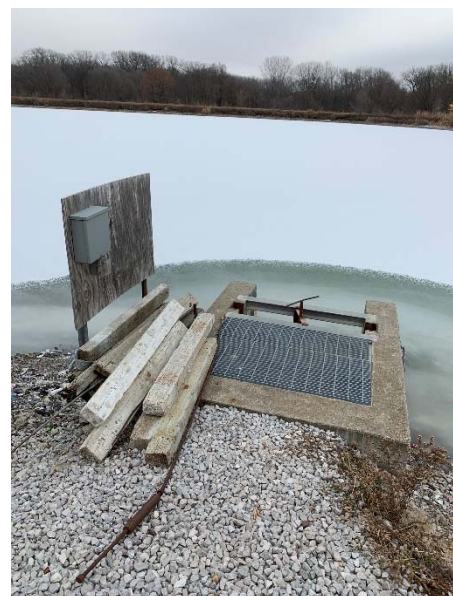
**Photo 12: 2019 Ash pond outlet structure**

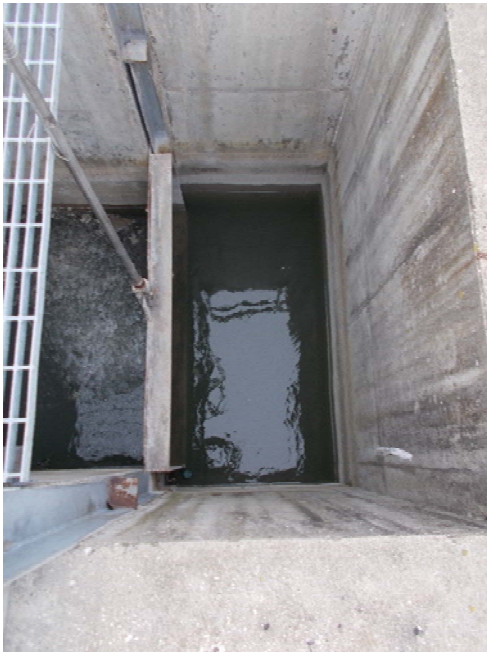
**Photo 13: 2018 Inside the Clear Water Basin outlet valve control structure**

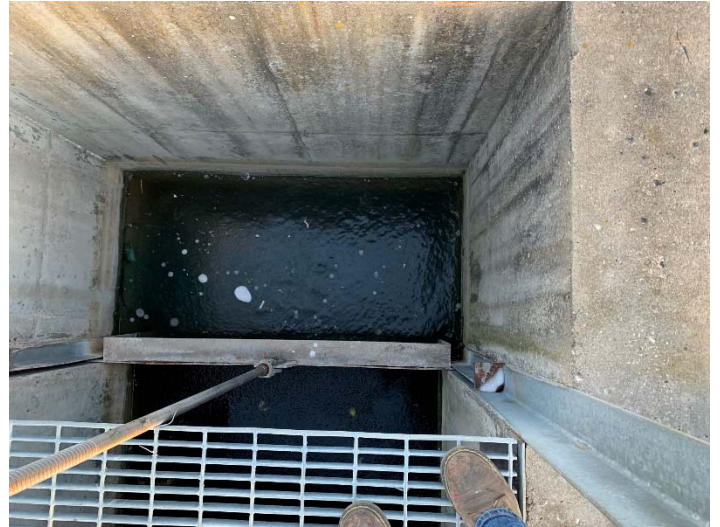
**Photo 14: 2019 Inside the Clear Water Basin outlet valve control structure**

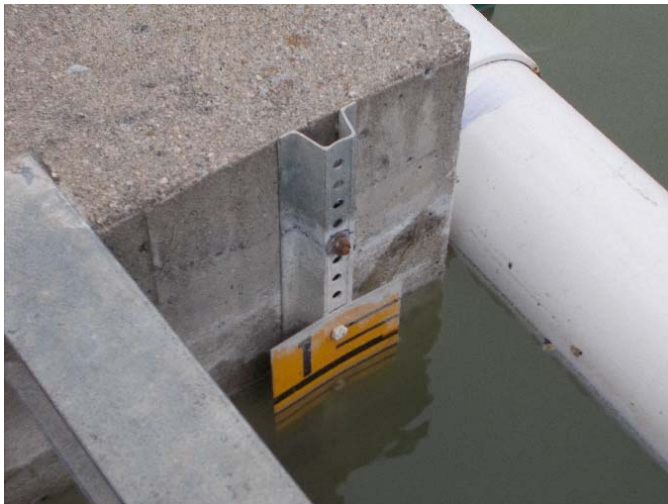
**Photo 15: 2018 Gauge located at ash pond outlet structure (AP-1)**

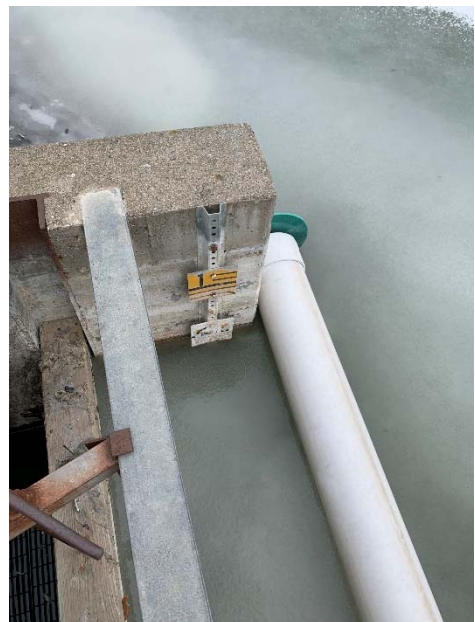
**Photo 16: 2019 Gauge located at ash pond outlet structure (AP-1)**

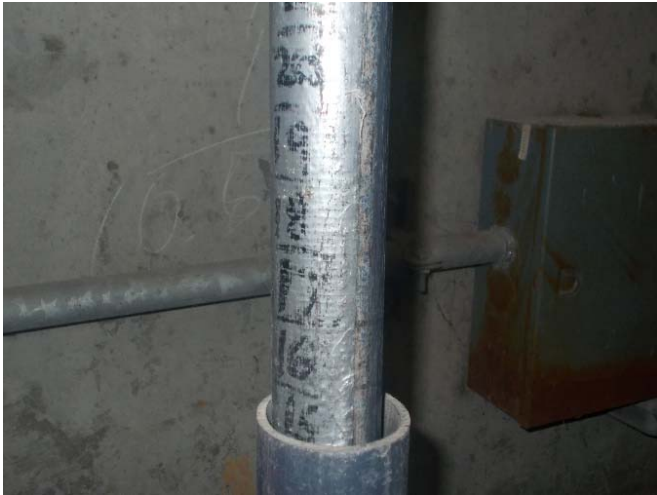
**Photo 17: 2018 Gauge located within pump house (CW-2)**

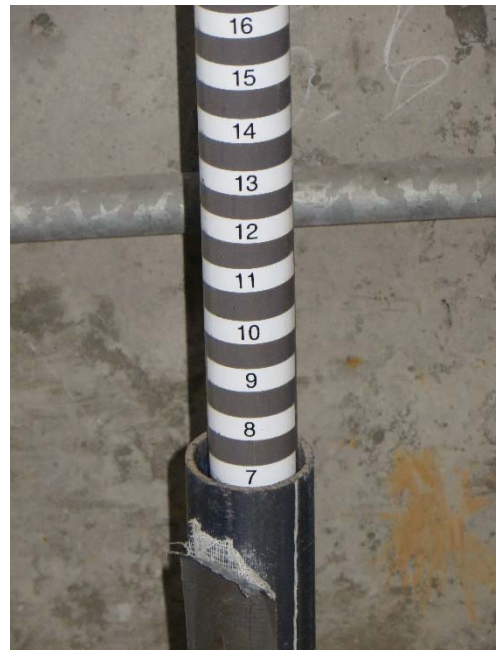
**Photo 18: 2019 Gauge located within pump house (CW-2)**

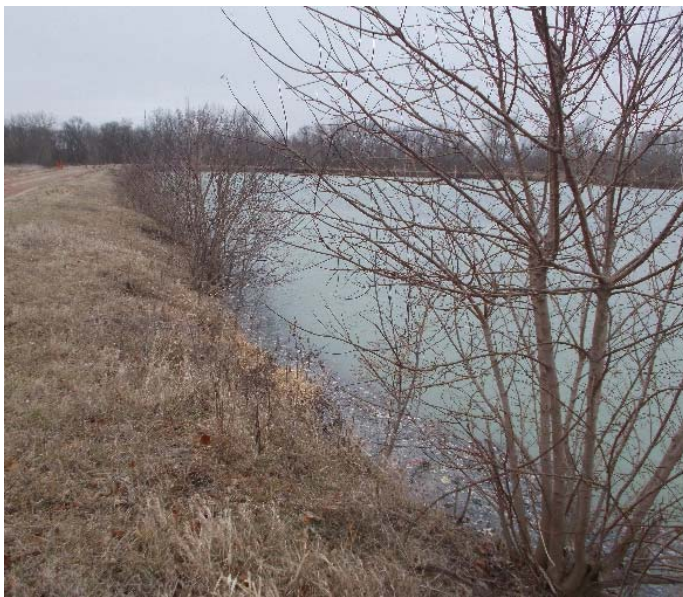
Item Noted	Comment	Action Level
Inappropriate vegetation growth	Trees were noted growing on both the upstream and downstream slopes.	Removal with routine maintenance
Animal impacts	Indications of beavers were noted based on tree marks and an apparent home in an interior CCR pile. There is no animal activity in the exterior dikes. See Appendix A Checklist Notes, Area 1 on the aerial photograph for approximate area.	Continued observation
Erosion damage	Erosion noted in southeast corner of Impoundment on the inboard slope. Also noted in the last site observation. Ames Municipal Electric System SEP staff stated they are in the process of developing a plan for the future of the Impoundment, with modifications to occur within the next 20 months. See Appendix A Checklist Notes, Area 2 on the aerial photograph for approximate area.	Repair with routine maintenance

**Photo 19: 2018 Example of vegetative growth to be removed on northeast corner of the ash pond.**

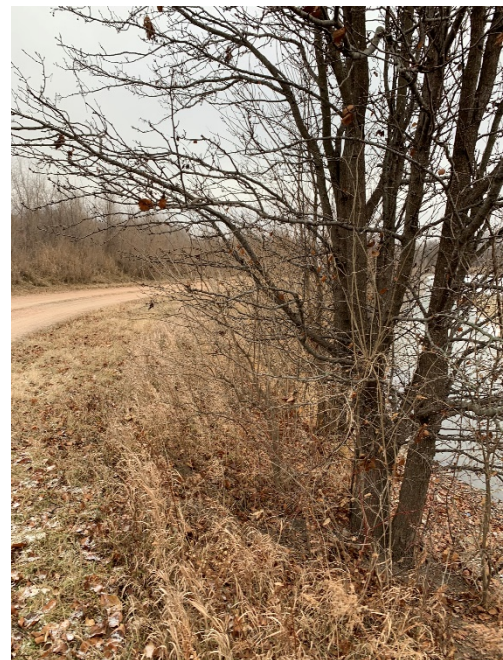
**Photo 20: 2019 Example of vegetative growth to be removed on northeast corner of the ash pond.**

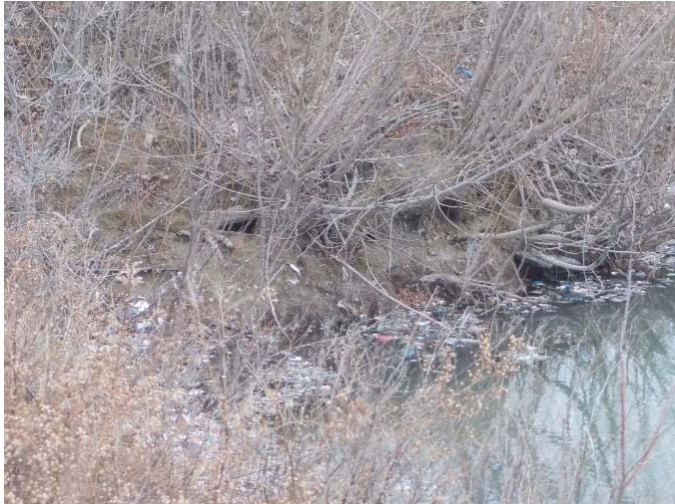
**Photo 21: 2018 Animal impacts. See Area 1 on aerial photo.**

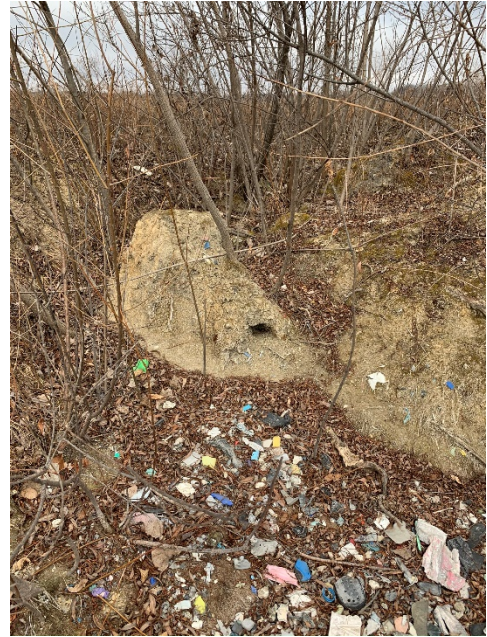
**Photo 22: 2019 Animal impacts. See Area 1 on aerial photo.**

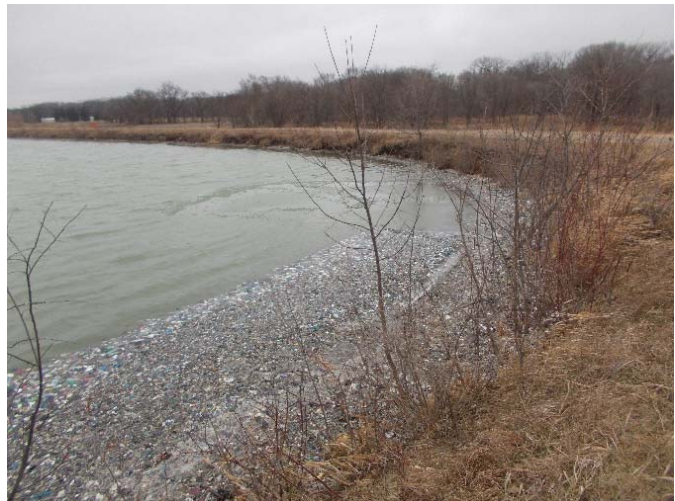
**Photo 23: 2018 Erosion on inboard slope southeast portion of the ash pond from south looking northeast. See Area 2 for location.**

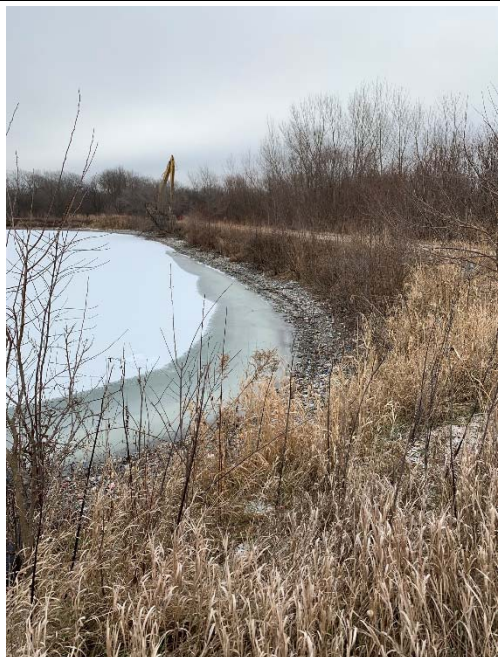
**Photo 24: 2019 Erosion on inboard slope southeast portion of the ash pond from west looking along the south/southeast. See Area 2 for location.**

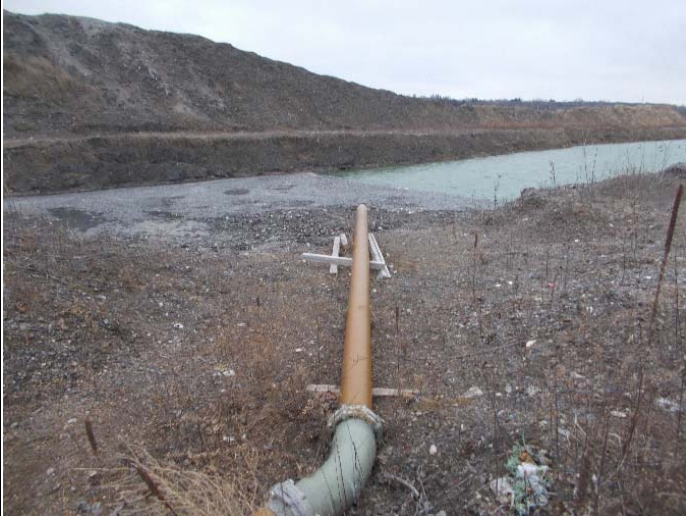
**Photo 25: 2018 Ash sluice pipe to West Ash Pond Receiving Ditch**

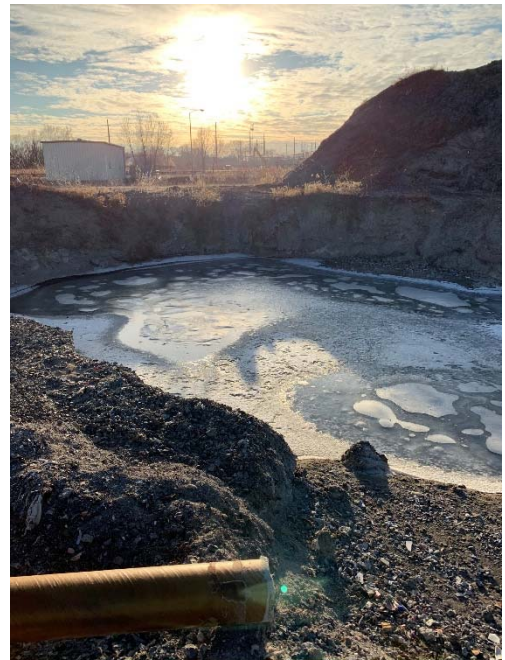
**Photo 26: 2019 Ash sluice pipe to West Ash Pond Receiving Ditch**

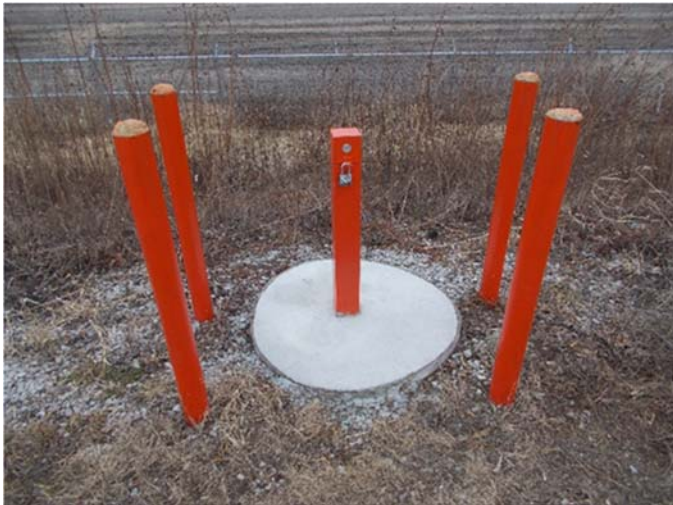
**Photo 27: 2018 Typical groundwater monitoring well installed in June 2018.**

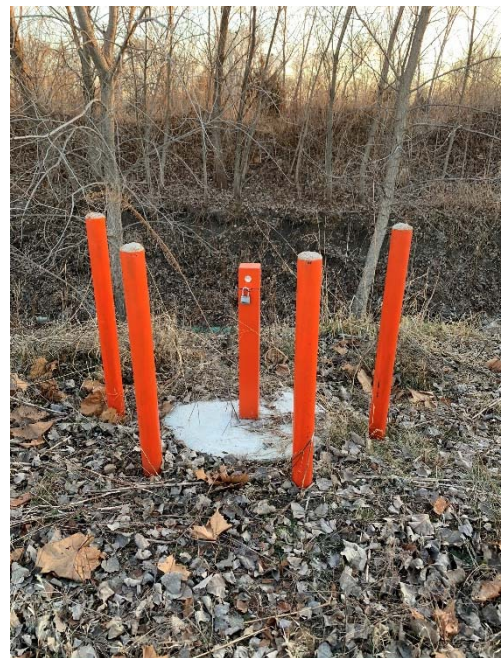
**Photo 28: 2019 Typical groundwater monitoring well installed in June 2018.**

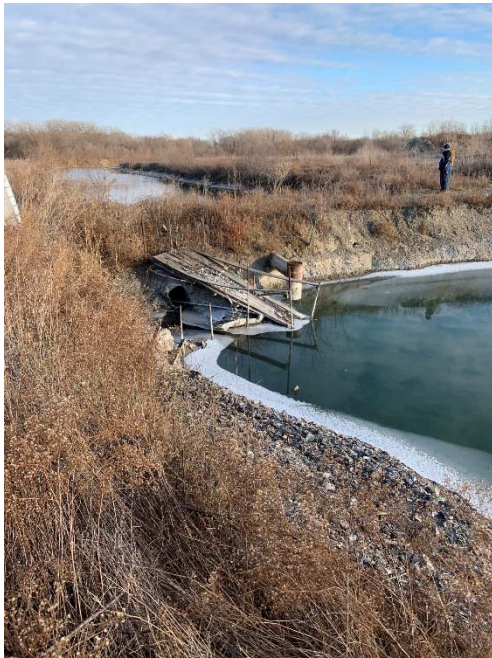
**Photo 29: 2019 Pipe structure connecting west channel to northern area in the ash pond.**

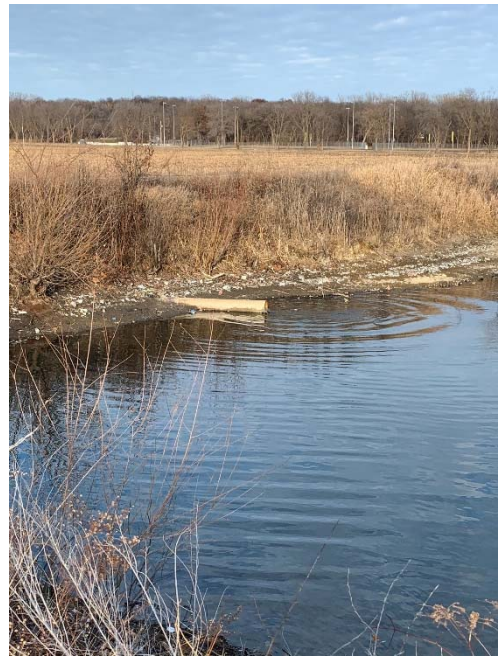
**Photo 30: 2019 SEP floor drain and cooling tower blowdown discharge pipe into the north side of north storage area in the ash pond.**

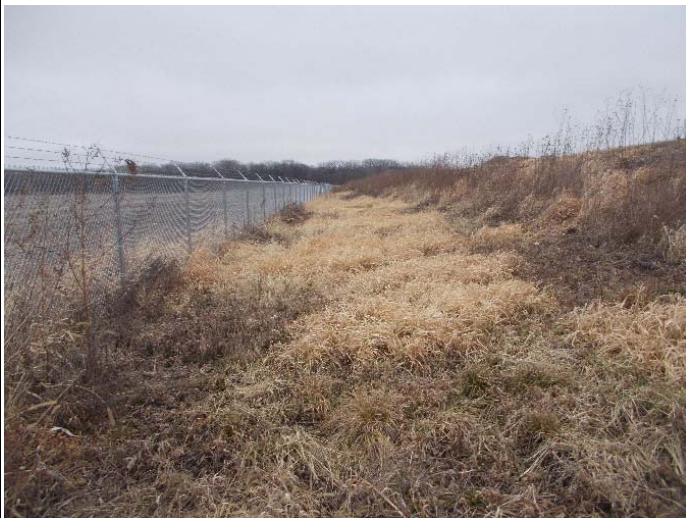
**Photo 31: 2018 Chain link fence installed around perimeter of the ash pond property.**

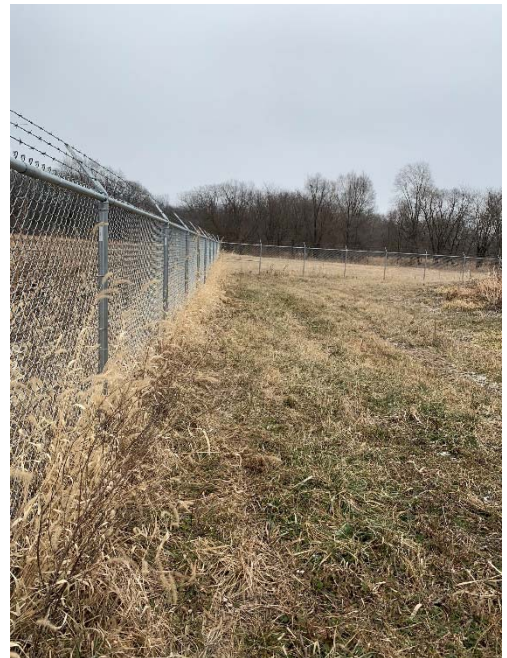
**Photo 32: 2019 Chain link fence installed around perimeter of ash pond property in 2018.**
