2021 Annual Inspection Report Inactive CCR Surface Impoundment

City of Ames Steam Electric Plant

Report Number 27221400.00 | April 2022

Subject: 2021 Coal Combustion Residuals (CCR) Inactive Surface Impoundment Inspection

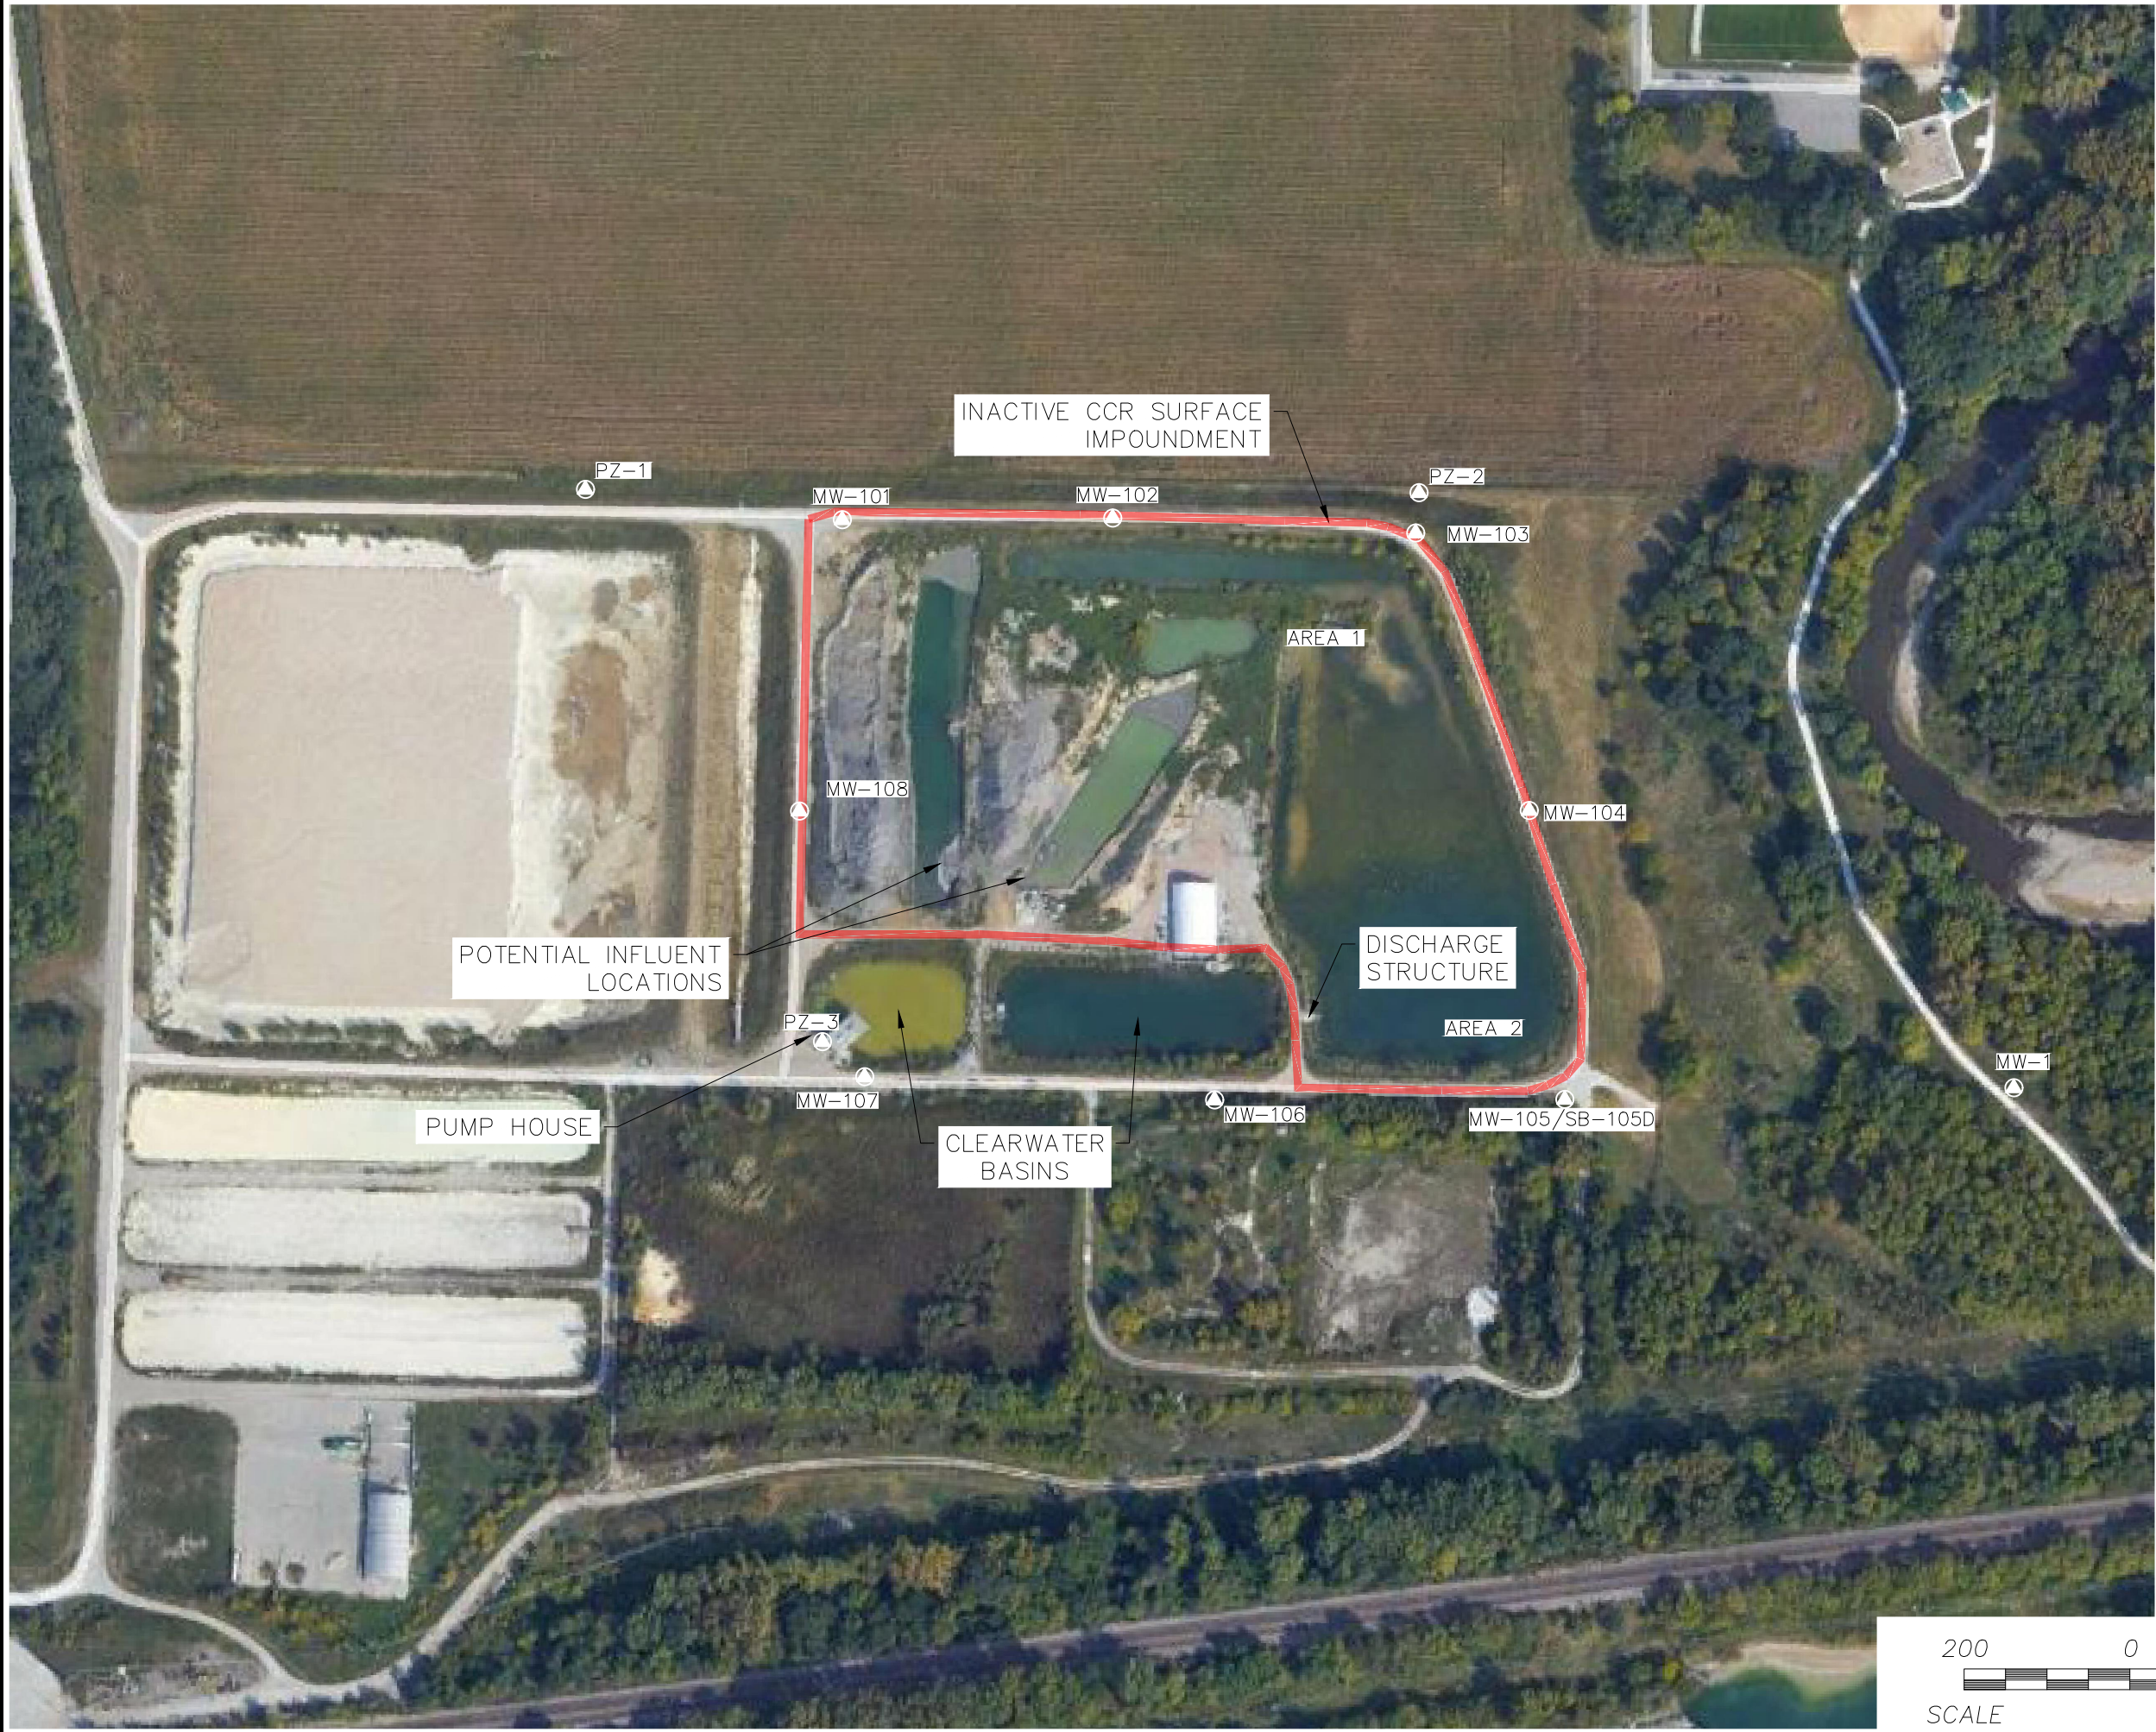
Item Noted	Comment	Action Level
Inappropriate vegetation growth	Trees were noted growing on both the upstream and downstream slopes.	Removal with routine maintenance or with closure of Impoundment
Animal impacts	Indications of beavers were noted based on tree marks. There was no observed animal activity in the exterior dikes. Area 1 on Figure 1 denotes area of past observations.	Continued observation
Erosion damage	Erosion noted in southeast corner of Impoundment on the inboard slope. Also noted in the last site observation. Ames Municipal Electric System are in the process of developing a plan for the future of the Impoundment. See Appendix A Checklist Notes, Area 2 on the aerial photograph for approximate area.	Repair with routine maintenance or with closure of Impoundment

2.	Are there any brush, trees, or other unwanted vegetation? Multiple locations	X		
3.	Are there any slumps or eroded areas? See Figure 1 Area 2	X		
4.	Are animal burrows present? Indications of beavers were noted based on tree marks. There was no animal activity observed in the exterior dikes and no animal burrows were observed during this inspection.		X

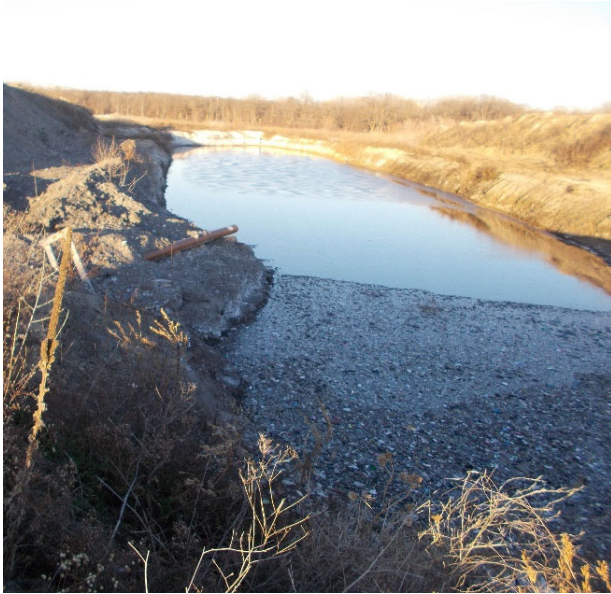
Photo 1: 2020 East Ash sluice pipe to Ash Pond Receiving Ditch

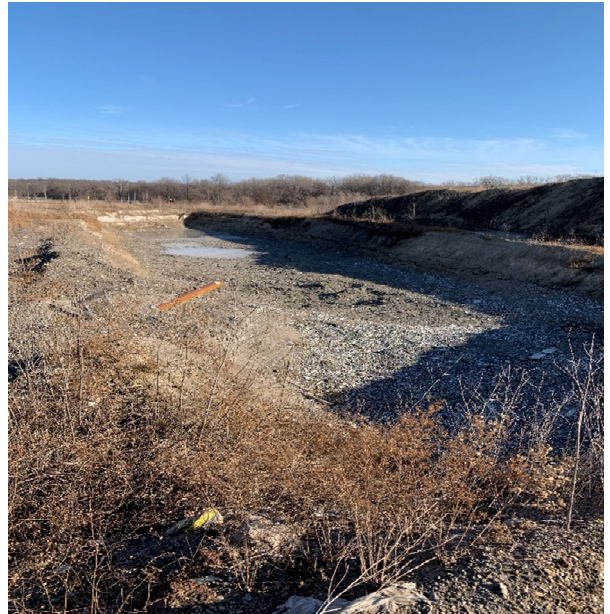
Photo 2: 2021 East Ash sluice pipe to Ash Pond Receiving Ditch

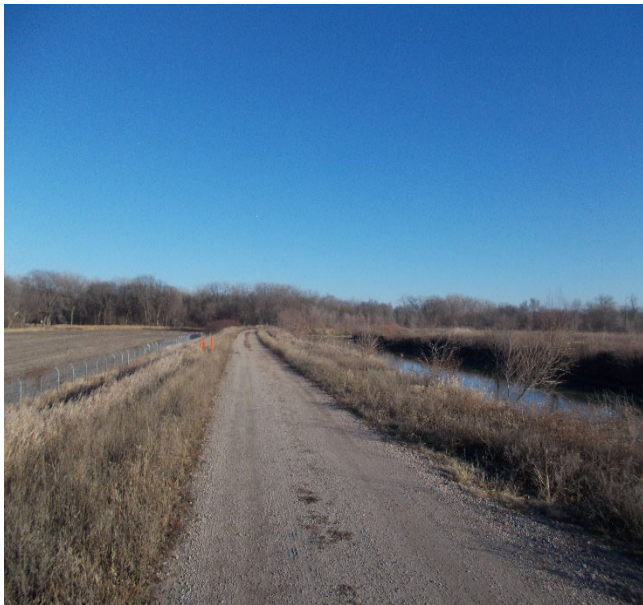
Photo 3: 2020 North dike crest view east along Ash Pond

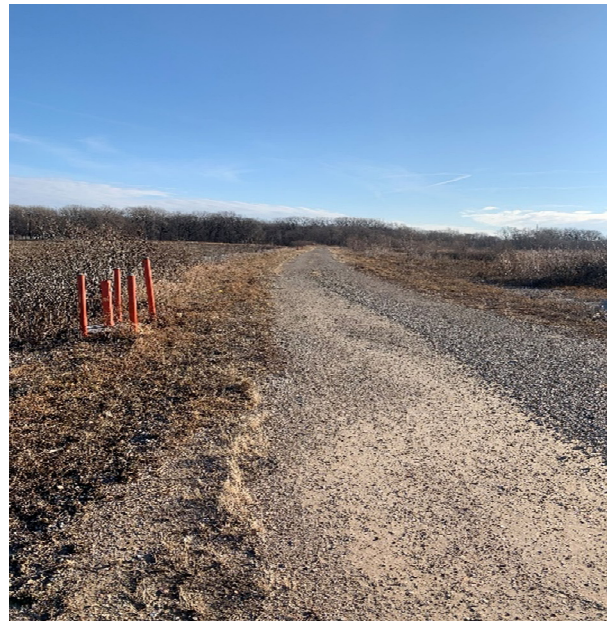
Photo 4: 2021 North dike crest view east along Ash Pond

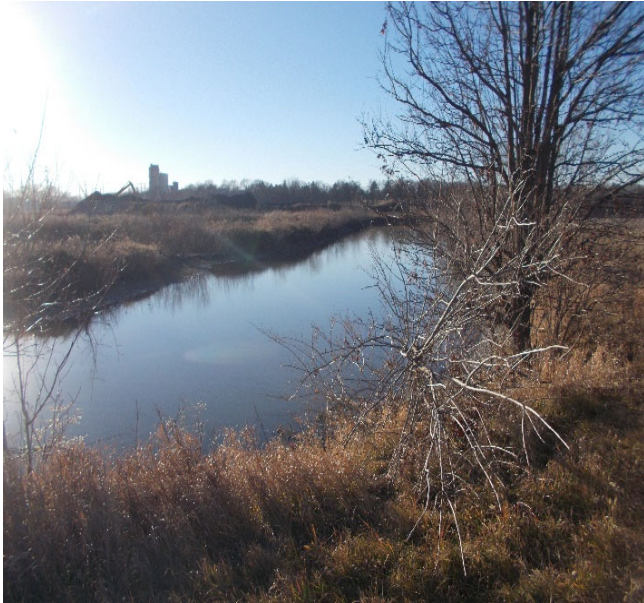
Photo 5: 2020 North dike interior slope view west along ash pond

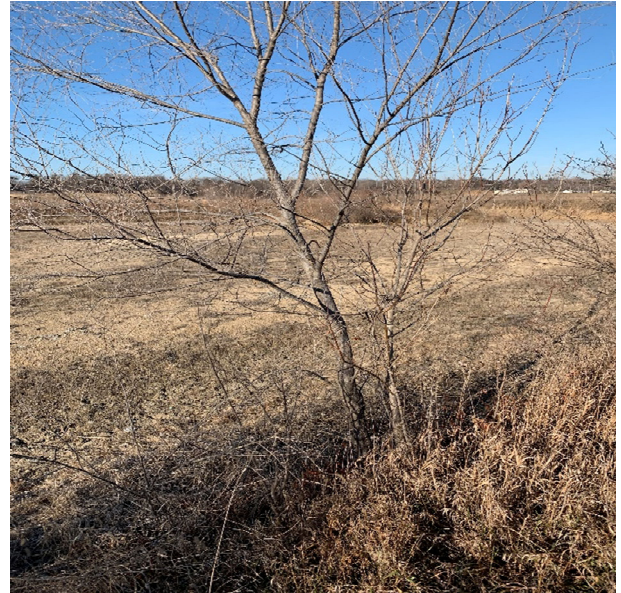
Photo 6: 2021 North dike interior slope view west along ash pond

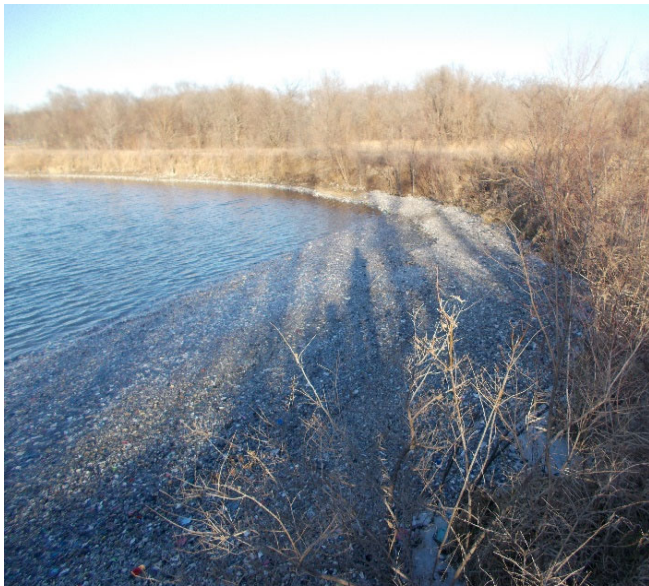
Photo 7: 2020 Erosion along inside slope south embankment

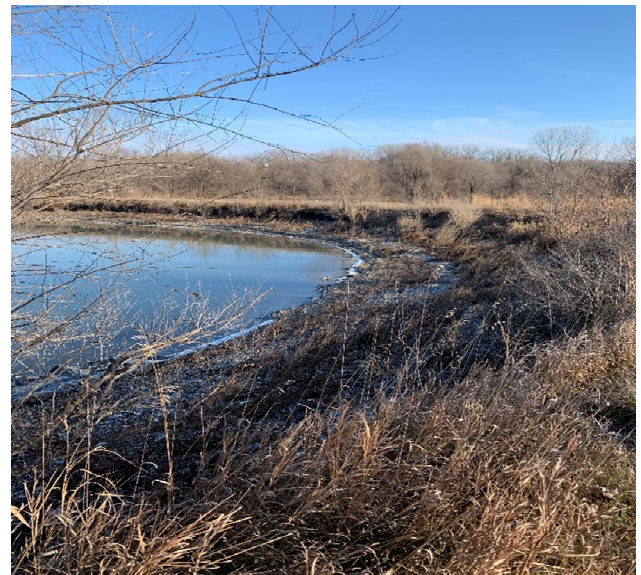
Photo 8: 2021 Erosion along inside slope south embankment

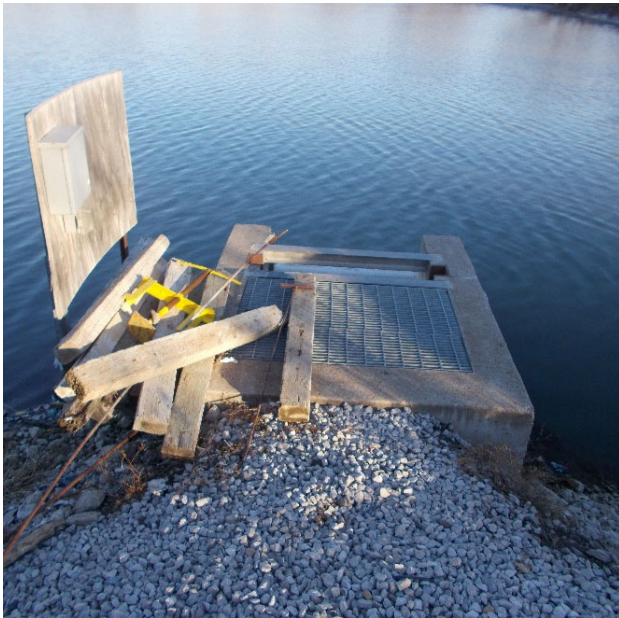
Photo 9: 2020 Ash pond outlet structure

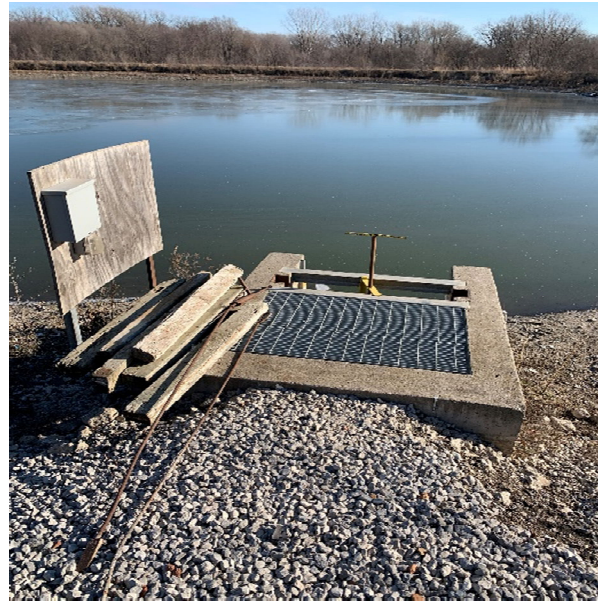
Photo 10: 2021 Ash pond outlet structure

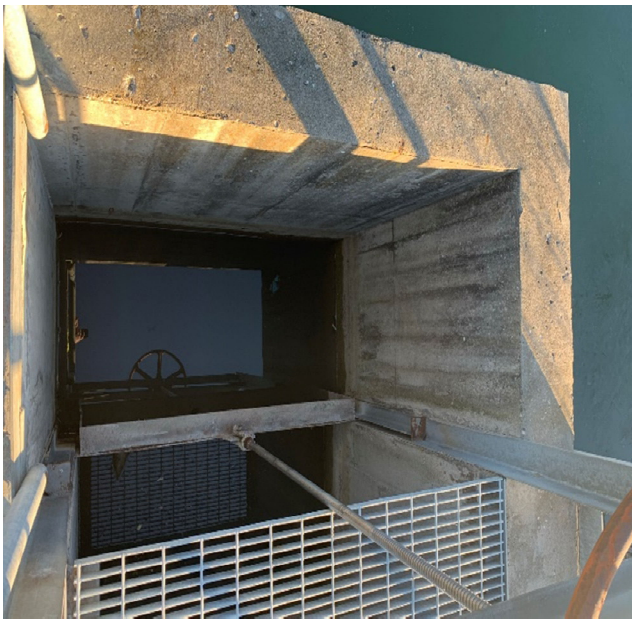
Photo 11: 2020 Inside the Clear Water Basin outlet valve control structure

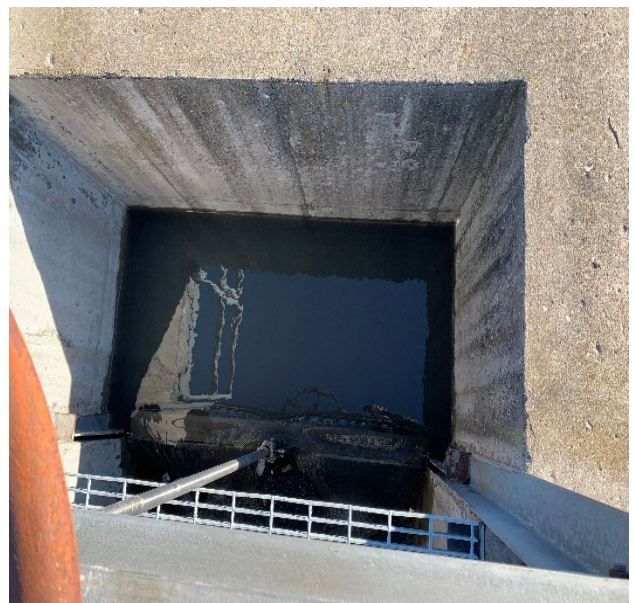
Photo 12: 2021 Inside the Clear Water Basin outlet valve control structure

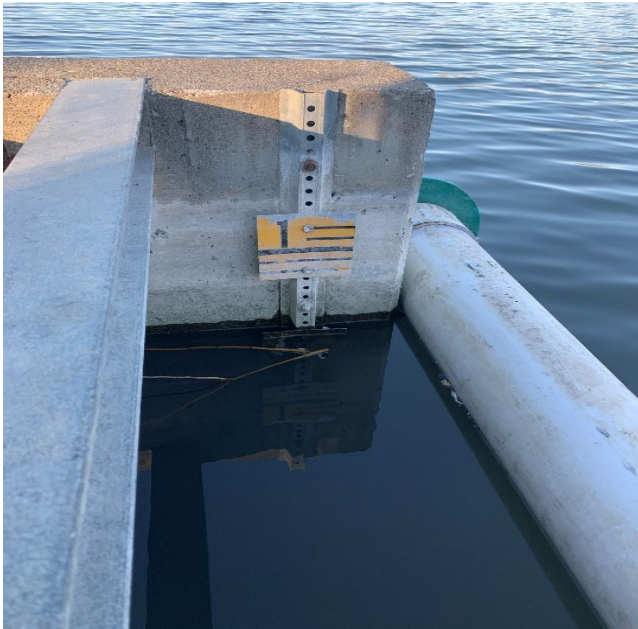
Photo 13: 2020 Gauge located at ash pond outlet structure (AP-1)

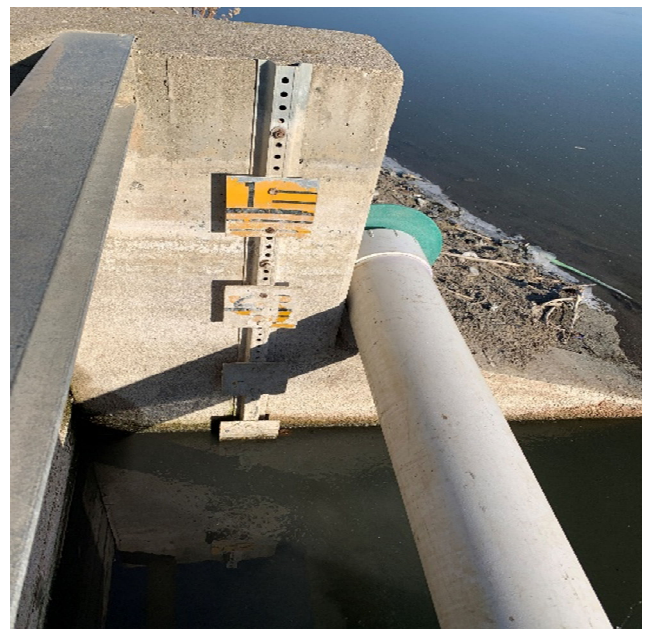
Photo 14: 2021 Gauge located at ash pond outlet structure (AP-1)

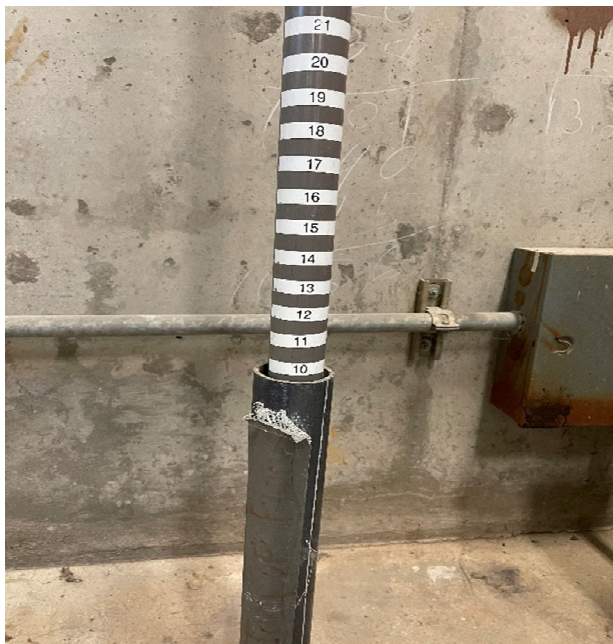
Photo 15: 2020 Gauge located within pump house (CW-2)

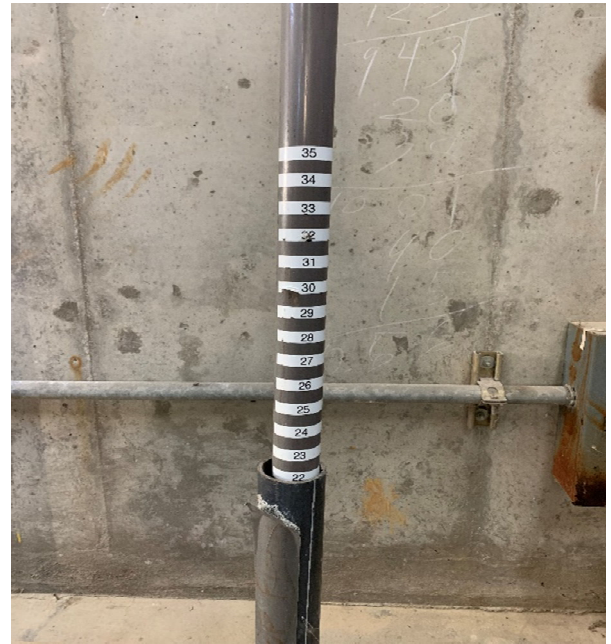
Photo 16: 2021 Gauge located within pump house (CW-2)

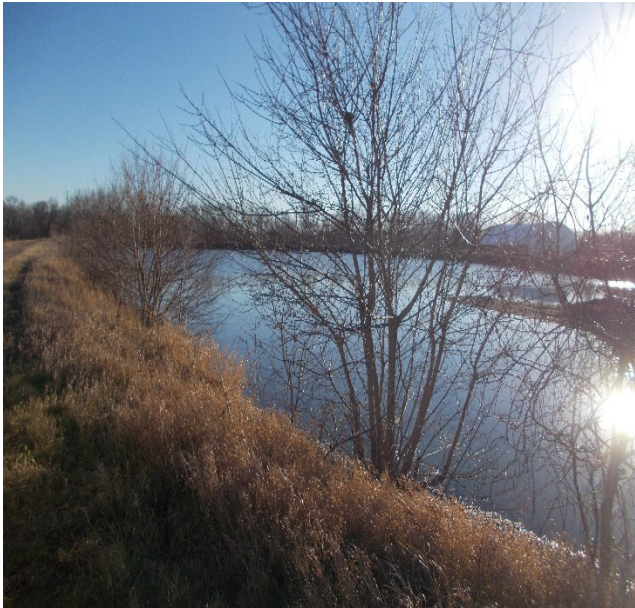
Photo 17: 2020 Example of vegetative growth to be removed on northeast corner of the ash pond.

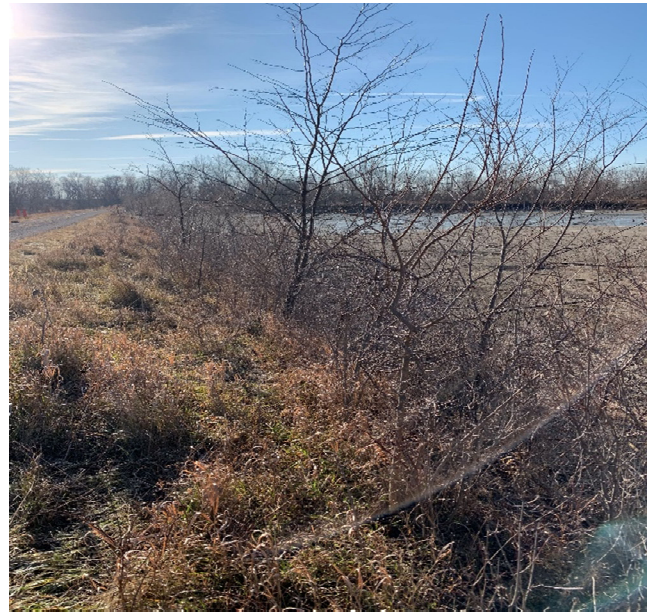
Photo 18: 2021 Example of vegetative growth to be removed on northeast corner of the ash pond.

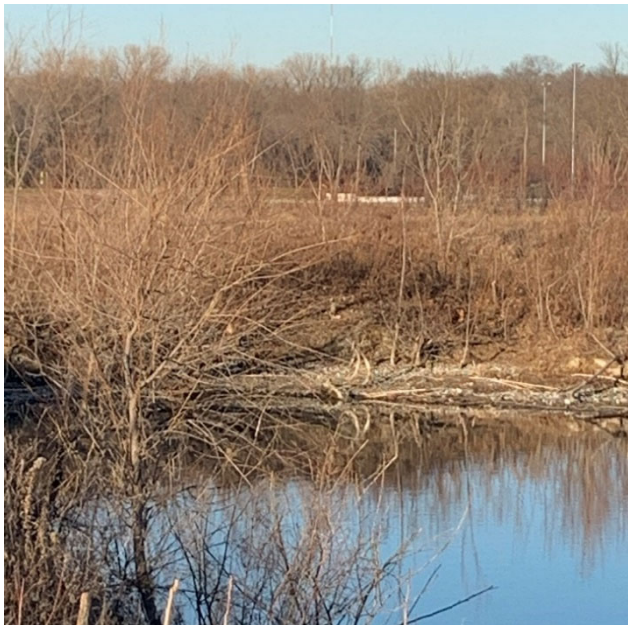
Photo 19: 2020 Area of previously noted animal impacts. See Area 1 on aerial photo.

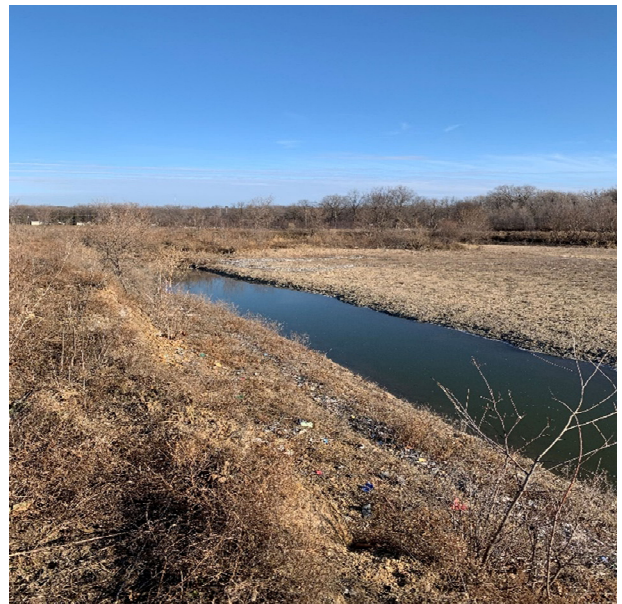
Photo 20: 2021 Area of previously noted animal impacts. See Area 1 on aerial photo.

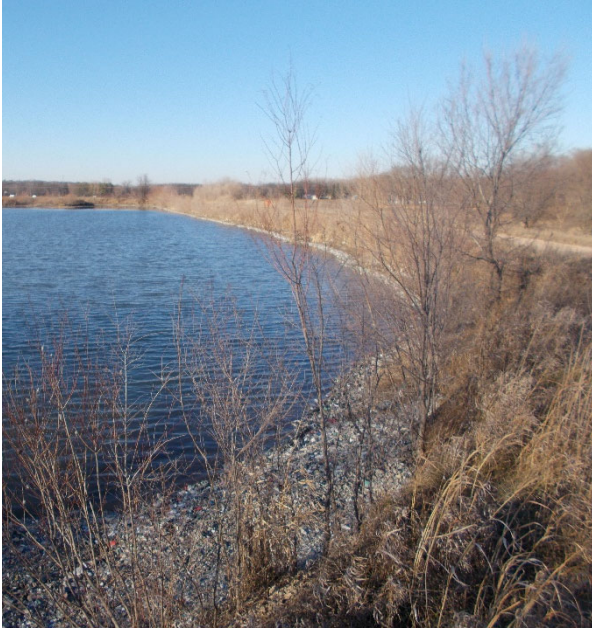
Photo 21: 2020 Erosion on inboard slope southeast portion of the ash pond from south looking northeast. See Area 2 for location.

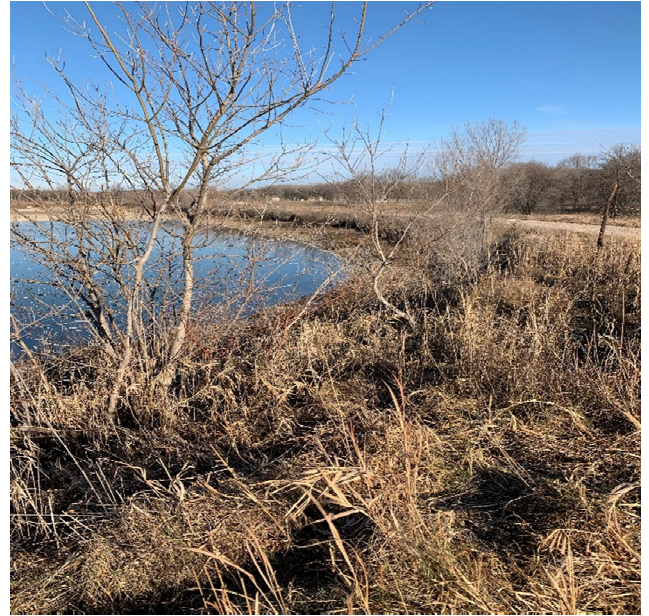
Photo 22: 2021 Erosion on inboard slope southeast portion of the ash pond from west looking along the south/southeast. See Area 2 for location.

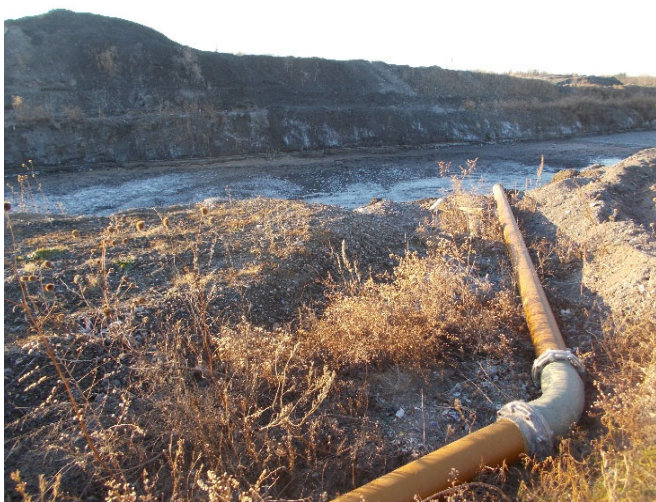
Photo 23: 2020 Ash sluice pipe to West Ash Pond Receiving Ditch

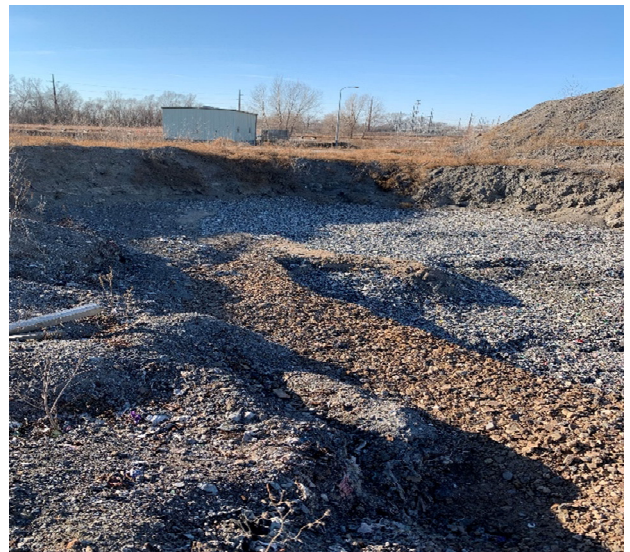
Photo 24: 2021 Ash sluice pipe to West Ash Pond Receiving Ditch

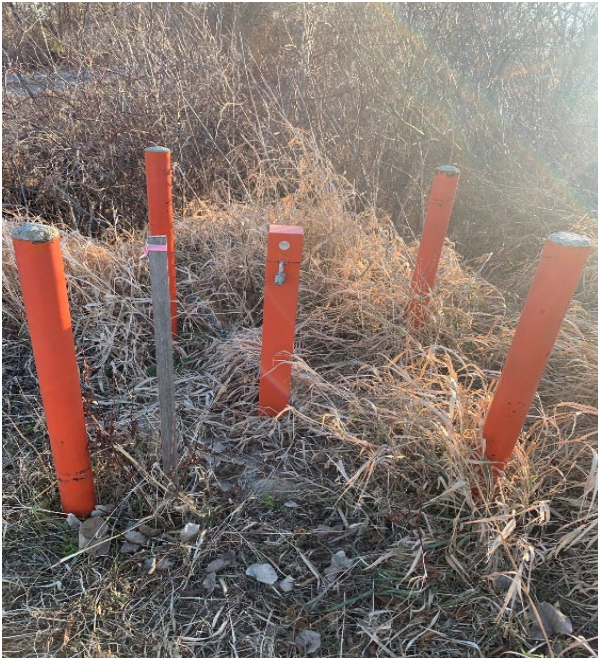
Photo 25: 2020 Typical groundwater monitoring well installed in June 2018.

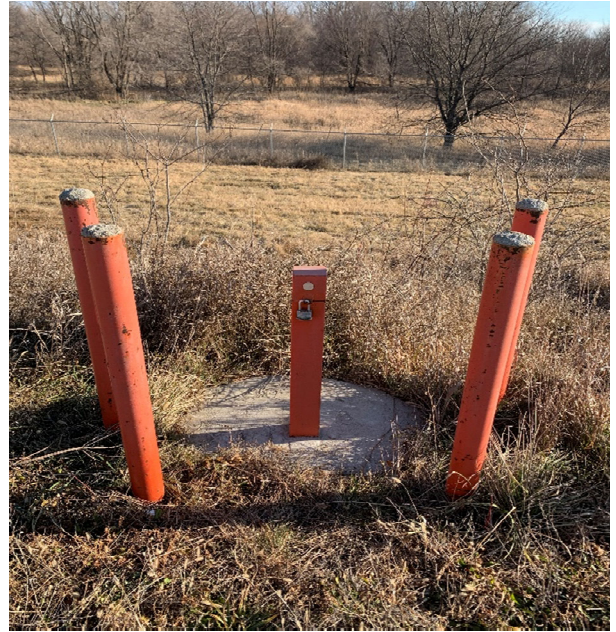
Photo 26: 2021 Typical groundwater monitoring well installed in June 2018.

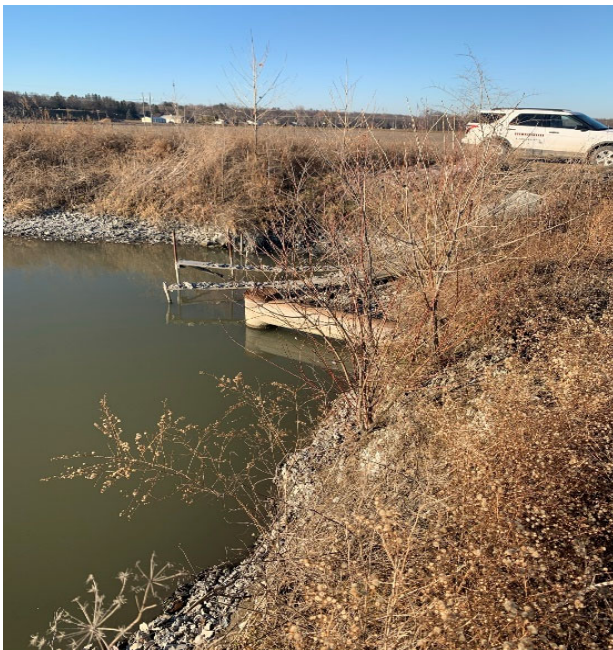
Photo 27: 2020 Pipe structure connecting west channel to northern area in the ash pond.

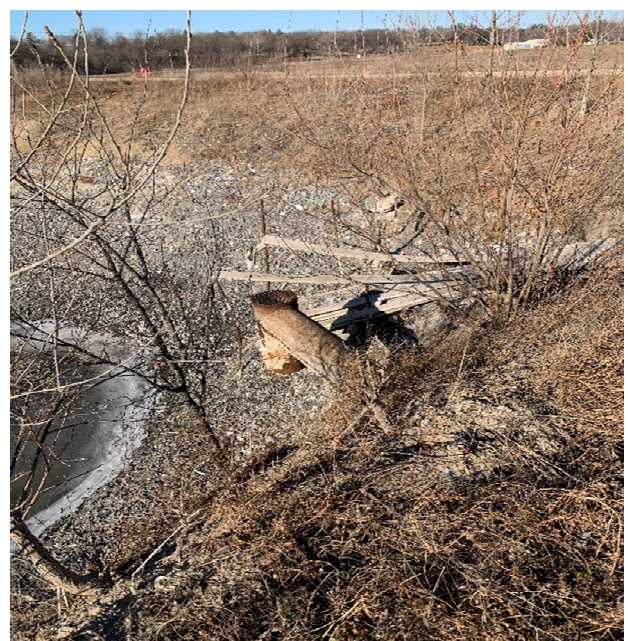
Photo 28: 2021 Pipe structure connecting west channel to northern area in the ash pond.

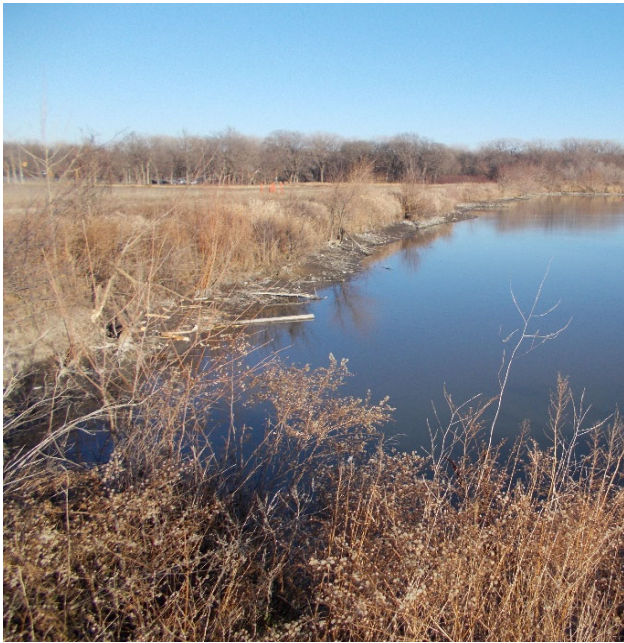
Photo 29: 2020 SEP floor drain and cooling tower blowdown discharge pipe into the north side of north storage area in the ash pond.

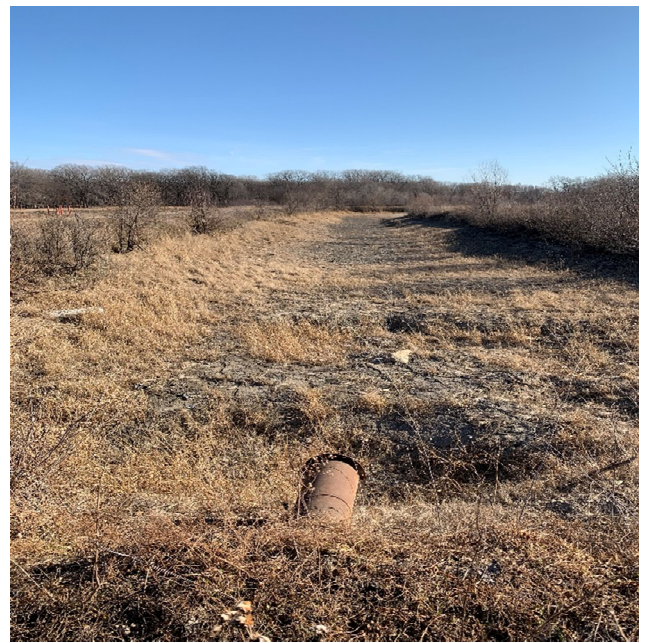
Photo 30: 2021 SEP floor drain and cooling tower blowdown discharge pipe into the north side of north storage area in the ash pond.

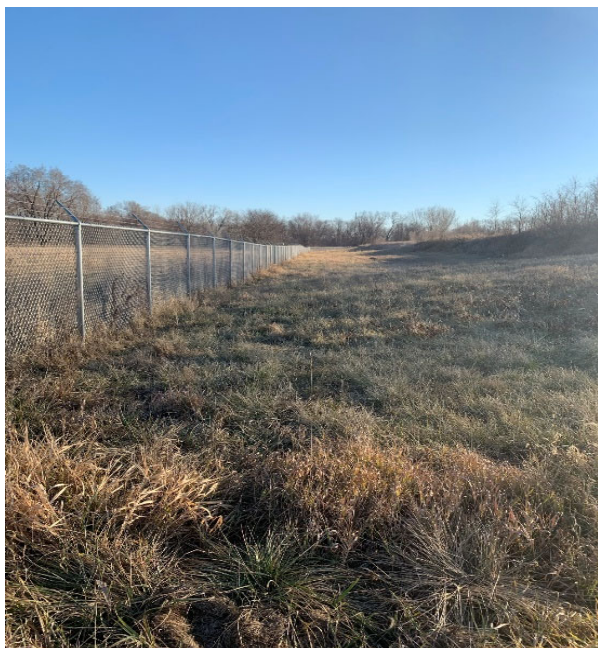
Photo 31: 2020 Chain link fence installed around perimeter of the ash pond property.

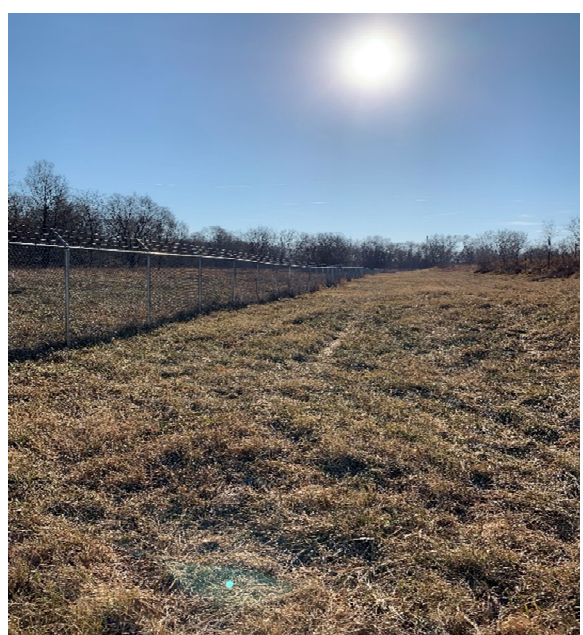
Photo 32: 2021 Chain link fence installed around perimeter of the ash pond property.
