Subject: 2022 Coal Combustion Residuals (CCR) Inactive Surface Impoundment Inspection

2022 Annual Inspection Report Inactive CCR Surface Impoundment

City of Ames Steam Electric Plant

Report Number 27222352.00 | April 2023

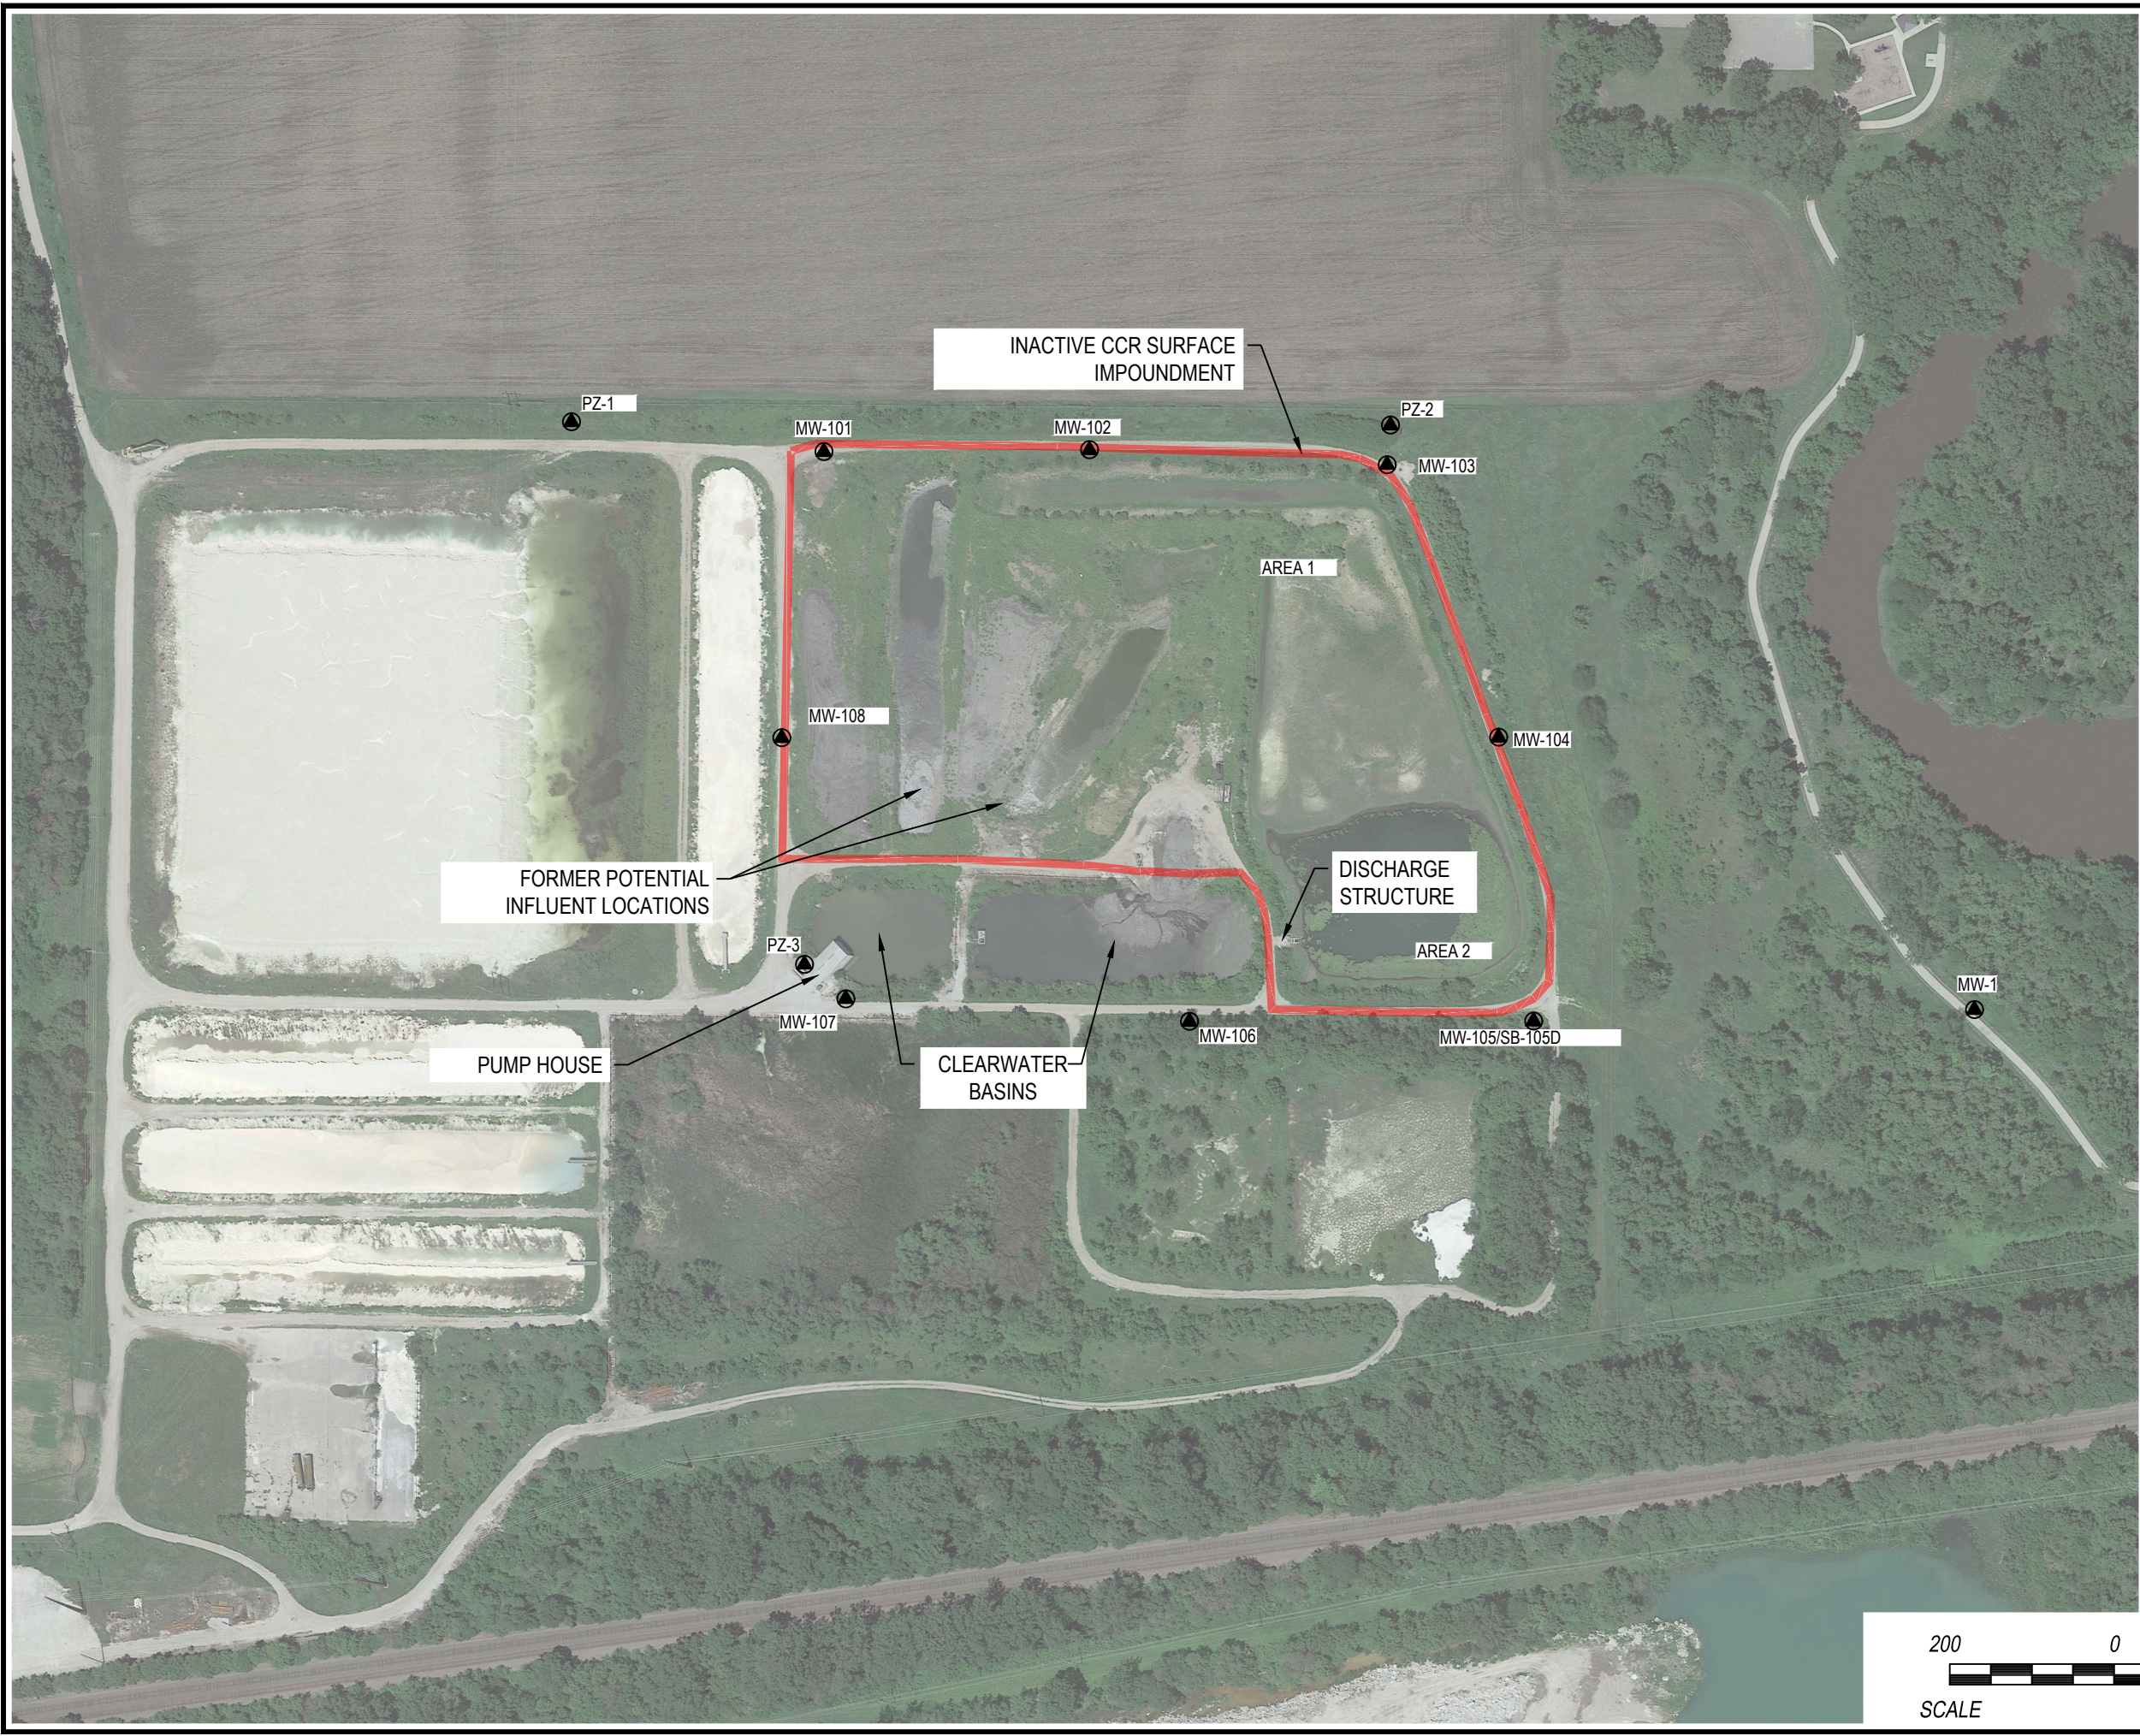
The site observation checklist, included in Appendix A, was utilized during the annual site inspection. The overall site layout is shown on Figure 1. Photographs taken to compare the current facility conditions to those during the 2021 site inspection are included in Appendix B. No significant changes were noted in comparing 2022 with 2021 photographs, with the exception of observed water levels and increased vegetative growth. The results of the annual site inspection, along with a description of any deficiencies identified during the visual observation, are further summarized in the following sections in accordance with 40 CFR §257.83(b)(2).

Historically there have been three piezometers and one groundwater monitoring well (east of the bike path and lying east of the Impoundment) that are utilized for groundwater level readings. Eight additional groundwater monitoring wells were installed in June 2018. Figure 1 shows the locations of these points. Table 1 below provides a summary of the monitoring points, maximum recorded readings since the previous annual site inspection and the date on which those readings occurred.

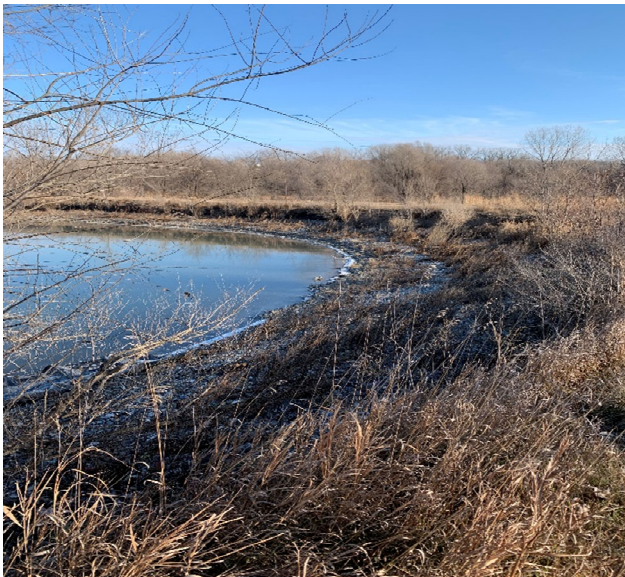
Photo 7: 2021 Erosion along inside slope south embankment

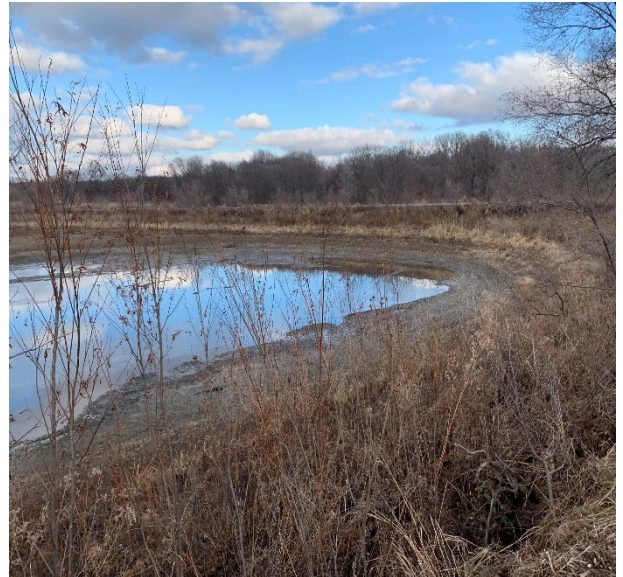
Photo 8: 2022 Erosion along inside slope south embankment

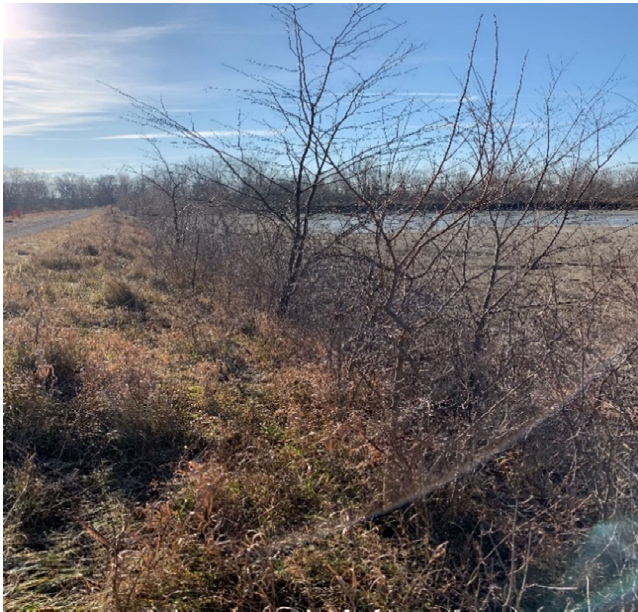
Photo 17: 2021 Example of vegetative growth to be removed on northeast corner of the ash pond.

Item Noted	Comment	Action Level
Inappropriate vegetation growth	Trees were noted growing on both the upstream and downstream slopes.	Removal with routine maintenance or with closure of Impoundment
Animal impacts	There was no observed indications of animal impacts within the Impoundment during this inspection. There was no observed animal activity in the exterior dikes. Area 1 on Figure 1 denotes area of past observations.	Continued observation
Erosion damage	Erosion noted in southeast corner of Impoundment on the inboard slope. Also noted in the last site observation. This will be addressed during the clean closure of this portion of the Impoundment. See Appendix A Checklist Notes, Area 2 on the aerial photograph for approximate area.	Repair during the closure of Impoundment

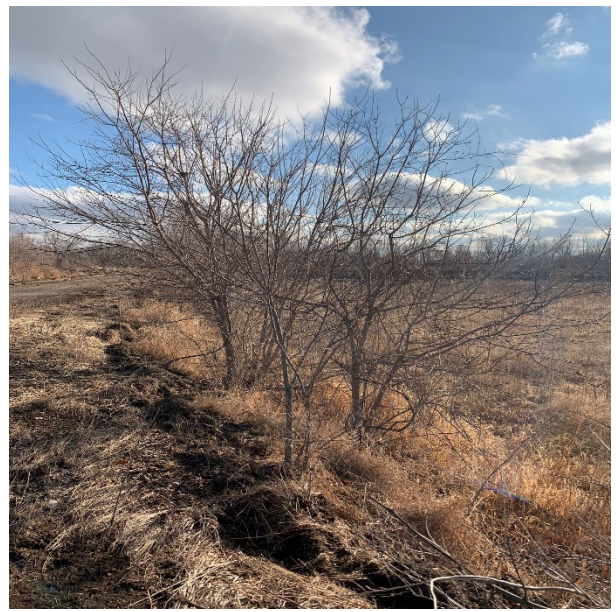
Photo 18: 2022 Example of vegetative growth to be removed on northeast corner of the ash pond.

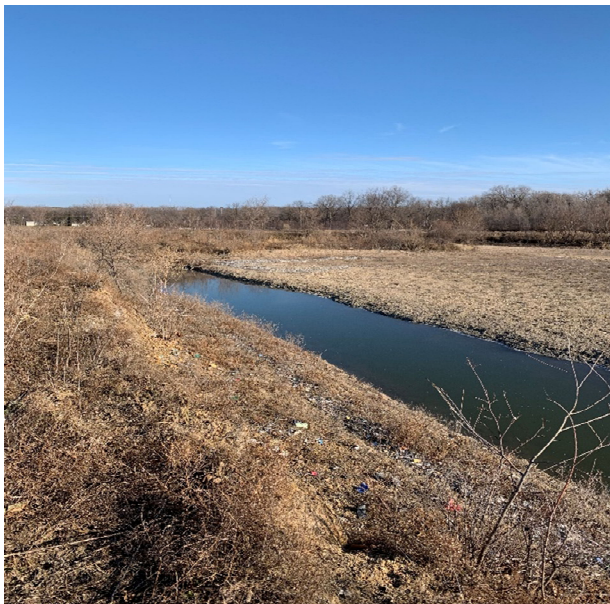
Photo 19: 2021 Area of previously noted animal impacts. See Area 1 on aerial photo.

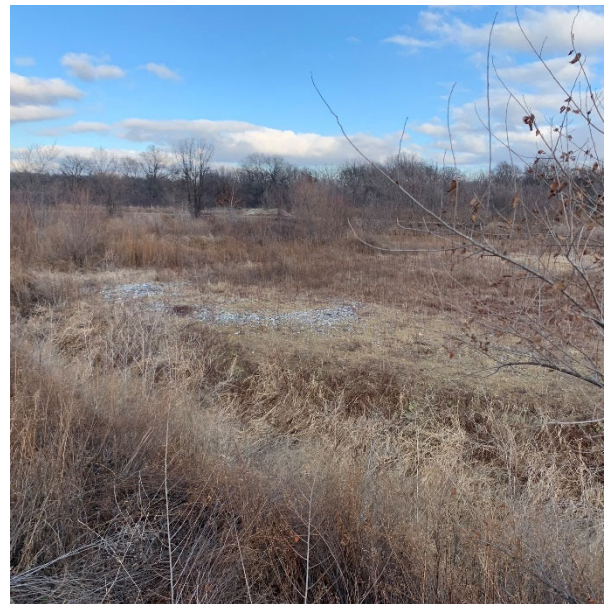
Photo 20: 2022 Area of previously noted animal impacts. See Area 1 on aerial photo.

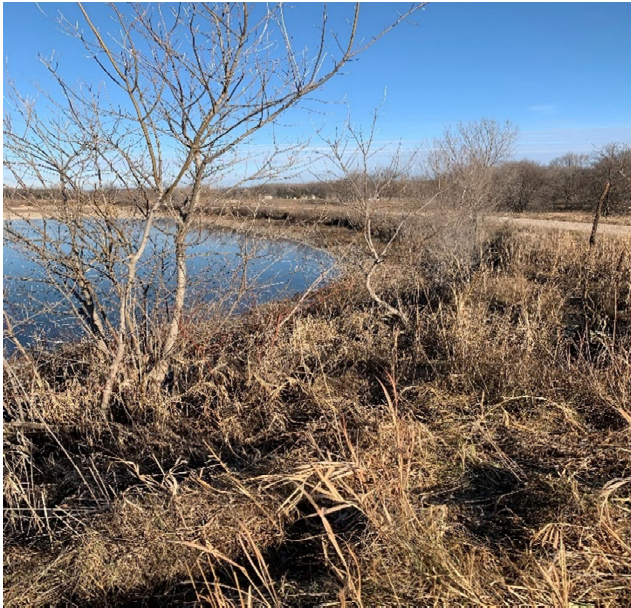
Photo 21: 2021 Erosion on inboard slope southeast portion of the ash pond from south looking northeast. See Area 2 for location.

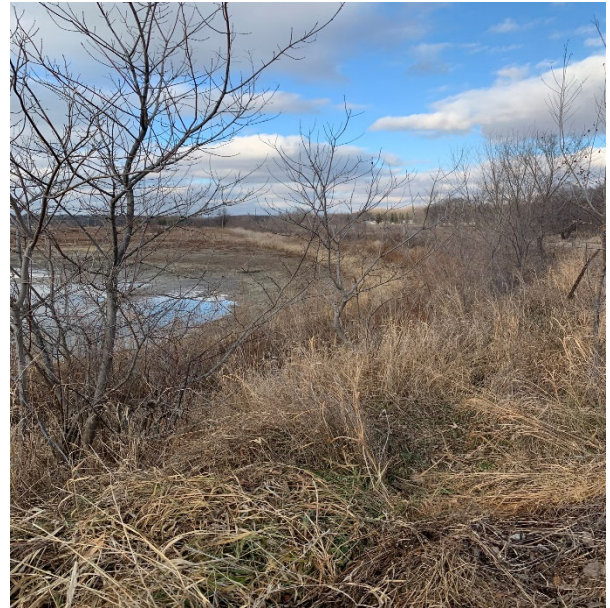
Photo 22: 2022 Erosion on inboard slope southeast portion of the ash pond from west looking along the south/southeast. See Area 2 for location.
