Annual Inspection Report for the Ames Inactive CCR Impoundment

**Ames Municipal CCR Impoundment
Ames (Story County), Iowa**

City of Ames, Iowa

July 30, 2025

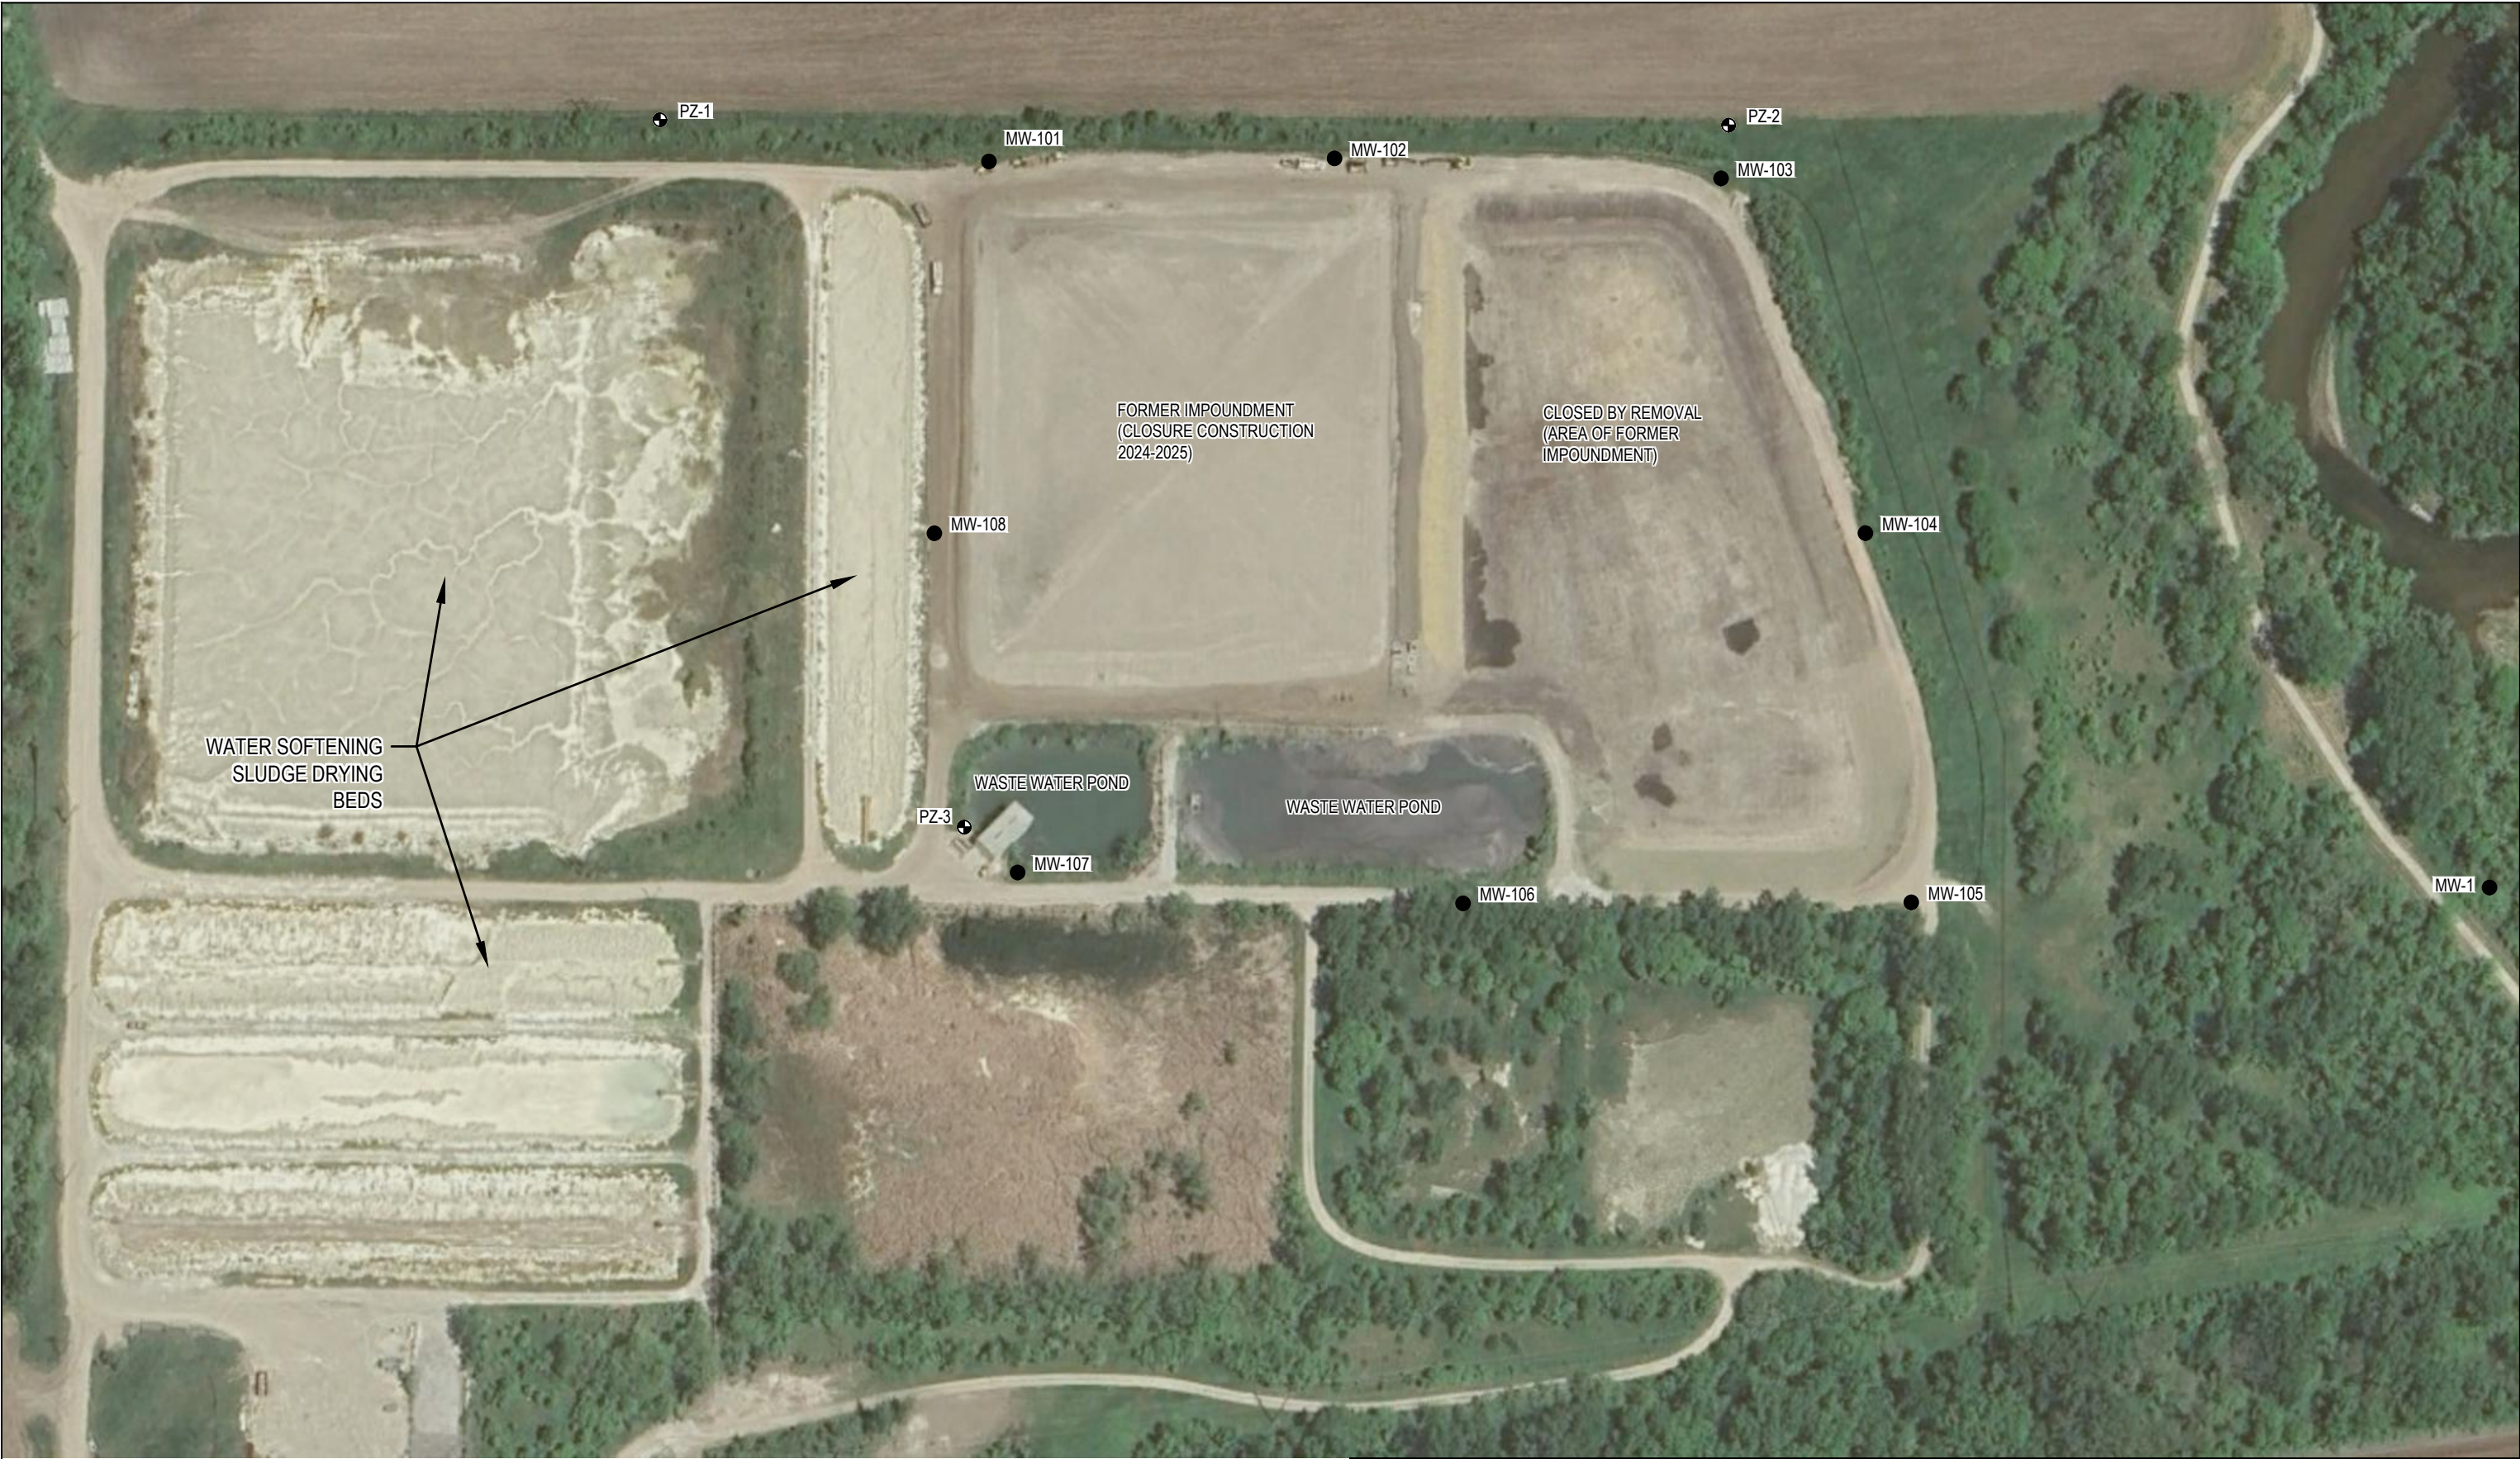
FIGURE 1

The surrounding monitoring well network is depicted on Figure 1 but is not considered instrumentation related to the engineering inspection of the inactive impoundment. Wells and piezometers were visibly observed during the inspection and field notes from groundwater monitoring were reviewed. Wells appear to be functioning properly. In July 2024, the bollards around one well were damaged by construction equipment; however, the monitoring well itself was undamaged. Previous inspection reports documented water level monitoring data; however, these data are not included herein as they are not applicable to the condition of the inactive impoundment.

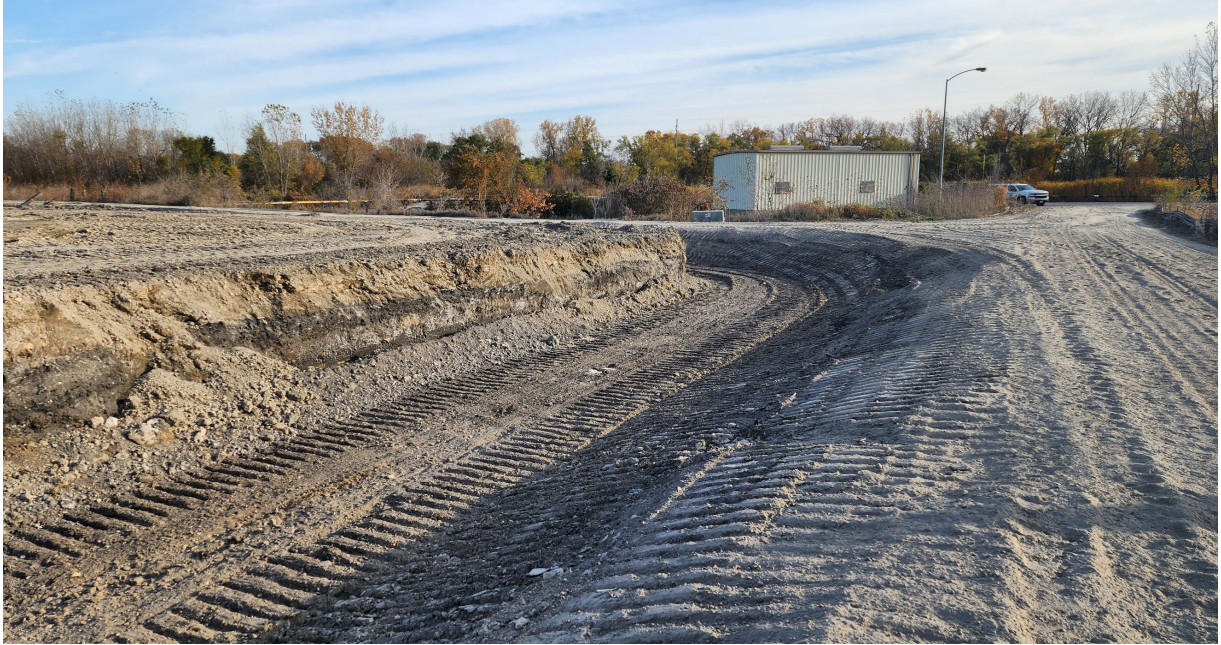
Photo 1 *Southeast corner of area to capped and closed with CCR in place. Area to right is the eastern access road. Looking south. October 21, 2025.*

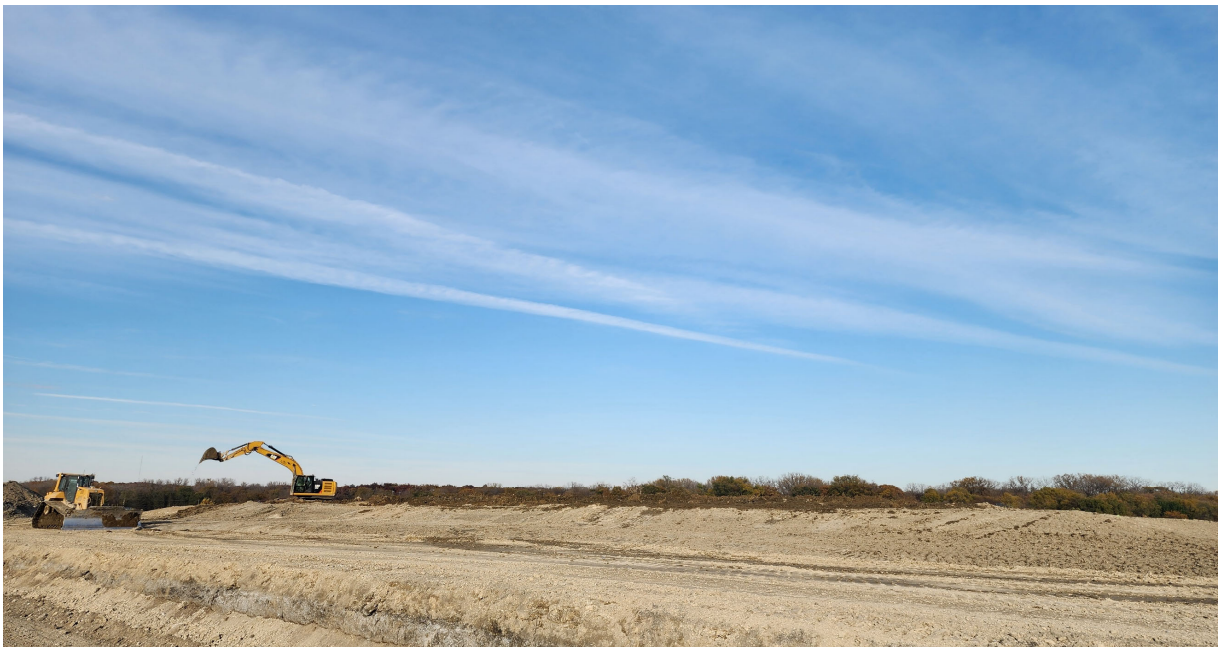
Photo 2 *CCR grading and consolidation activities on the western portion of the inactive surface impoundment. Looking northeast. October 21, 2024.*

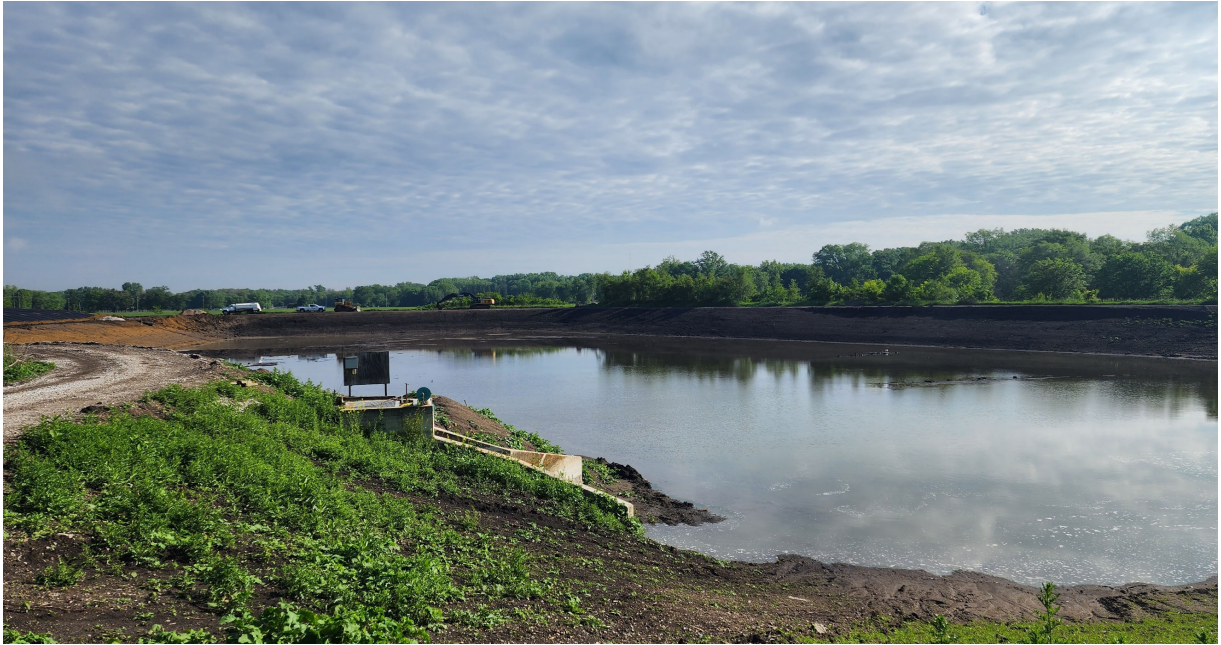
Photo 3 *East portion of inactive impoundment. Closed by removal. Looking northeast. May 29, 2025.*

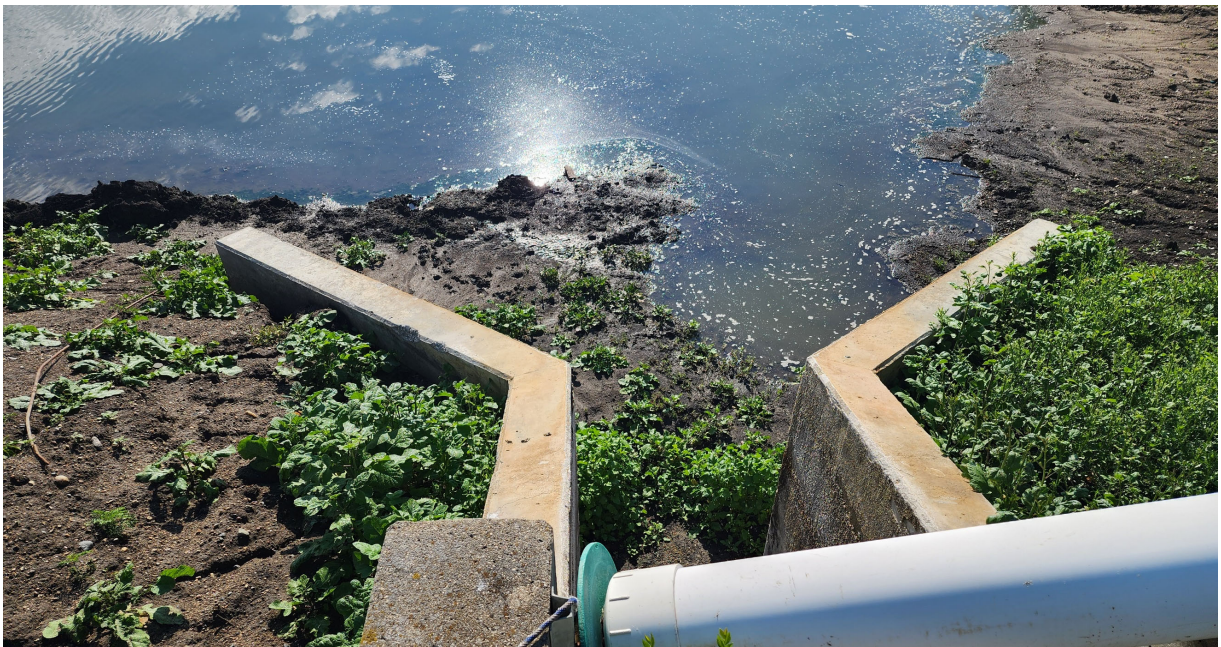
Photo 4 *Former flow control structure at the southwest corner of the closed by removal portion of the inactive impoundment. Looking east. May 29, 2025.*

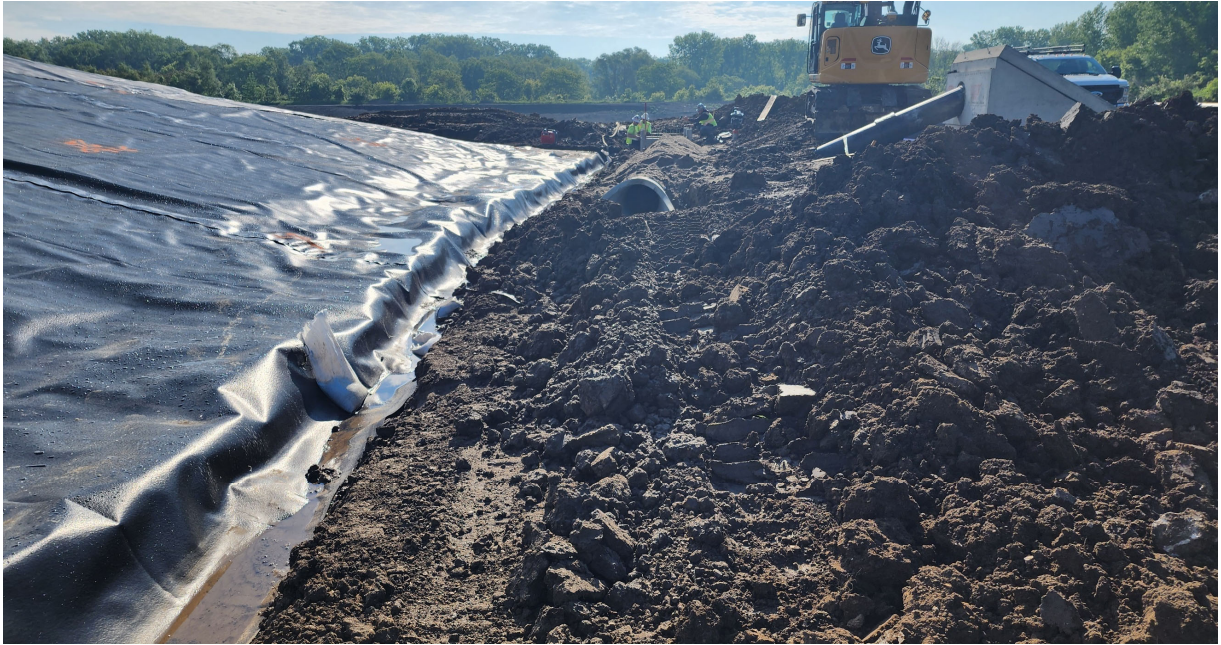
Photo 5 *Portion of the southern perimeter of the consolidated and capped area of the inactive impoundment showing geomembrane liner and anchor trench. Looking east. May 29, 2025.*

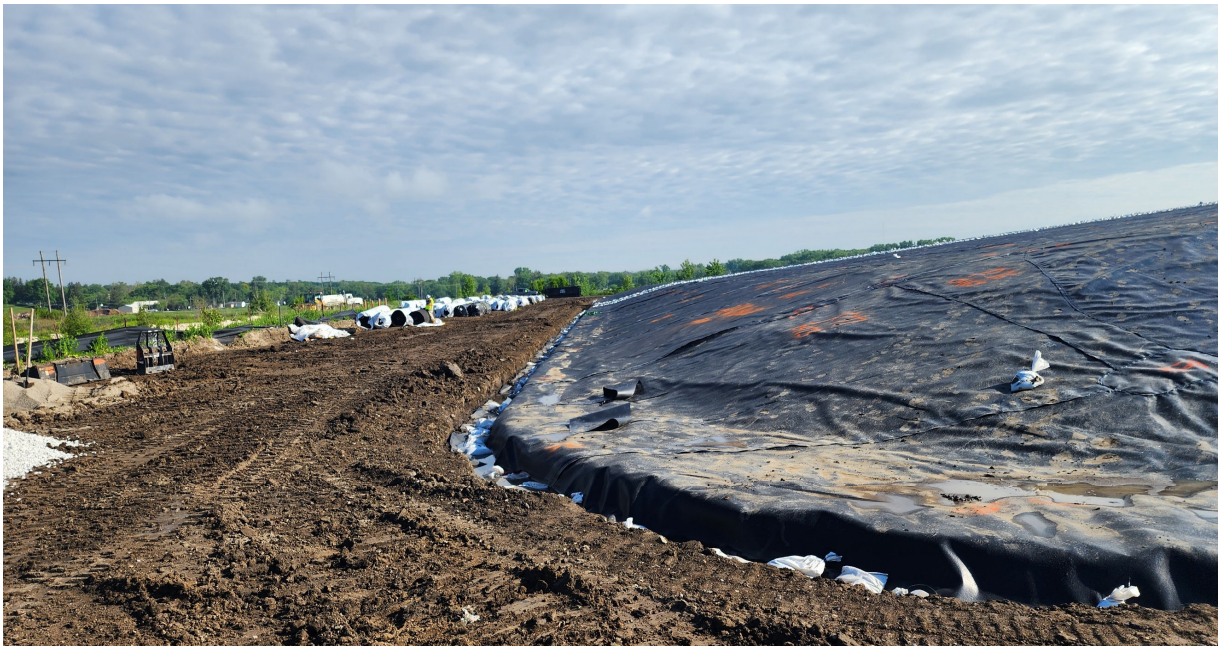
Photo 6 *The southwest corner of the consolidated and capped area of the inactive impoundment showing geomembrane and anchor trench. Looking north. May 29, 2025.*

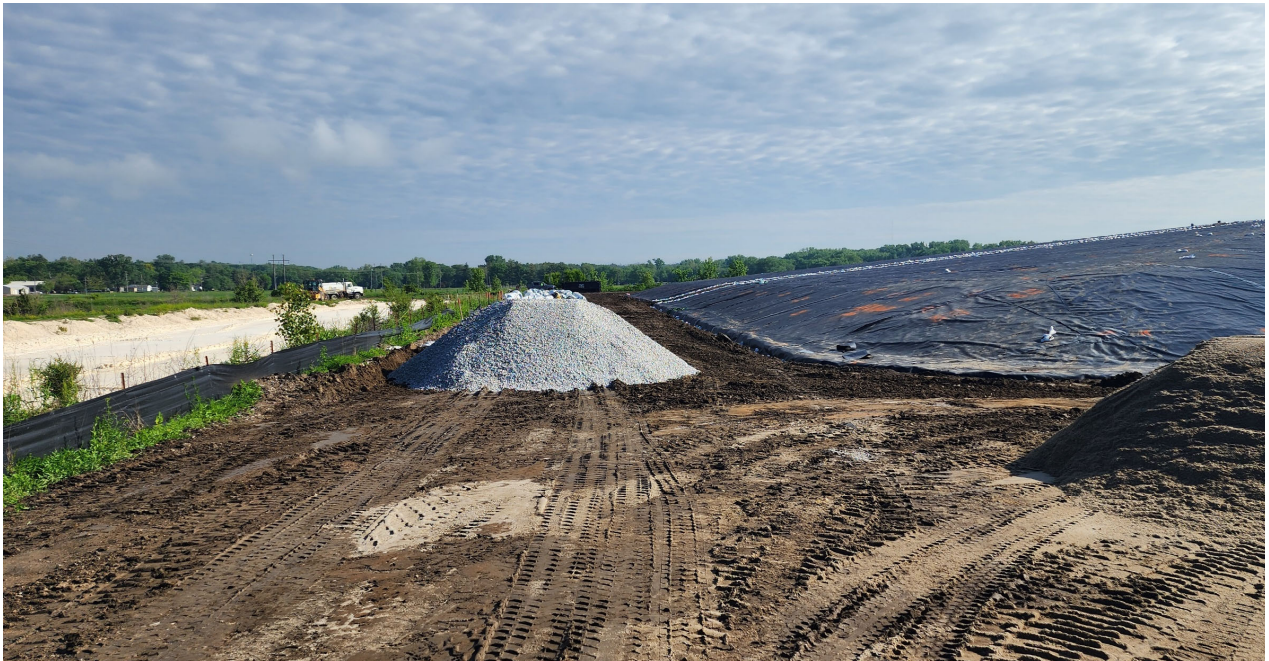
Photo 7 *Further out view of Photograph 4 showing the road conditions at the time of inspection. Looking North. May 29, 2025.*

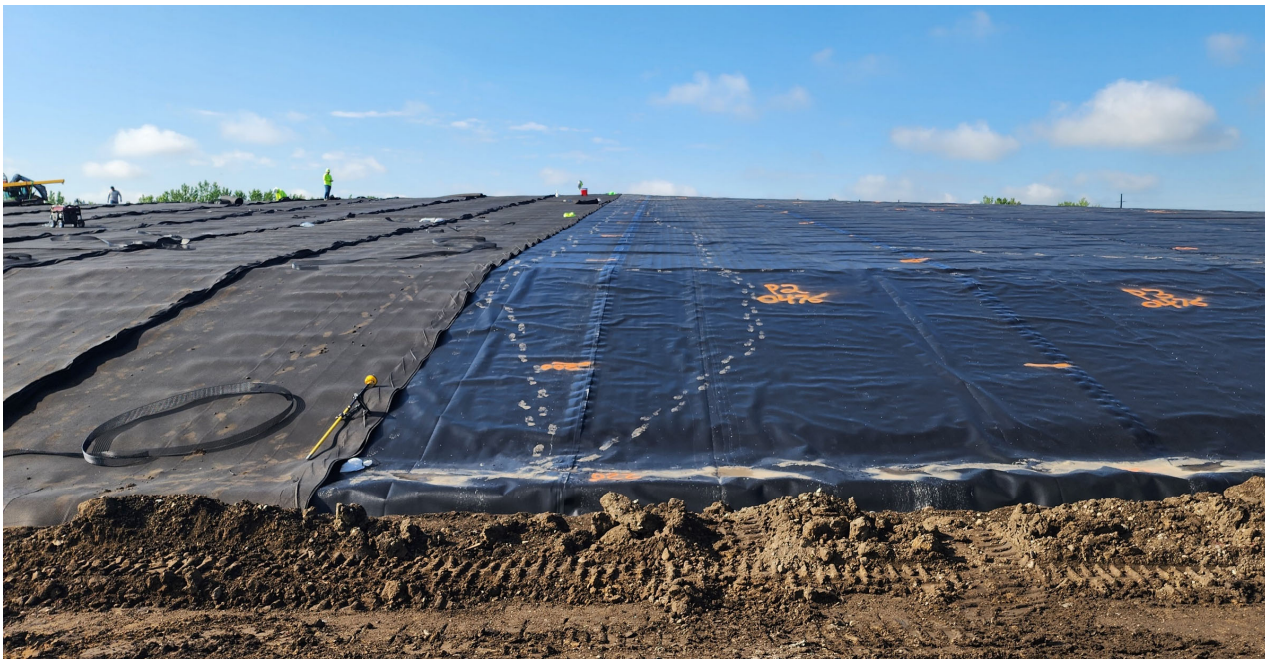
Photo 8 *Installation of geocomposite drainage layer proceeding over geomembrane in the consolidated and capped portion of the inactive impoundment. May 29, 2025.*

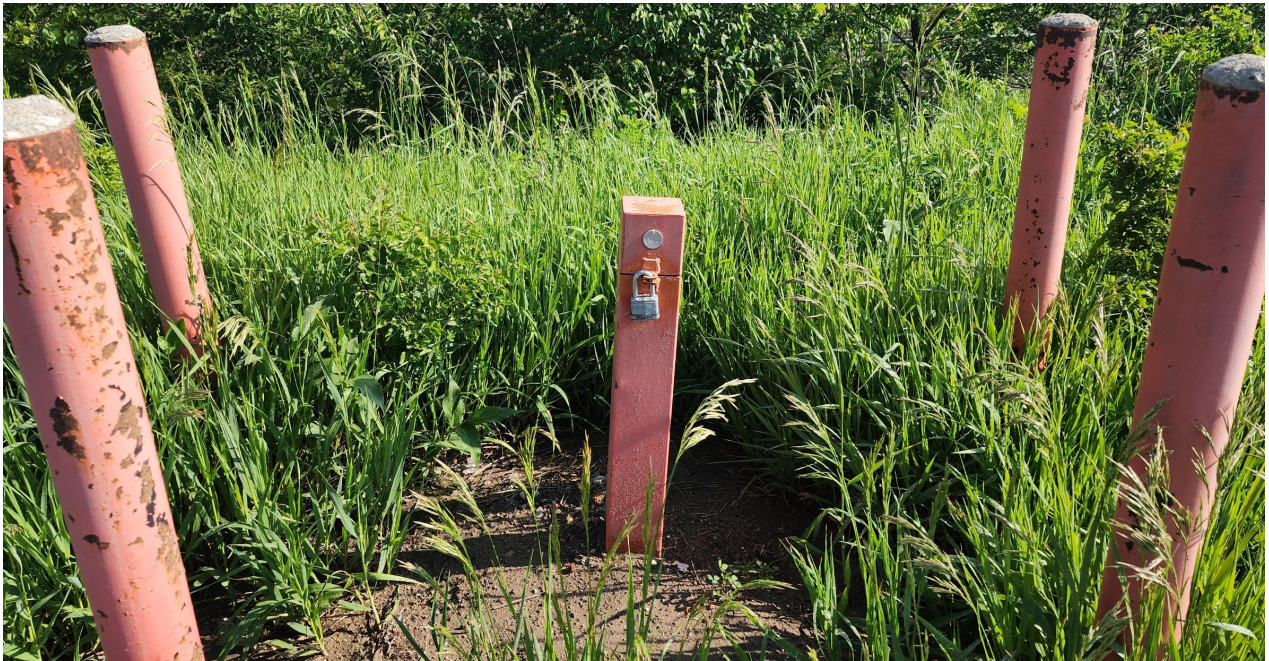
Photo 9 *Monitoring well MW-102. Typical monitoring well configuration with bumper posts. May 29, 2025.*

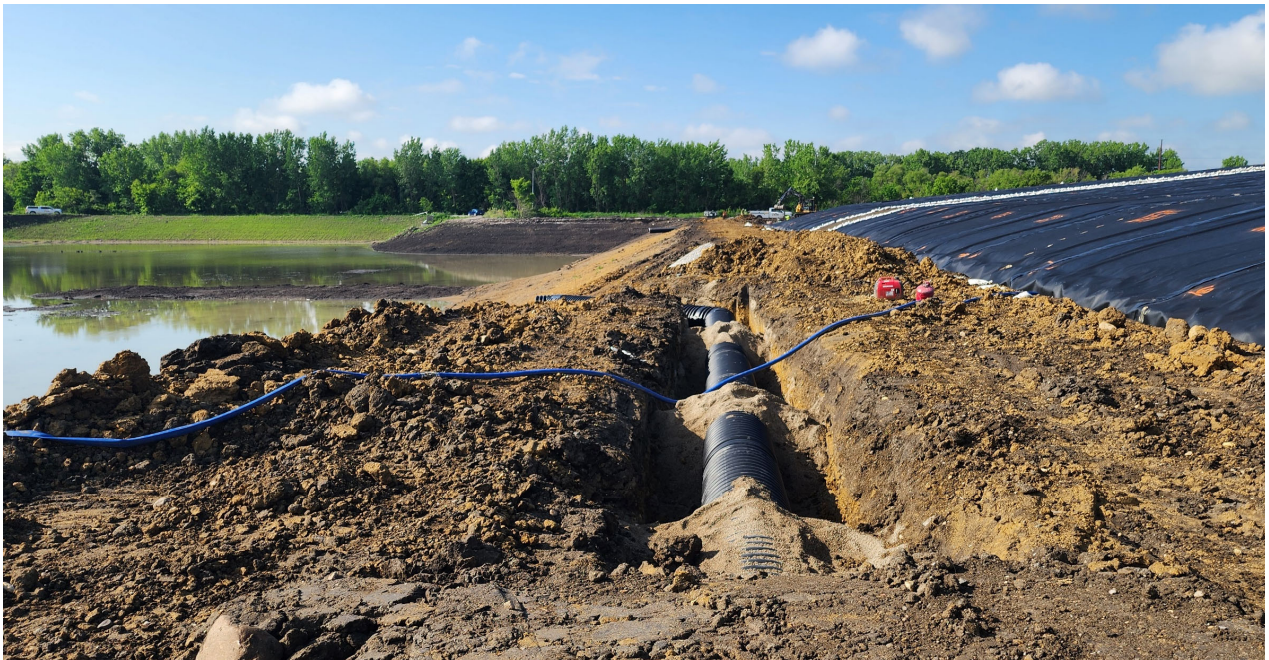
Changes were observed at the northeast area of the consolidated CCR area where stormwater controls were being installed. This was not observed to be a structural weakness or failure point, but part of closure activities. This berm separating the consolidated CCR and the closed by removal section was part of closure construction activities. Site perimeter roads were graded and fortified during closure construction.

Photo 10 *Stormwater management infrastructure in dividing berm between closed by removal area (left or east) and consolidated and capped area (right or west) of inactive impoundment. Looking south. May 29, 2025.*
