United States Department of the Interior  
National Park Service**National Register of Historic Places Registration Form**

**1. Name of Property**Historic name: Chautauqua Park and Ridgewood Historic DistrictOther names/site number: N/A

A Home for Science and Technology: Ames, Iowa, 1864–1941 (NRIS 64500871)

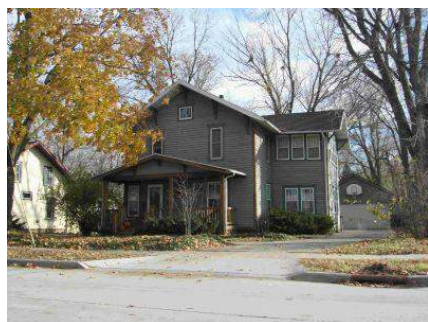
**600 Ridgewood Ave Arther Miller House 1910 1**  
**Contributing House; 1 Noncontributing Garage**

Description: Located on the east side of Ridgewood Avenue, facing west, this is a two-story L-shaped, wood-frame Craftsman home built in 1910 according to Ames City Assessor data. The house has a cross-gable roof with brackets, a right-side wing, and a gable-roofed front porch. The foundation is brick, and the roofing material is composition shingles. Clad in the original clapboard, the building has corner boards and frieze boards with simple molding, wide fascia boards at the eaves and gables, and triangular knee braces. The first level of the

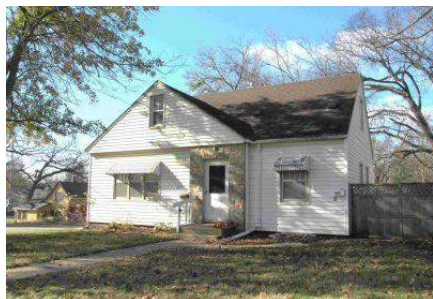
**603 Ridgewood Ave      Edwin S. Hatlestad House      1946      1**  
**Contributing House; 1 Contributing Garage**

**Description:** Located on the west side of Ridgewood Avenue, facing east, this is a one-and-one-half-story, wood-frame Minimal Traditional cottage with Colonial Revival influences and a front-and-side-gable roof. It was constructed in 1946 according to the Ames Inspection Division permit files. The foundation material is brick, the roof is covered with composition shingles, and the building is clad in vinyl. The front door is accessed by a small concrete stoop and is surrounded

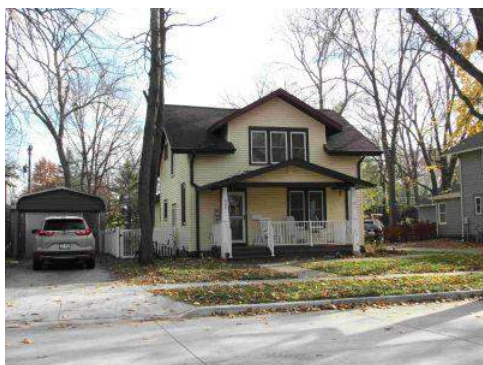
Description: Located on the east side of Ridgewood Avenue, facing west, this one-and-one-half-story wood-frame Craftsman home was built in 1920, according to Ames City Assessor records. The house features a side-gable roof, a prominent front-gable wall dormer, and a front-gabled porch. The foundation is poured concrete, and the roof is covered in composition shingles. The exterior is clad in replacement siding (aluminum or vinyl), with fascia boards accenting the gable eaves. A nearly full-length porch, which appears to be a later

Integrity: The storm windows, storm door, and replacement siding are alterations. According to the Story County Assessor, a rear addition was constructed in 2016, and assessor's photos indicate that the front porch was previously enclosed and has since been opened. This property retains its original massing, some original windows, and key character-defining features, and the rear addition does not substantially diminish its overall integrity. The property retains the feeling and association of a 1920 Craftsman-style home and is contributing to the historic district.

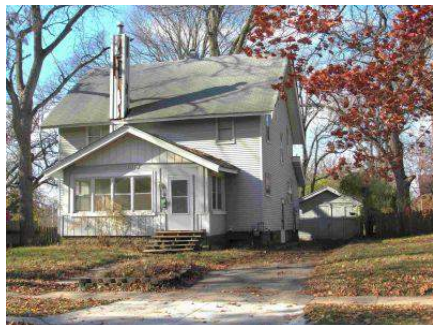
Description: Located on the west side of Ridgewood Avenue, facing east, this two-story wood-frame Craftsman home was constructed in 1910, according to Ames City Assessor records. The house features a side-gable roof, a three-quarter-width front porch with a front gable, and a shed-roof rear addition. The foundation is made of concrete blocks, and the roof is covered with composition shingles. The exterior is clad in narrow clapboard with corner boards, fascia boards

accenting the gables, and extended eaves. The enclosed porch is finished with vertical boards, and wood steps lead to the porch door, which is a later replacement. The façade includes one-over-one double-hung windows, with two positioned on the second story, flanking the porch gable. There are two chimneys: one at the roof ridge and another offset to the left behind the porch, clad in vertical boards. The front chimney shows significant wear. A contributing detached garage is located at the rear of the property to the north. Built in 1929, the contributing garage features a front-gable roof with wide fascia boards and exposed rafter tails beneath the projecting eaves, and it retains its original wood cladding, doors, and many windows, adding to the historic character of the property.

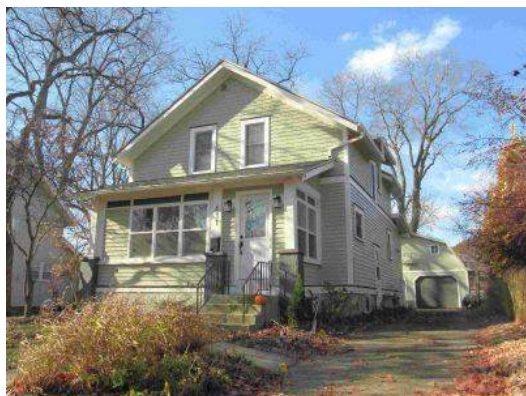
Description: This one-and-a-half-story wood-frame Craftsman home, built in 1920 according to Ames City Assessor records, is located on the west side of Ridgewood Avenue, facing east. The house has a front-gable roof with shed-roof dormers and a shed-roofed porch. While the foundation is covered in stucco, the assessor records list it as poured concrete. The roof is clad in composition shingles, and the exterior features clapboard siding, accented by wood shingles under the gable. The siding is a modern replacement installed to resemble the original

material. Architectural details include fascia boards, frieze boards, corner boards, and molded belt courses at the foundation and the base of the second floor. The enclosed front porch, topped by a shed roof, is supported by square columns resting on stucco piers. Concrete steps with metal railings lead to the front door on the right. Behind the enclosed porch, the original façade remains visible and retains its Craftsman-style four-over-one double-hung windows with narrow vertical panes. This window style is also found on the two second-story windows, framed with thick boards and molded lintels, with similar trim details used on the other windows and on the north-side door. At the rear of the property stands a noncontributing detached garage built in 1977 with a gambrel roof and a loft.

Integrity: The storm windows are alterations, and the siding has been replaced; however, these changes do not substantially diminish the property's integrity. The house retains its original massing, many of its original windows, and key character-defining features such as its front-gabled form, dormers, and Craftsman window configurations. The property retains the feeling and association of a 1920 Craftsman-style home and is contributing to the historic district.

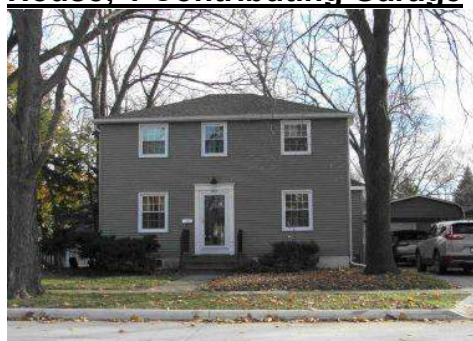
Description: Located on the east side of Ridgewood Avenue, facing west, this two-story Colonial Revival home was built in 1946, according to Ames City Assessor data and Inspection Division permit files. The house features a hipped roof clad in composition shingles, while the chimney on the north elevation is covered in vinyl. The foundation is made of concrete blocks. Concrete steps with metal railings lead to the centered front door, which is framed by Colonial

Integrity: The replaced siding, chimney cladding, and the windows are alterations to the home. This property retains its original massing, and character-defining features, feeling and association of a Colonial Revival home and is contributing to the historic district.

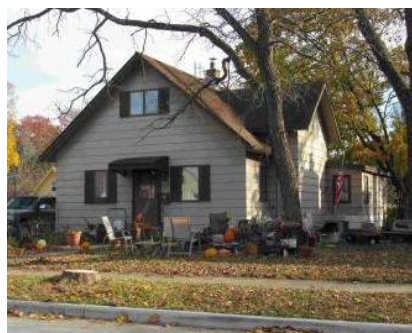
Description: Located on the east side of Ridgewood Avenue, facing west, this one-and-a-half-story wood-frame house was built in 1926, according to Ames City Assessor data. This vernacular cottage features a cross-gable roof and a recessed right-side wing, both clad in Masonite siding and accented with decorative shutters. The front entrance, accessed via a concrete stoop, is sheltered by a metal awning. The foundation is poured concrete, and the roof is finished with composition shingles. The façade includes a window on either side of

the front door, with a pair of replacement casement windows beneath the gable. A small vent is positioned at the gable's apex. A rear one-story addition is visible, and a detached garage built in 1965 is located at the back of the property and is noncontributing to the property.

Integrity: The Masonite siding and replacement windows are alterations that diminish materials integrity but do not compromise the building's overall historic character. The house retains its original massing and key character-defining features, preserving the feeling and association of a 1926 vernacular cottage. It is contributing to the historic district.

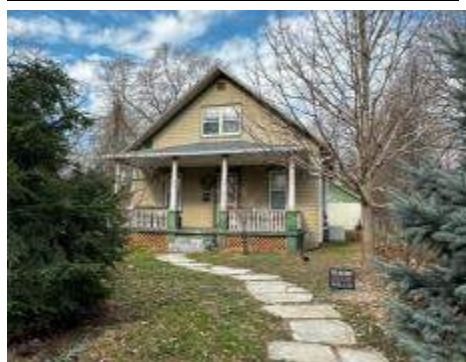
Description: Located on the west side of Ridgewood Avenue, facing east, this is a one and a half-story front gable Craftsman home constructed in 1912 according to Ames City Assessor data. The house has a front gable roof with a hip-roofed porch and is clad in wide clapboards with frieze boards. The foundation material is brick, and the roof is covered with composition shingles. The front porch foundation is made of lattice brick work and the tapered columns are supported by square brick piers. The columns

have molded headers and four-sided cast details with stars. The porch railing spindles are made from 1x4s cut to mimic the profile of turned spindles. Concrete steps to the porch align with the entrance which is slightly offset to the north. The front door has a boldly molded lintel repeated in a simpler form on other fenestration frames. Two windows on the first level, both one-over-one double-hung are replacements. The double window opening at the half-story has been altered and replaced with paired one-over-one double-hung windows. A vent is situated in the gable peak. Additional vents

are found at the vertex, where the porch's roof-to-wall junction meets the upper story's rake line. A contributing detached garage from 1912 is on the northwest corner of the property, accessible by an alley on the west side of lot.

Integrity: The siding, storm windows, and replacement windows are alterations. The property retains its original massing, workmanship, and character-defining features. The property retains the feeling and association of a Craftsman style home, and it is contributing to the historic district.

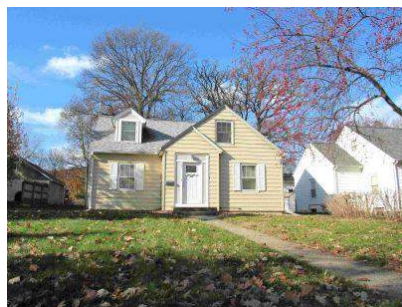
Description: Located on the west side of Ridgewood Avenue, facing east, this is a one and a half-story Minimal Traditional cottage constructed in 1945 according to Ames Inspection Division permit files. The house has a cross-gable roof, layered front gable entrance, a left side front dormer, and a rear addition. The foundation material is concrete block, and the roof is covered with composition shingles. The exterior is clad in wide vinyl with narrow frieze boards at the flush eaves and

Integrity: The replacement siding and shutters are alterations. This property still retains its original massing, workmanship, and character-defining features. The property retains the feeling and association of a Minimal Traditional cottage and is contributing to the historic district.

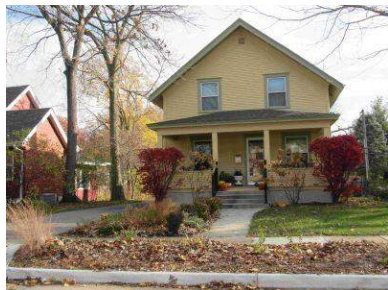
**622 Ridgewood Ave Claridon E. Arrasmith House 1915 1 Contributing House; 1 Noncontributing Garage**

Description: Located on the east side of Ridgewood Avenue, facing west, this is a two-story frame Craftsman home constructed in 1915 according to Ames City Assessor data. The rectangular house has a front gable, brick foundation, and the roof is covered in composition shingles. The exterior is clad in a narrow clapboard with style-indicative fascia and frieze board at the gable. The full-width front porch has a hipped roof decorated with a

simple entablature and molding where it meets square columns. The porch rail is enclosed with narrow clapboard; concrete steps topped with modern metal railings lead to the slightly south-offset front door. The front door is framed with a simple accent board and a molded lintel, a treatment that trims all window openings as well. Two windows on the first floor, one on either side of the door, and two windows on the second floor all have replacement one-over-one double-hung sash covered by storm windows. A small vent is situated at the apex of the gable. The porch hipped roof intersects the house's wall at the lower, inner corners of the second story windows. This building is part of a subtype of early Craftsman homes in the district, distinctive by their simple two-story, front gable, rectangular structure, and age. A noncontributing garage built in 2003 is at the rear of the lot.

Integrity: The storm windows and replacement windows are alterations, and the fascia board appears to be a replacement. The property retains its original massing, workmanship, and character-defining features, preserving the feeling and association of a Craftsman-style home. It is contributing to the historic district.

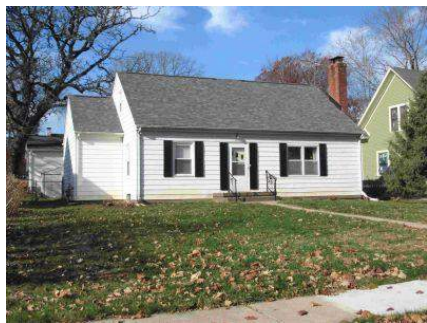
Description: Located on the west side of Ridgewood Avenue, facing east, this is a one-story Cape Cod Revival cottage constructed in 1945 according to Ames Inspection Division permit files. The house has a side-gabled roof, a small side-gabled addition set back on the south elevation, and a rear addition. The foundation material is concrete block, and the roof is covered with composition shingles. The exterior is clad in aluminum siding, with decorative shutters surrounding the three

**Integrity:** The windows, storm windows, and front door are replacements. Additions on the south elevation and the rear of the house are alterations but do not substantially diminish the property's overall integrity. The property retains its original massing, workmanship, and character-defining features, preserving the feeling and association of a Cape Cod Revival cottage. It is contributing to the historic district.

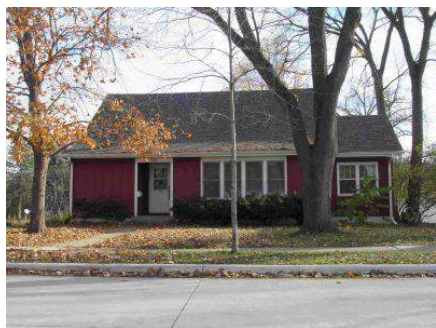
**Description:** Located on the east side of Ridgewood Avenue, facing west, this vernacular inter-war period cottage was constructed in 1930 according to Ames City Assessor data. The one-story frame house has a side-gabled front-swooped roof, a set-back wing on the south elevation with a separate, smaller gable, and a rear addition. The foundation is poured concrete, and the roof is composite shingles. The exterior cladding is 8" horizontal aluminum on the sides with vertical boards

**Integrity:** The replacement windows on the façade and the replacement façade siding are alterations. The property retains its original massing and character-defining features and preserves the feeling and association of a vernacular inter-war cottage. It is contributing to the historic district.

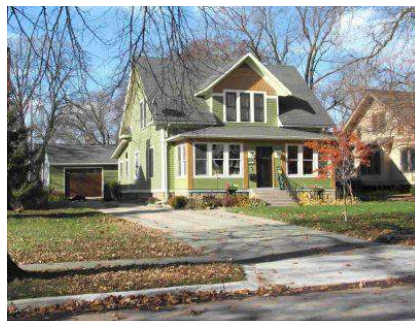
**Description:** Located on the west side of Ridgewood Avenue, facing east, this is a one and a half-story Craftsman home constructed in 1915 according to Ames City Assessor data. The house has a steep side-gabled roof, a large front-gabled wall dormer, and a hip-roofed porch. The foundation material is concrete block and brick, and the roof is covered with composition shingles. The exterior cladding is clapboard, which may be original; additionally, fish scale-style shingles clad the

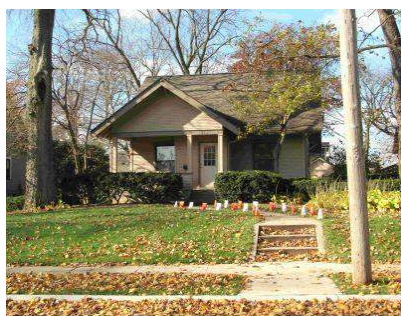
**Description:** Located on the west side of Ridgewood Avenue, facing east, this is a one and a half-story Craftsman cottage constructed in 1925 according to Ames City Assessor data. The house has a side gable roof and a front gable porch. The foundation is concrete, and the roof is covered with composition shingles. The exterior cladding is narrow clapboards with extended fascia boards, rake boards, and corner boards. Triangular knee braces are details on the projecting overhangs of the side gables. A portion of the porch was enclosed to create an entrance vestibule. Square molded columns support the front gable roof and rest atop a knee wall enclosed by siding. Centered steps lead to the modern, steel entrance door and are flanked by low, enclosed low walls. The two façade windows are wide one-over-one double-hung in configuration, with molded lintels. A contributing detached garage built in 1925 is at the rear of the property and is accessible by the alley on the west side of the lot.

**Integrity:** The enclosed entrance vestibule, and the windows are replacements. This property still retains its original massing and character-defining features, feeling and association, and is contributing to the historic district.

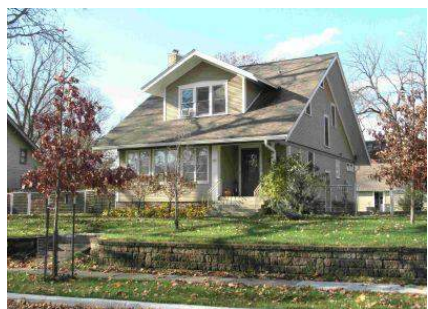
**Description:** Located on the west side of Ridgewood Avenue, facing east, this is a one and a half-story Craftsman home constructed in 1911 according to Ames City Assessor data. The house has a steep side gable roof, a prominent centered front-gabled dormer, and a small front porch on the right side of the façade. The foundation is brick, and the roof is covered with composition shingles. The home is clad in narrow clapboards with extended rake boards at the projecting eaves, frieze boards, corner boards, and a molded belt course at the height of the first-level window lintels. The roof envelope covers the porch area. The eight-light door behind the storm door is possibly original, with molded lintel and trim. The central dormer houses a set of three windows, all one-over-one double-hung (likely replacements). Second-story windows have original trim featuring molded lintels,

including beneath the gables on both north and south elevations. The first level fenestrations on the side elevations vary from original to altered and replaced, in a similar style to porch enclosure fenestration. A painted brick chimney is on the south elevation. The contributing detached garage was constructed circa 1930 and is centered on the western edge of the lot, accessible from Lee Street, with a front gable roof and Craftsman-indicative rafter tails at the eaves. The front lawn has a modern stone retaining wall and concrete steps and a side cyclone fence. This home is part of a subtype of Craftsman homes in the additions that feature a steep side-gabled roof with a prominent central dormer.

**Integrity:** The added storm windows and doors and the replacement windows, and cyclone fence are alterations. This property still retains its original massing and character-defining features, feeling and association, and is contributing to the historic district.

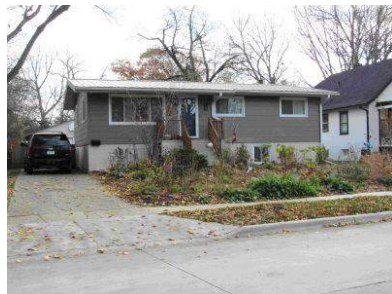
**Noncontributing House; 1 Noncontributing Garage**

Description: Located on the east side of Ridgewood Avenue, facing west, this home is a raised Ranch-style house constructed in 1970 according to Ames City Assessor data. The foundation is concrete block, the side gable low profile roof is covered with standing seam metal panels, and the home is clad in wide clapboard. The fenestration is sliding vinyl windows. This exposed basement on the façade is brick veneer, painted white.

Concrete steps lead to the entrance porch that is enclosed with replaced wood railings. This is the first manufactured Wausau Ranch-style house in Ames according to a local newspaper advertisement in the *Ames Tribune*, Aug 14, 1970.

Integrity: The windows are replacements. The storm door, wood railing, and metal roof are alterations. This property is not contributing to the historic district because it is a second generation property and was built after the period of significance.

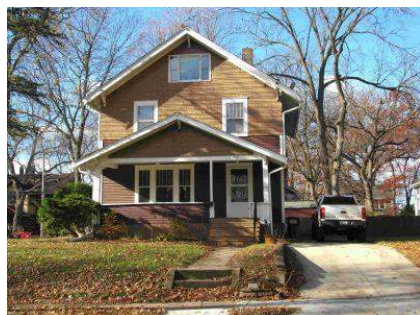
Description: Located on the west side of Ridgewood Avenue, facing east, this is a two-story Craftsman home constructed in 1919 according to Ames City Assessor data. The house has a front gable roof, front gable porch, and a rear addition. The foundation is stucco-covered brick, and the roof is covered with composition shingles. The exterior cladding is narrow clapboards which have been covered at the second story with wood shingles, wood shingles also clad the gable triangle

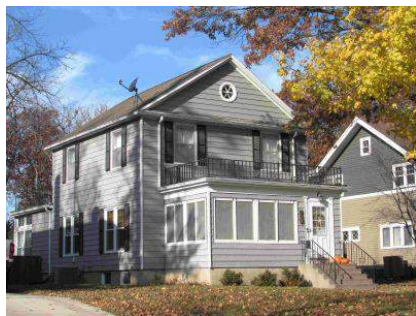
**Description:** Located on the west side of Ridgewood Avenue, facing east, this is a two-story Colonial Revival home constructed in 1920 according to Ames City Assessor data. The house has a front gable roof with a gable pent overhang, an enclosed porch, and a rear addition. The foundation is brick covered with stucco, and the roof is covered with composition shingles. The home is clad in aluminum siding with decorative shutters. Narrow rake boards and fascia trim out the gable pent

**Integrity:** The railing on the second level above the porch roof is an alteration. The storm windows and doors and the replaced windows are an alteration. The porch enclosure is not original, but it is congruent with the other porch enclosures that are now characteristic in the district. The back addition is not reversable but is difficult to discern from the street. This property still retains its original massing, windows and character-defining features. The property retains the feeling and association of a Colonial Revival house and is contributing to the historic district.

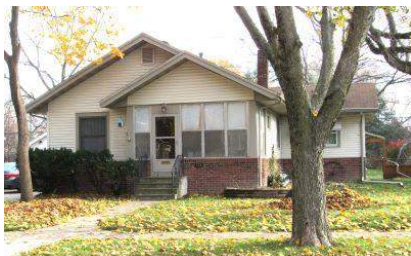
**House; 1 Contributing Garage**

**Description:** Located on the east side of Ridgewood Avenue, facing west, this is a one-story Craftsman bungalow constructed in 1928 according to Ames City Assessor data and Inspection Division permit files. The L-shaped house has a cross-gable roof, overlapping front gable porch and side wing on south elevation. The foundation is brick, and the roof is covered with composition shingles. The exterior cladding is brick

veneer on the lower third and vinyl on the upper two-thirds. The inner front gable covers the half-length enclosed porch and cast concrete steps with metal railings leading to the south-offset entrance. The porch retains original, slightly tapered columns as they frame the enclosure. The façade window features a seven-over-one double-hung configuration in which the top sash houses narrow panes separated by vertical muntins. A metal awning covers smaller paired double-hung windows on the south addition façade. A vent is located at the apex of the main gable. The projecting eaves have been wrapped with aluminum fascia and soffit panels. The interior brick chimney is on the south side. This home is part of a subtype of Craftsman bungalows in the additions, distinctive for their one-story, overlapping front-gabled design and enclosed half-length porches. A detached garage is recorded to have been constructed in 1940 and is a contributing structure.

**Integrity:** The replacement siding, replaced windows, enclosed eaves, and wrapped fascia boards are alterations. The porch enclosure is not original, but it is congruent with the other examples of enclosures of these bungalows. This property still retains its original massing and character-defining features, feeling and association, and is contributing to the historic district.

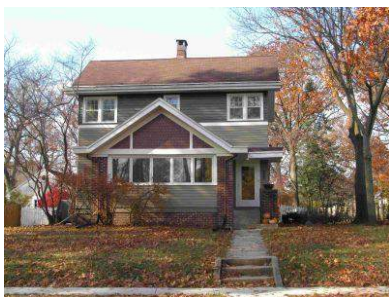
**Contributing House; 1 Contributing Garage**

**Description:** Located on the west side of Ridgewood Avenue, facing east, this is a two-story Craftsman home constructed in 1925 according to Ames City Assessor data. The house has a side gable roof, a front-gabled porch, and a rear addition. The foundation material is brick, and the roof is covered with composition shingles. The home is clad in clapboard up to a string course that wraps the entire second floor, just below windowsill level,

above which vinyl siding completes the second-floor wall cladding. The eaves and overhangs have been covered with aluminum panels and the fascia and rake boards have been wrapped in aluminum. The former front porch has been enclosed and it may

Integrity: The siding-boxed eaves, vinyl siding on the second level, storm windows and doors are alterations. The rear addition is barely visible from the street. This property still retains its original massing and character-defining features, feeling and association of a Craftsman home, and it is contributing to the historic district.

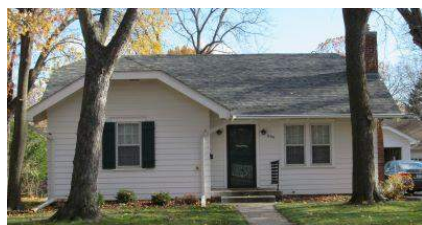
**804 Ridgewood Ave      John and Marie Ames House      1930      1**  
**Contributing House; 1 Contributing Garage**

Description: Located on the east side of Ridgewood Avenue, facing west, this is a one-story frame Craftsman cottage constructed in 1930 according to Ames City Assessor data and Inspection Division permit files. The house has a side-gabled jerkinhead roof with a front-gabled wing on the north side (also jerkinhead). The foundation is brick, and the roof is covered with composition shingles. The exterior cladding is wide clapboard, possibly original. Projecting roof eaves and rafter tails are emphasized by wide rake and fascia boards. A concrete step and stoop leads to the entrance with a wrought iron railing on the south side. The door trim is made of wide boards with a molded lintel. The door trim repeats itself on the fenestration openings. The façade has three windows, two paired on the south side and one beneath the front gable on the north wing, all are six-over-six double-hung. A small vent is tucked beneath the jerkinhead of the north wing's front gable. A brick chimney is situated west of the center on the south elevation. A contributing garage was constructed in 1934, with a similar front-gabled jerkinhead roof, clad in Dutch lap siding.

Integrity: The storm windows and doors are alterations. This property still retains its original massing, materials, windows, and character-defining features. The property retains the feeling and association of a Craftsman cottage and is contributing to the historic district.

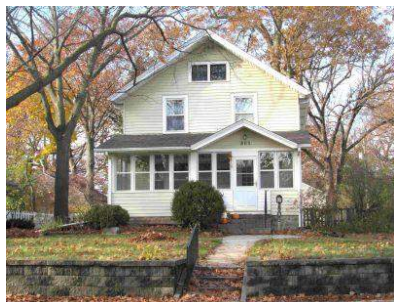
**Contributing House; 1 Noncontributing Garage**

**Description:** Located on the west side of Ridgewood Avenue, facing east, this is a two-story Craftsman home constructed in 1915 according to Ames City Assessor data. The house has a front gable, an enclosed porch, and a rear addition. The foundation material is concrete block, and the roof is covered with composition shingles. The home is clad in vinyl with narrow fascia and rake boards. The eaves and overhangs are covered with aluminum.

The enclosed porch is covered with a shed roof with a front gable over the north-offset entrance. Thin paving tiles cover the steps with a metal railing leading to the front door. Original façade door and window openings are visible behind the enclosure and show the original trim with molded lintels that likely framed all window openings originally. Second-level windows are replacements, one-over-one double-hung. Centered beneath the gable, in the attic space, sits a pair of identical fixed windows each with four vertical lights and they are likely original. A stone retaining wall on the sidewalk includes a short concrete stair and metal railing. A noncontributing detached garage built in 1974 is located at the north rear corner of the lot is accessible by the alley on the west side of the property. This home is part of a subtype of early Craftsman buildings in the additions, distinctive by their simple two-story, front gable, rectangular structure, and age.

**Integrity:** The storm windows and replaced windows are alterations. The rear addition is almost imperceptible from the street. This property still retains its original massing, materials, and character-defining features. The property retains the feeling and association of a Craftsman style home and is contributing to the historic district.

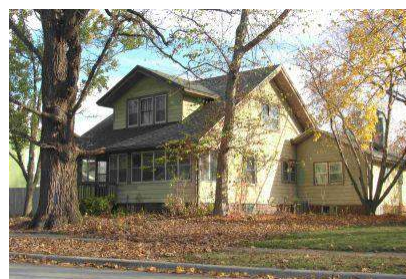
**Contributing House; 1 Contributing Garage**

**Description:** Located on the east side of Ridgewood Avenue, facing west, this is a one and a half-story Craftsman home constructed in 1925 according to Ames City Assessor data. The house has a steep side gable and a prominent front-gable dormer. A later addition is set back on the south and rear of the building with a separate front gable and interior chimney. The foundation is brick, and the roof is covered with composition shingles. The exterior cladding is aluminum siding with vertical corner trim. The roof envelope extends forward over the full-width front porch and has projecting eaves with narrow fascia boards wrapped in aluminum. The porch is enclosed with ribbon windows. It is accessed via steps leading to a wood deck with wood railings arriving at the entrance.

exterior cladding is aluminum siding with vertical corner trim. The roof envelope extends forward over the full-width front porch and has projecting eaves with narrow fascia boards wrapped in aluminum. The porch is enclosed with ribbon windows. It is accessed via steps leading to a wood deck with wood railings arriving at the entrance.

Integrity: The original steps in place of the wood deck and the storm windows are alterations. While the porch enclosure is not original, it is historic and congruent with the other examples of these side-gabled Craftsman homes. This property still retains its original massing, materials, and character-defining features feeling and association, and is contributing to the historic district.

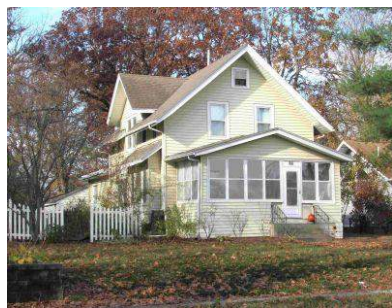
**811 Ridgewood Ave      Arrbie W. Caul House      1918      1**  
**Contributing House; 1 Contributing Garage**

Description: Located on the west side of Ridgewood Avenue, facing east, this is a one and three-quarters-story Craftsman home constructed in 1918 according to Ames City Assessor data. The house has a front gable roof, an enclosed porch, and a rear addition. The foundation material is poured concrete, and the roof is covered with composition shingles. The exterior cladding is vinyl with aluminum clad fascia and rake boards. The soffits are also enclosed with aluminum panels. Dormers on either side of

the house give a nearly cross-gabled effect. A shallow shed-roofed bay is also visible on the south elevation. The enclosed porch has a shallow-pitched front gable roof, with north-offset concrete stairs and metal railings that lead to the entrance door. The original façade door and window are visible behind the enclosure and contain original trim and molded lintels. Two one-over-one double-hung replacement windows are on the second level with a small two-over-one original window tucked into the gable. There is a single-story addition at the rear of the home. A contributing detached garage built in 1918 is accessible by the alley on the west side of the property.

Integrity: The replaced windows and storm windows are an alteration. While the porch enclosure is not original, it is congruent with the other porch enclosures that are now characteristic in the district. This property still retains its original massing, materials, and character-defining features. The property retains the feeling and association of a Craftsman style home and is contributing to the historic district.

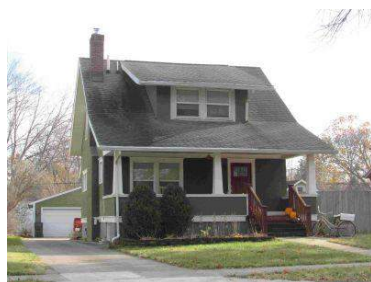
**Contributing House; 1 Noncontributing Garage**

Description: Located on the east side of Ridgewood Avenue, facing west, this is a one and a half-story Craftsman home constructed in 1921 according to Ames City Assessor data. The house has a steep side gable covered with composition shingles and a prominent shed-roof central front and rear dormer. The foundation material is covered in stucco, which is poured concrete according to Ames City Assessor data. The exterior finish is stucco with

a molded belt course just above the top of the foundation. The full-width front porch features a low stucco wall that functions as a railing. The porch roof is supported by three tapered wood columns. The pitch of the front roof line is reduced over the porch to maintain sufficient headroom in the porch. Wooden stairs with wood railings lead to the porch. The entrance door is offset to the south, with bold board trim and molded lintel. This molded trim is repeated in the window opening on the north side of the façade, framing the paired six-over-one double-hung windows, as well as the window openings beneath the side gable on the north and south elevations. Paired six-over-one double-hung windows are on the dormers. A brick chimney on the north elevation is coated with stucco below the roofline. A noncontributing detached garage built in 1992 is at the north rear of the property. This home is part of a subtype of Craftsman homes in the additions that feature a steep side-gabled roof with a prominent central dormer.

Integrity: The replacement windows in the dormer and the wood front steps are alterations. This property still retains its original massing, materials, and character-defining features and is contributing to the historic district.

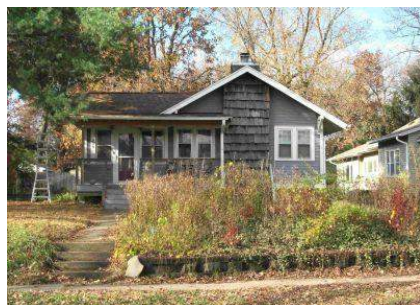
Description: Located on the west side of Ridgewood Avenue, facing east, this is a one-story Craftsman cottage built in 1920 according to Ames City Assessor data. The house has a cross-gable roof, an enclosed corner porch, and a rear addition. The foundation material is brick, and the roof is covered with composition shingles. The exterior cladding is clapboard with corner boards and rake boards trim out the gables. The projecting eaves have rafter tails. Wood steps and a

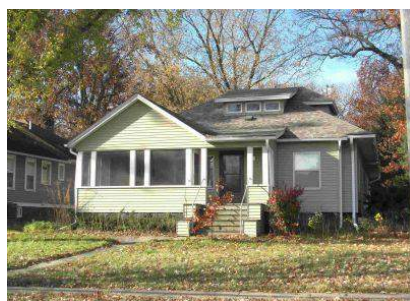
**Description:** Located on the west side of Ridgewood Avenue, facing east, this is a one and a half-story Craftsman home constructed in 1934 according to Ames Inspection Division permit files. The house has a hipped roof, a front gable half-width porch, front shed dormer, and multiple rear additions. The foundation material is brick, and the roof is covered in composition shingles. The home is clad in vinyl. The projecting eaves and overhangs have been wrapped with aluminum fascia and soffit panels. The front porch is screened, and the steps railings are enclosed with siding. Concrete steps lead to the central entrance door to the north of the porch enclosure. Double columns support the porch and entrance roof. The front three-light shed-roof dormer protrudes from the hip roof. A noncontributing detached garage built in 1995 is located at the south rear corner and is accessible by the alley on the west side of the lot.

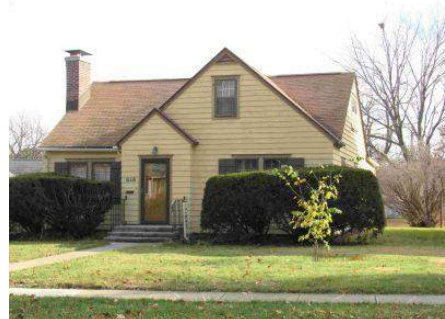
**Description:** Located on the east side of Ridgewood Avenue, facing west, this is a frame one and a half-story cross-gabled Minimal Traditional cottage constructed in 1934 according to Ames City Assessor data. The foundation material is concrete block, and the roof is covered with composition shingles. Clad in what is likely the original wide clapboard. The cross-gable roof is lined with narrow rake boards. The centered entrance vestibule protrudes from the home.

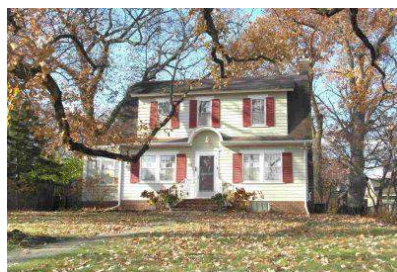
**821 Ridgewood Ave Edward R. Meredith House 1919 1**  
**Contributing House; 1 Contributing Garage**

**Description:** Located on the west side of Ridgewood Avenue, facing east, this is a two-story Dutch Colonial Revival home constructed in 1919 according to Ames City Assessor data. The house has a side gambrel roof, a one-story south elevation wing, and a central shed-roofed dormer that spans most of the façade. The foundation material is brick, and the roof is covered with composition shingles. The exterior siding is clapboard with decorative shutters. The pent roof is interrupted by an arch above the centered entrance. Low-rise brick steps flanked by flared iron handrails lead to a small brick stoop and the front door, framed by the same molded lintel trim as the façade fenestration openings. Paired windows are on either side of the door, with six-over-six double-hung sashes. The dormer has three windows of the same style. A flat-roofed enclosed one-story wing is on the south elevation. A brick chimney is on the north elevation. This home is one of a subset of uncommon Dutch Colonial Revival homes that falls within the umbrella of Colonial Revival, notable for their side-gambrel roofs and nearly full-width front dormers. A contributing detached garage from 1940 is at the south rear corner of the lot, and accessible by the alley on the west side of the lot.

**Integrity:** The storm windows and the left side porch wing enclosure are alterations. This property still retains its original massing, materials, workmanship, and character-defining features. The property retains the feeling and association of a Dutch Colonial Revival home and is contributing to the historic district.

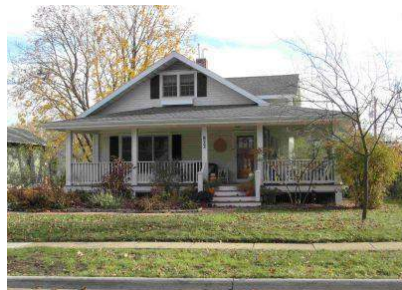
**Contributing House; 1 Noncontributing Garage**

Description: Located on the east side of Ridgewood Avenue, facing west, this is a one and a half-story Craftsman bungalow constructed in 1923 according to Ames City Assessor data. The house has a front gable roof and an L-shaped front porch, and a rear addition. The foundation material is brick, and the roof is covered in composition shingles. The exterior cladding is narrow clapboards. The rake and fascia boards have been

wrapped in aluminum and the projecting eaves and overhangs have been covered with aluminum soffit panels. The full-width hip-roofed porch was altered to extend to the right side. Molded columns support the porch roof. The space between columns is spanned by a wooden railing that extends down the front steps. The front door is framed with a molded lintel that is also present on the fenestration frames. A set of three four-over-one double-hung windows in the distinctive vertical-pane Craftsman style are on the north side of the façade beneath the porch roof. Beneath the gable at the half-story sits a pair of six-over-six double-hung windows, a different style than the first-level windows. A centered brick chimney is at the roof's ridge at the rear of the house. A noncontributing garage from 2016 is at the north rear of the property.

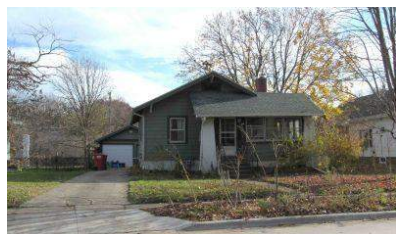
**Contributing House; 1 Contributing Garage**

Description: Located on the east side of Ridgewood Avenue, facing west, this is a one-story Craftsman bungalow constructed in 1910 according to Ames City Assessor data. The house has a front gable roof and a side-gabled porch that extends on the right side. The foundation material is stucco-covered brick, and the roof is covered with composition shingles. The exterior is vinyl

siding with fascia boards and two triangular knee braces are situated beneath the front gable. Large, tapered stucco columns support the enclosed shed roof porch. Concrete steps with metal railings lead to the south-offset porch entrance; behind it, the original centered entrance can be seen. Paired five-over-one double-hung Craftsman windows (multi-pane vertically oriented upper sash over a single-pane lower sash) are also visible behind the porch enclosure, matching the single five-over-one double-hung window on the north side of the façade. A narrow, horizontally oriented single-light

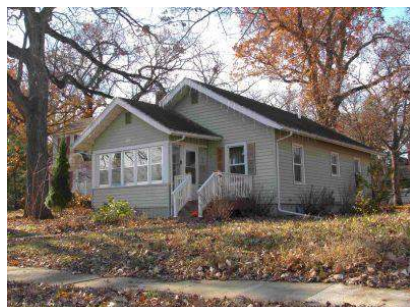
Description: Located on the west side of Ridgewood Avenue, facing east, this is a one-story Craftsman bungalow constructed in 1925 according to Ames City Assessor data. The house has a front gable roof with an overlapping front gable porch on the left side. The foundation material is brick, and the roof is covered in composition shingles. The exterior siding is vinyl. The rake and fascia boards have been wrapped in aluminum and the projecting eaves and overhangs have been

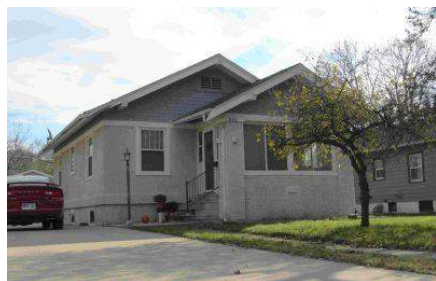
Description: Located on the east side of Ridgewood Avenue, facing west, this is a one-story Craftsman bungalow constructed in 1918 according to Ames City Assessor data. The house has a front gable roof and overlapping front gable porch on the right side of the façade. The foundation material is stucco-covered brick, and the roof is covered with composition shingles. The exterior cladding is stucco with wood shingles on

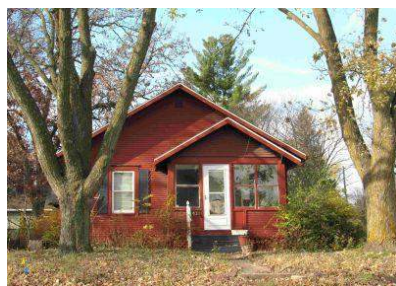
**1 Contributing House; 1 Noncontributing Garage**

Description: Located on the west side of Ridgewood Avenue, facing east, this is a one-story Craftsman bungalow constructed in 1922 according to Ames City Assessor data. The house has a front gable roof and overlapping front gable porch on the right side. The foundation is brick, with wood lattice work concealing the crawl area under the porch. The roof is covered with composition shingles. The exterior cladding is narrow

clapboards with extended rake boards, frieze boards, corner boards, and decorative shutters. The projecting eaves have rafter tails and triangular brackets sit beneath the gable overhangs. The porch is covered by the lower gable roof and is on the north side

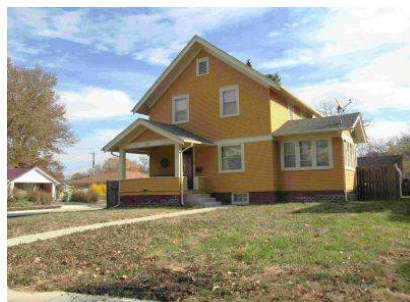
Description: Located on the east side of Ridgewood Avenue, facing west, this is a two-story frame Craftsman home constructed in 1916 according to Ames City Assessor data. The rectangular plan house has a front gable with a one-story side-gable wing on the south side. The foundation material is brick, and the roof is covered with composition shingles. The exterior cladding is narrow clapboards with wide rake boards, molded frieze

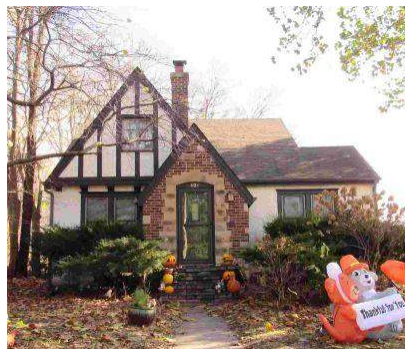
Description: Located on the east side of Brookridge Avenue, facing west, this is a one and a half-story Tudor Revival cottage constructed in 1933 according to Ames City Assessor data. The house has a cross-gable roof with steep overlapping front and side gables. The foundation material is brick, and the roof is covered with composition shingles. The exterior cladding is decorative half-timbering with stucco, brick, and stone. The gables are detailed with simple vergeboards at the gable ends. Front layered gables are on the north side of the façade

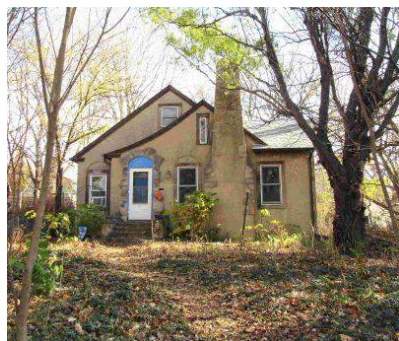
Description: Located on the east side of Brookridge Avenue, facing west, this is a one-and-a-half-story, cross-gable, Tudor Revival with overlapping front gables, with the secondary gable sporting a swooping roofline on the left side. The roof is covered with composition shingles, and the cladding is stucco. The roofline includes modest eaves, which extend slightly beyond the walls but lack decorative brackets or detailing. Rake boards are molded and include returns. The front entryway is recessed within a shallow arched opening beneath the secondary front

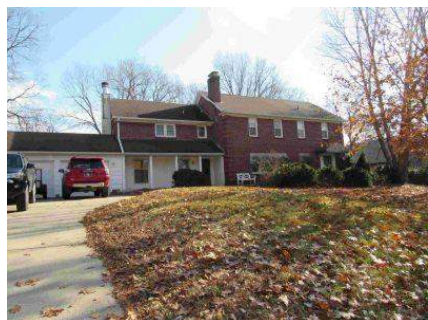
Description: Located on the east side of Brookridge Avenue, facing west, this is a two-story Colonial Revival home constructed in 1924 according to Ames City Assessor data. The house has a side-gable roof and a side-gabled set back addition. The foundation material is brick, and the roof is covered with composition shingles and includes gable returns. The home is brick with brick quoins at the corners of the original volume. The left side addition has vertical boards on the first level and

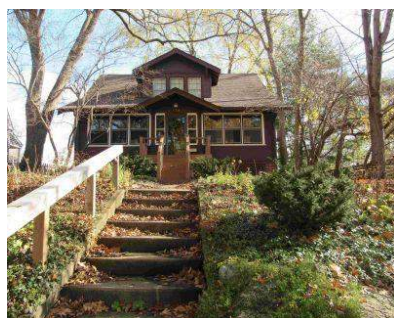
**Description:** Located on the east side of Brookridge Avenue, facing west, this is a one and a half-story Craftsman home constructed in 1929 according to Ames Inspection Division permit files. The house has a steep side gable roof with a large front-gable dormer, an enclosed porch, and a rear addition. The foundation material is brick, and the roof is covered with composition shingles. The building is clad in stucco on the first level, with wood shingles beneath the gable. A molded belt

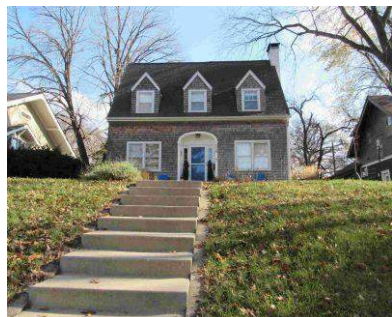
**Description:** Located on the east side of Brookridge Avenue, facing west, this is a two-story Colonial Revival home constructed in 1934 according to Ames City Assessor data and Inspection Division permit files. The house has a steeply pitched side gable roof. The foundation material is poured concrete, and the roof is covered with composition shingles. The building is clad fully in natural wood shingles. The front roofline has features narrow fascia and vergeboards without overhangs along the gable. A triangular fixed vent fit sits at the apex. Three front-gabled dormers project from the roof at the second level with simple vergeboards, absent any overhangs. The centered, recessed entrance features a three-point arch with a concrete stoop. The door is flanked by three-pane sidelights with a transom panel fan above. Windows on the first level are paired and placed symmetrically on either side of the entrance. All windows are six-over-six double-hung with flat board trim. A painted brick chimney is on the south elevation. A noncontributing detached garage built in 2005 is directly behind the home, accessible by the alley on the east side of the property.

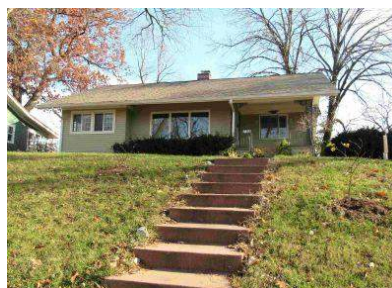
**Contributing House; 1 Noncontributing Garage**

**Description:** Located on the east side of Brookridge Avenue, facing west, this a one-story Ranch house was constructed in 1920 according to Ames City Assessor data. The house has a side gable roof, a parged brick foundation, and the roof is covered with composition shingles. The exterior is vinyl siding, with a molded belt course, fascia boards at the gables, and frieze boards and rafter tails beneath the eaves. The façade has significant mid-twentieth-century alterations that include a significant front volume addition, large, fixed pane windows, paired multi-light sliding windows, casement windows, and a stone floored porch at the southwest corner with decorative filigree decorative forged metal columns. The changes include the use of metal columns, typical of 1950's renovations. A noncontributing detached garage from 2018 is at the rear of the lot is angled to face northeast and is accessible by the alley on the east side of the property.

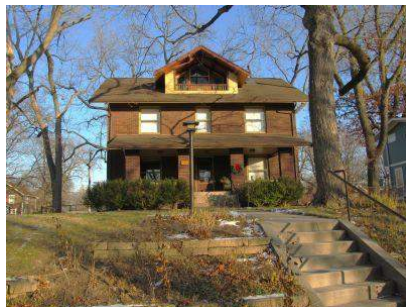
Description: Located on the east side of Brookridge Avenue, facing west, this is a two and a half-story Craftsman home constructed in 1916 according to Ames City Assessor data. The house has a side gable roof with a front dormer and a full-width shed-roofed porch. The foundation material is brick, and the roof is covered by composition shingles. The exterior is brick with clapboard siding on the additions. Rake boards run along the gables and frieze boards sit beneath the projecting overhangs.

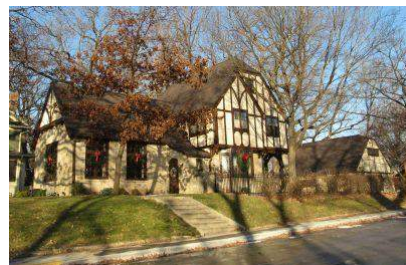
**House; 1 Contributing Garage**

Description: Located on the east side of Brookridge Avenue, facing south, this is a two and a half-story Tudor Revival home constructed in 1932 according to Ames Inspection Division permit files. This house has a cross-gable roof with overlapping front gables and a side-gable wing with slate tiles. The foundation is poured concrete, and the exterior is random ashlar rock face and smooth limestone, brick, and decorative half-timbering with

stucco. The entranceway is beneath and extended, swooped roof, that creates a west-facing vestibule with a small single-pane light on its south side. A Tudor arch in an irregularly cut limestone frames the eight-light door (likely original) and the uncoursed stone continues to create a small buttress-like wall that leads to the front garden fence. The south facing gable has a jerkinhead apex and the second floor beneath the gable

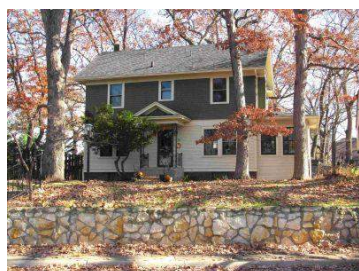
**728 Brookridge Ave      John M. Evvard House      1912      1**  
**Contributing House; 1 Contributing Garage**

Description: Located on the east side of Brookridge Avenue and facing west, this two-story Colonial Revival home was constructed in 1912, according to Ames City Assessor data. The house features a side-gable roof and a one-story, shallow sloped roof, enclosed porch on the south side. The foundation is brick, and the roof is covered with composition shingles. The exterior consists of narrow clapboard siding on the first level and in the gable triangles, with wood shingles

on the second level. Molded belt courses at the foundation and at the first- and second-level window lintel heights separate these cladding materials. Architectural details include gable returns, rake boards, fascia, and frieze boards. The centered entrance is sheltered by a projecting pediment supported by replacement wrought-iron supports. The entryway features concrete steps with metal railings. The windows, likely replacements, exhibit a Craftsman-style design with multiple vertical muntins. The main windows are one-over-four double-hung: paired on either side of the front door at the first level and symmetrically spaced as three separate windows on the second level. All windows are trimmed with flat boards, and the first-level windows have molded lintels. On the right side, the enclosed porch wing features paired six-over-six double-hung

**Integrity:** The replacement windows, storm windows and door, and the pediment supporting columns are alterations. While the right-side enclosure on the first level is not original, it is congruent with other wing enclosures that are now characteristic in the district. This property still retains its original massing, materials, workmanship, and character-defining features. The property retains the feeling and association of a Colonial Revival home and is contributing to the historic district.

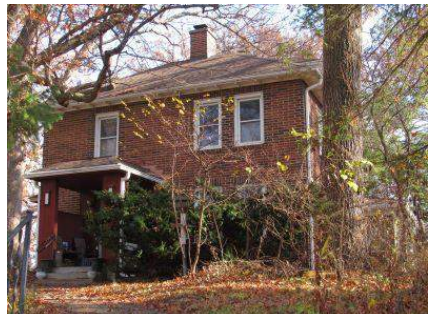
Description: Located on the east side of Brookridge Avenue, facing west, this is a two-story brick Colonial Revival home constructed in 1922 according to Ames City Assessor data. The house has a hip roof covered with composition shingles, and the foundation is brick. There is a centrally located, interior brick chimney. The fascia and frieze boards are wood with wood brackets under the wood clad soffits. A later addition entrance porch, has a flat roof with a hip perimeter, supported by vertical wood sided columns, located on the left side of the façade, partially enclosed by wood walls ascending three-quarters of the ceiling height. Two one-over-one double-hung windows complete the first level façade fenestration. The second level façade has three one-over-one double-hung windows. A contributing detached garage from 1922 is accessible by the alley on the east side of the property.

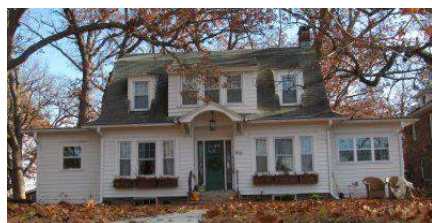
**Contributing House; 1 Contributing Garage**

Description: Located on the east side of Brookridge Avenue, facing west, this is a two-story Dutch Colonial Revival home constructed in 1923 according to Ames City Assessor data. The house has a side-gambrel roof. The house has a north and south wing, both of which are likely additions, given the fact that the foundation for both wings is at a lower elevation. The building is clad in clapboard siding, has a brick foundation, and the roof is covered with composition shingles. Three shed-roofed dormers project from the front roof: one large, centered dormer and two smaller partially recessed dormers. The gambrel roof has gable returns and terminates directly at the wall line, with no overhangs. Both wings are covered with flat roofs. A small projected front gable portico with an arched inset is supported by paired brackets. The front door has a six-light window with sidelights and a molded entablature above. Concrete steps with metal railings lead to the stoop. The first and second floor windows are typical six-over-one double-hung windows with wide flat board trim and molded lintels. A set of three windows sits on either side of the entrance on the first floor. On the second level, three windows are in the central dormer while the flanking dormers have one window each. The north elevation has one centered window, and the south elevation has a

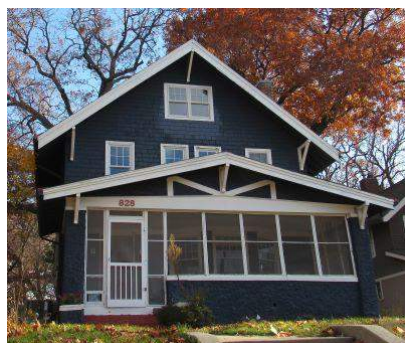
**Description:** Located on the east side of Brookridge Avenue, facing west, this is a two-story Craftsman home constructed in 1914 according to Ames City Assessor data. The house has a front gable roof, enclosed full-width front-gable porch, and a rear addition. The foundation material is brick, and the roof is covered with composition shingles. The exterior has heavily textured stucco on the first level and wood shingles on the upper level, with a wide molded belt course separating the two materials at the first-level window lintels. Wood shingles

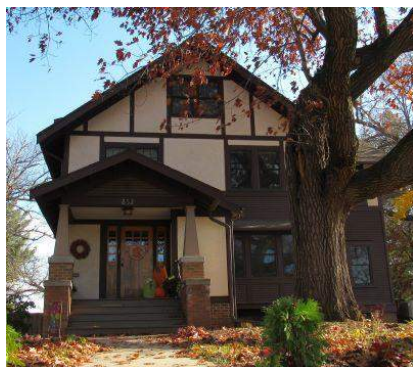
Description: Located on the east side of Brookridge Avenue, facing west, this is a two-story Craftsman home constructed in 1923 according to Ames City Assessor data. The house has a front gable roof, a half-width porch, and a two-story south elevation wing. The foundation material is brick, and the roof is covered with composition shingles. The exterior cladding is narrow clapboard on the first level and decorative half-timbering with stucco on the upper story. These materials are separated by a flat, narrow belt course at the height of

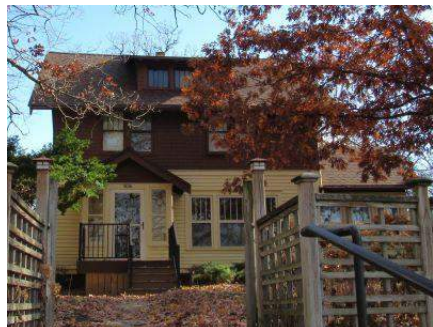
Description: Located on the east side of Brookridge Avenue, facing west, this is a two and a half-story Craftsman home constructed in 1916 according to Ames City Assessor data. The house has a side-gabled roof with a central shed dormer, a one-story south elevation wing (possibly an addition), and rear addition. The foundation material is brick, and the roof is covered with composition shingles. The building is clad in wood shingles on the

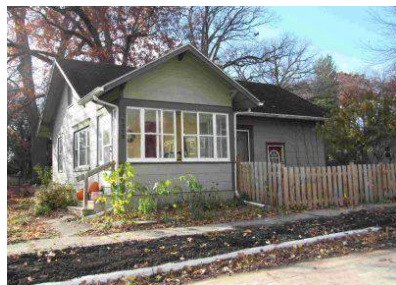
**Contributing House; 1 Noncontributing Garage**

**Description:** Located on the south side of 9th Street, facing north, this is a one-story craftsman cottage constructed in 1922 according to Ames City Assessor data. The house has a side-gabled roof and a front-gabled enclosed half-width porch. The foundation material is concrete or covered brick, and the roof is covered with composition shingles. The exterior cladding is asbestos-cement shingles with the original narrow clapboards are

visible behind the porch enclosure. Narrow fascia boards along the gables, with frieze boards and triangular knee braces are beneath the projecting eaves. Concrete steps with wood railing leads to the enclosed porch door, and an original door is visible behind the enclosure. A molded entablature beneath the porch gable is supported by square columns. The fenestration openings, including doors, are framed with flat boards and molded lintels. Replacement and altered windows are on the façade, and left side elevation though window openings on the east elevation likely original. A secondary door is on the right side of the façade is a later alteration. A noncontributing detached garage built in 2005 is at southwest corner of property, and accessible by an alley on the west side of the lot.

**Integrity:** The replacement windows, storm windows and siding are alterations. While the porch enclosure is not original, it is historic and congruent with the other porch enclosures that are now characteristic in the district. This property still retains its original massing, materials, workmanship, and character-defining features. The property retains the feeling and association of a craftsman cottage and is contributing to the historic district.

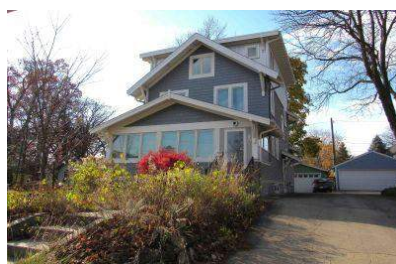
**Noncontributing House; 1 Contributing Garage**

**Description:** Located on the west side of Ridgewood Avenue, facing east, this is a two-story Craftsman home constructed in 1922 according to Ames City Assessor data. The house has a front gable roof, an enclosed full-width front porch, and rear addition. Significant dormer additions create a third level and a flat roof. The foundation material is stucco-covered brick, and the roof is covered with composition shingles. The exterior cladding

is narrow clapboards, with fascia boards, frieze boards, triangular knee braces, and rafter tails beneath the projecting eaves. A molded belt course is at the foundation level. The enclosed porch has a shallower pitched gable with a pendant at its peak and a wide entablature beneath the gable. The door is offset to the right side of the façade. The large dormer additions on either side have rafter tails and triangular knee braces. Fenestration is made of paired single-pane casement replacement windows within original flat board and molded lintel trim (second level north side window with replacement lintel). Stucco-covered brick chimney on the south elevation. The dormer additions are clad in ribbed metal, with small, fixed pane windows. This house is an example of the two-story front gable Craftsman homes that are found throughout the additions. A detached garage at the rear of the house on the north side is considered a contributing structure to a potential district, constructed circa 1928 according to Ames City Assessor data.

**Integrity:** The replacement windows, storm windows, dormer additions, and replaced lintel are alterations. While the porch enclosure is not original, it is historic and congruent with the other porch enclosures that are now characteristic in the district. Due to the third level addition this house is not contributing to the historic district because it changes the scale and massing, which results in a lack of historic feeling and association.
