United States Department of the Interior  
National Park Service**National Register of Historic Places Registration Form**

**1. Name of Property**Historic name: Chautauqua Park and Ridgewood Historic DistrictOther names/site number: N/A

A Home for Science and Technology: Ames, Iowa, 1864–1941 (NRIS 64500871)

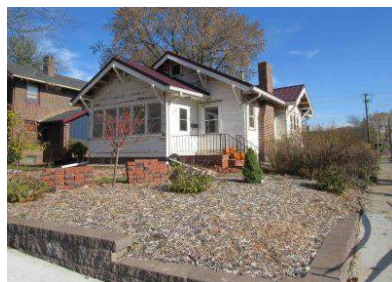
**902 Ridgewood Ave      Julian L. Boatman House 1925      1 Contributing House; 1 Noncontributing Garage**

**Description:** Located on the east side of Ridgewood Avenue, facing west, this is a one-story Craftsman bungalow constructed in 1925 according to Ames City Assessor data. The house has overlapping front gables, an enclosed three-quarters width porch, and an attached garage. The foundation material is brick, and the roof is covered with composition shingles. The home is clad in narrow clapboards with rake boards capping the gables

and triangular knee braces beneath the projecting overhangs. A three-quarters length enclosed porch sits under the secondary gable on the north side of the façade, with brick stairs and stoop leading to the south-oriented door. The window on the south side of the façade is a one-over-one double-hung. A four-over-one double-hung window with Craftsman-style vertical panes on the top sash is visible behind the porch enclosure. A small, three-light fixed window is under the gable. A shallow side-gabled wing is on the south elevation. A brick chimney is on the south elevation. An attached noncontributing garage is on the east elevation. This home is part of a subtype of Craftsman bungalows in the additions, distinctive for their one-story, overlapping front-gabled design and enclosed half-length porches.

**Integrity:** The replacement windows, storm windows, and the brick stairs and stoop are alterations. This property still retains its original massing, materials, workmanship, and character-defining features. The property retains the feeling and association of a Craftsman bungalow and is contributing to the historic district.

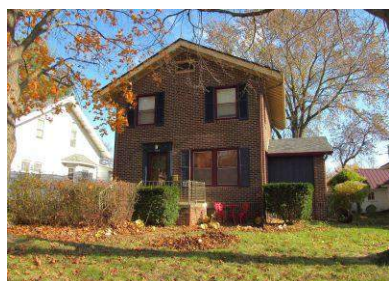
**Contributing House; 1 Noncontributing Garage**

**Description:** Located on the east side of Ridgewood Avenue, facing west, this is a two-story home constructed in 1921 according to historian William Page with Craftsman and Colonial Revival influences. The house has a front gable roof, a one-story side-gable porch, and a rear addition. The foundation material is brick, and the roof is covered with composition shingles. The building is clad in brick, with a soldier belt course at the foundation level, and

decorative shutters. The front and side gables have wide rake boards. The eaves have exposed rafter tails and frieze boards about the eaves and overhangs. The entrance is surrounded by the Colonial Revival-style engaged pilasters and entablature. An alteration documented in 1935, removed a front porch roof, the scar of which appears to be still visible on the façade brick. A brick and concrete elevated stoop with metal railings and stairs is oriented to the north. The first level has paired one-over-one double-hung windows, while the second story has two one-over-one double-hung windows. Additionally, there is a small original fixed three-light window beneath the gable. All windows are surrounded by flat boards with molded lintels and rowlock course brick sills. The south elevation porch wing is enclosed with T-111 reverse board and batten siding situated between brick piers, likely added around the same time the entrance was altered. An internal central brick chimney, and a secondary chimney are visible on the south elevation of rear addition. A noncontributing detached garage from 1984 is at the rear of the property. The stylistic modifications of this building documented in 1935 are indicative of the influences of the Colonial Revival and Minimal Traditional styles being constructed nearby and illustrate the transition away from Craftsman aesthetics visible in the architecture built at this time.

**Integrity:** The replacement windows and porch wing enclosure are alterations. This property still retains its original massing, materials, workmanship, and character-defining features. The property retains its feeling and association and is contributing to the historic district.

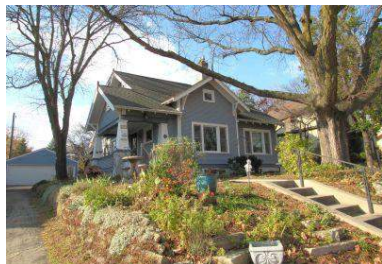
**Contributing House; 1 Noncontributing Garage**

**Description:** Located on the west side of Ridgewood Avenue, facing east, this is a one and a half-story Craftsman home constructed in 1918 according to Ames City Assessor data. The house has a side gable roof, rear dormer addition, and porch. The foundation material is brick, and the roof is covered with composition shingles. The exterior cladding is narrow clapboards, corner boards, a molded belt course at the foundation level, and fascia

boards with decorative peaks capping the gables. Frieze boards, triangular knee braces, and rafter tails beneath the projecting eaves. The entrance and porch are on the south elevation beneath a layered gable. The porch roof is supported by large stucco piers with a molded entablature and the rail is enclosed. Concrete stairs with metal railing lead from the sidewalk to the wood stairs of the porch. A projecting front-gable wing is offset to the south on the façade. Two Chicago-style window configurations on the façade at the first level, with fixed panes are flanked by one-over-one double-hung windows. A small, square window is tucked beneath the front gable. The fenestrations are surrounded by wide flat boards and molded lintels. Interior stucco-covered brick chimney with decorative coursework is visible at the top. A noncontributing garage from 1972 is on the southwest corner of the property.

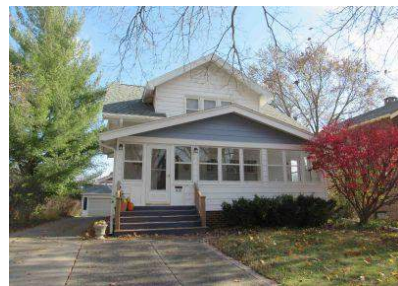
**Contributing House; 1 Noncontributing Garage**

**Description:** Located on the east side of Ridgewood Avenue, facing west, this is a one and a half-story Craftsman home constructed in 1928 according to Ames City Assessor data. The house has a steep side gable roof, front-gable dormer, full-width enclosed front-gable porch, and rear addition. The foundation material is brick, and the roof is covered with composition shingles. The exterior cladding is aluminum, wide fascia boards line the

gables with subtle rafter tails beneath the projecting eaves. Original narrow clapboards visible behind the porch enclosure. Modern wood steps lead to the north-offset porch entrance, original door visible behind enclosure. Set of three original Craftsman windows sit on the south side of the original façade behind the enclosure, with four-over-one double-hung configurations. The central front-gabled wall dormer houses a set

of three windows, likely historic replacements, with six-over-one double-hung configurations. This style of window is repeated on the side elevations. Internal centered brick chimney. A noncontributing garage built in 1960 is at the northeast corner of the lot. This home is part of a subtype of Craftsman homes in the district that features a steep side-gabled roof with a prominent central dormer.

**Integrity:** The aluminum siding, replacement windows, storm windows, and porch stairs are alterations. This property still retains its original massing, materials, workmanship, and character-defining features. The property retains the feeling and association of a Craftsman style home and is contributing to the historic district.

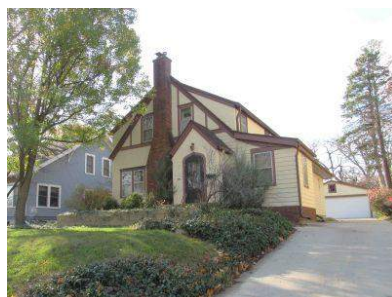
**Contributing House; 1 Noncontributing Garage**

**Description:** Located on the west side of Ridgewood Avenue, facing east, this is a one and a half-story Tudor Revival home with a front gable, dormer additions, and two north elevation additions. Constructed in 1928 according to Ames Inspection Division permit files. The foundation material is brick, and the roof is covered with composition shingles. The home is clad in stucco with decorative half-timbering, brick, and clapboard with molded vergeboards

at the gables. The nested-gable entrance vestibule offset to the north with a Tudor-arched door surrounded by flat boards. The façade chimney is centered within the gable and extends past the peak. Paired windows to the south of the chimney base on first level with six-over-one double-hung configuration and another of the same style to the north of the entrance vestibule. One window on either side of the chimney in the half-story, each one-over-one double-hung. Windows are surrounded by flat boards with molded headers. The dormers on either side of the front gable are historic, and the front north elevation addition is also historic. A noncontributing garage built in 2001 is on the northwest corner of the property.

**Integrity:** The replacement windows in the half story and right-side additions are alterations. This property still retains its original massing, materials, workmanship, and character-defining features. The property retains the feeling and association of a Tudor Revival home and is contributing to the historic district.

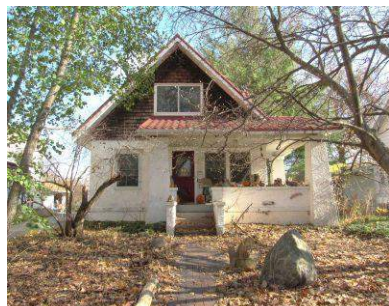
**House; 1 Noncontributing Garage**

**Description:** Located on the east side of Ridgewood Avenue, facing west, this is a one and a half-story Craftsman home constructed in 1919 according to Ames City Assessor data. The house has a cross-gabled roof, half-width porch, and rear addition. The foundation material is covered in stucco (likely brick) and the roof is covered with stamped metal roofing in a clay-tile pattern. The exterior cladding is stucco on the first level and wood shingles beneath the gables with a flat belt course along the foundation. Gables lined with fascia boards. The shed-roofed half-width porch is offset to the south, framed with tapered stucco piers spanned by the stucco-enclosed rail. Concrete steps to the porch are slightly offset from the centered door, which is surrounded by flat boards and molded lintel trim. Three windows on the first level are one-over-one double-hung replacements, one north of the central door and two paired south of the door. Paired fixed-pane window replacements are under the gable in an altered opening. A noncontributing detached garage built in 1981, also with a cross-gable roof, is located along the north property line.

**Integrity:** The replacement windows and tile roof material are alterations. This property still retains its original massing, materials, workmanship, and character-defining features. The property retains the feeling and association of a Craftsman style home and is contributing to the historic district.

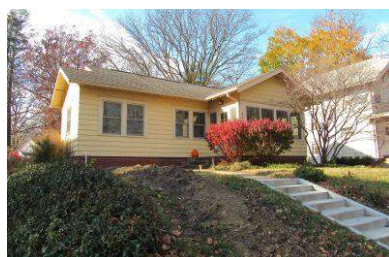
**Contributing House; 1 Contributing Garage**

**Description:** Located on the west side of Ridgewood Avenue, facing east, this is a one-story Craftsman bungalow, constructed in 1925 according to Ames City Assessor data. The house has layered side gables and a front-gable half-width enclosed porch. The foundation is brick, and the roof is covered with composition shingles. The exterior cladding is aluminum with wide fascia boards at the gables. Frieze boards and rafter tails beneath the projecting eaves. Brick steps lead to the south-oriented porch door. The porch covers the north side of the façade, while the south side of the façade is fenestrated with two pairs of four-over-one double-hung windows with Craftsman-typical vertical panes in the upper sash. The windows are framed with flat boards and molded lintels. Porch enclosure glazed with the same style of window. A contributing detached garage from 1925 is at the northwest corner of the property.

**Integrity:** The aluminum siding, storm windows, and porch stairs are alterations. The porch enclosure is congruent with the other porch enclosures of these bungalows. This property still retains its original massing, materials, workmanship, and character-defining features. The property retains the feeling and association of a Craftsman bungalow and is contributing to the historic district.

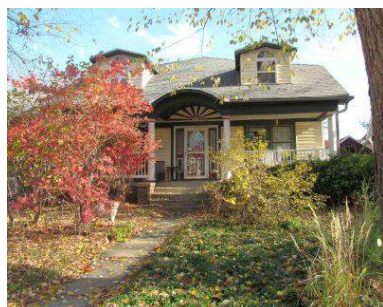
**918 Ridgewood Ave Robert Cochran House 1928 1 Contributing House; 1 Contributing Garage**

**Description:** Located on the east side of Ridgewood Avenue, facing west, this home is a one and a half story wood frame Colonial Revival style home constructed in 1928 according to Ames City Assessor data. The roof is hipped, has two front dormers with double-hung windows, and a semicircular transom. The foundation is brick, and the siding has been replaced with vinyl. A full front porch on the façade has four tapered columns supporting the porch roof, and simple wood railings on either side of the centered entrance steps enclose the porch. The front door has two side lights and is flanked by two sets of two double-hung windows. A contributing detached garage built in 1940 is located along the north property line directly behind the house.

**Integrity:** The vinyl siding, storm windows, and replaced windows are alterations. This property still retains its original massing, materials, workmanship, and character-defining features. The property retains the feeling and association of a Colonial Revival style home and is contributing to the historic district.

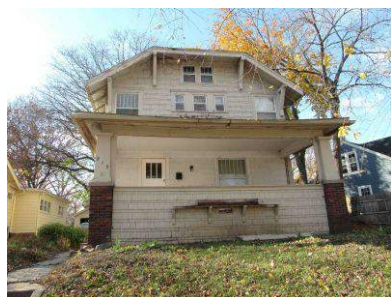
**919 Ridgewood Ave Lawrence B. Anderson 1920 1 Contributing House; 1 Contributing Garage**

**Description:** Located on the west side of Ridgewood Avenue, facing east, this is a two-story Craftsman home with a pronounced jerkinhead front gable and hip-roofed full-width porch. The home was constructed in 1920 according to Ames City Assessor data. The foundation is brick, and the roof is covered with composition shingles. The home is clad in wood shingles with corner boards and a molded belt course at the second-level windowsill height. The gable is lined with wide fascia boards, and frieze boards, rafter tails, and large triangular knee braces sit beneath the projecting eaves. The front porch is beneath a replacement hip roof with entablature atop tapered piers with brick supports. Enclosed rail, porch stairs on the south side. Five concrete steps with metal railing in the front

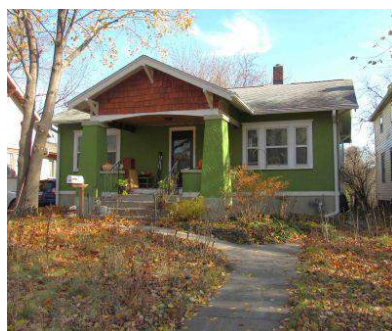
**Description:** Located on the east side of Ridgewood Avenue, facing west, this is a one-story Craftsman cottage constructed in 1920 according to Ames City Assessor data. The house has a side gable roof and a centered one-third-width porch. The foundation material is stucco-covered brick, and the roof is covered with composition shingles. The home is clad in stucco with wood shingles beneath the porch front gable, a flat belt course at the foundation level. The fascia boards line the side and front gables with triangular knee braces beneath the projecting eaves. Five concrete steps with metal railings lead to the centered porch and entranceway door. The porch roof is perched upon thick, tapered piers with curved entablature, and three wood brackets are on the front gable porch roof. Façade fenestration consists of one-over-one paired double-hung windows on the north side and a set of three windows, two slimmer outer windows flanking an inner wider window, sits on the south side. All one-over-one double-hung windows and framed with flat boards and molded lintels. An interior south-offset chimney is made of brick. A noncontributing detached garage built in 1989 is directly behind the home along the south property line.

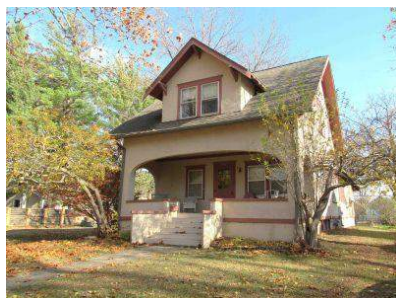
**Purl O. Rutledge House 1924 1 Contributing**

**Description:** Located on the east side of Ridgewood Avenue, facing west, this is a one and a half-story Craftsman home Constructed in 1924 according to Ames City Assessor data. The house has a steeply pitched side-gable, central front-gabled dormer, full-length porch, and an attached garage. The foundation material is covered in stucco, but likely brick or concrete block, and the roof is covered with composition shingles. The exterior cladding is stucco with a flat belt course at the foundation level,

wide fascia boards lining the gables, and triangular knee braces beneath the projecting eaves, with dormer eaves retaining original rafter tails. The porch is covered by the main roof envelope with a partial, arched stucco wall descending from the roofline. This arch taper to form piers at the corners of the porch. Stucco enclosed the rail with a simple cap and central flared steps that lead to the centered entrance. Original door may remain behind storm door. One-over-one double-hung window on the north side of the façade and paired one-over- one double-hung windows on the south. The dormer has paired one-over-one double-hung windows. All windows and the front door are framed by flat boards and molded lintels. The attached rear garage is an addition from 1924. This home is part of a subtype of Craftsman homes in the additions that feature a steep side- gabled roof with a prominent central dormer.

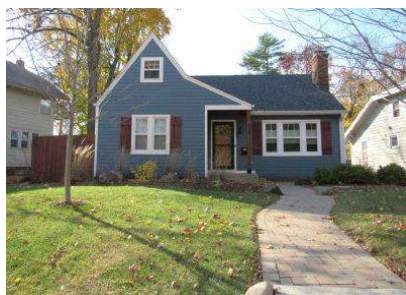
**Contributing House; 1 Contributing Garage**

**Description:** Located on the west side of Ridgewood Avenue, facing east this is a one and a half-story Minimal Traditional home with Tudor Revival influences constructed in 1933 according to Ames Inspection Division permit files. The house has a cross-gable roof covered with composition shingles, and the foundation is brick. The building is clad in clapboard with narrow vergeboards at the gable and decorative shutters. The

front gable projects from the south side of the façade and the north roofline extends at a secondary angle to cover the small concrete porch, supported by a thin post at the corner. The front entrance door is centered on the façade. The first level fenestrated

with paired four-over-one fixed windows on the gable wall and a set of three windows north of the door, two four-over-one fixed window flanking a central six-over-one fixed window. Six-over-one fixed window in the front gable. All the windows are framed by flat boards and their trims are replacements. A brick chimney is on the north elevation with slightly flared top and limestone accents. A contributing detached garage built in 1950 is located behind the home.

**Integrity:** The storm windows, replaced windows, and siding are alterations. This property still retains its original massing, materials, workmanship, and character-defining features. The property retains the feeling and association of a Minimal Traditional home and is contributing to the historic district.

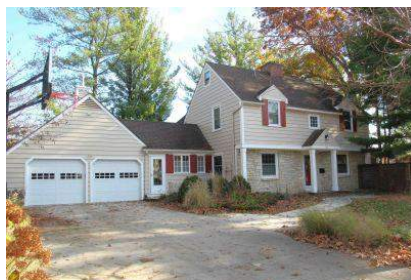
**1004 Ridgewood Ave**  
**House**

**Description:** Located on the east side of Ridgewood Avenue, facing west, this is a two-story Colonial Revival home constructed in 1937 according to Ames City Assessor data and Inspection Division permit files. The house has a side gable roof, flat-roofed south elevation wing, and an attached garage. The foundation material is concrete, and the roof is covered with composition shingles. The exterior cladding is faux stone, vinyl siding,

and wood shingles. A modern projecting portico roof with wood-shingles in the gable pediment is supported by square columns. The centered entranceway door has replaced trim altered. First level with two eight-over-eight double-hung windows on either side of the entranceway. The second level slightly overhangs the first, and this overhang is supported by wood columns. The second level has two six-over-six double-hung windows in wall dormers and a central fixed nine-light window. A secondary entrance door and window are at the connecting volume to the attached garage that was built in 1985. The south elevation is hidden by the fence line. An interior brick chimney is centered on the main volume at the roof ridge.

**Integrity:** The storm windows, shutters, replaced windows, siding and substantial garage addition are alterations. This property does not retain its original massing, materials, and scale, and impact of alterations change this property and has lost integrity. Therefore, the house is not contributing to the historic district.

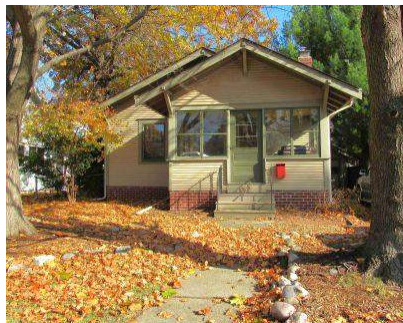
Description: Located on the east side of Ridgewood Avenue, facing west, this is a one-story Craftsman bungalow constructed in 1929 according to Ames Inspection Division permit files. The house has overlapping front gables and enclosed half-width porch. The foundation material is brick, and the roof is covered with composition shingles. The home is clad in narrow clapboard, with wide fascia boards on the gables; frieze boards, triangular knee braces, and rafter tails beneath the projecting eaves; and corner boards. The enclosed porch beneath the layered gable offset to the south with its door centered beneath the gable. Two concrete steps with metal railing lead up to the porch door, door original to the historic enclosure, and a subtly molded entablature caps the enclosure beneath the gable. The original façade windows with the style-typical of Craftsman style homes have vertical panes in five-over-one double-hung configurations, one behind the enclosure and one on the north side of the façade. A small, three-light fixed-pane window beneath the main gable. The windows are framed by flat board and molded lintel trim. A brick chimney is on the south elevation. A contributing detached garage from 1936 is on the south property line.

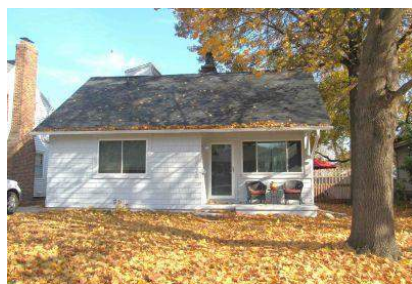
**1020 Ridgewood Ave                      Fannie E. Wellhouse House                      1930    1**  
**Contributing House; 1 Contributing Garage**

Description: Located on the east side of Ridgewood Avenue, facing west, this is a one-story side-gable Craftsman cottage constructed in 1930 according to Ames City Assessor data and Inspection Division permit files. The foundation is concrete block, and the roof is composition shingles. The exterior cladding is wood shingles with fascia boards and rafter tails present, and a single triangular knee brace is located at the south end of

the façade. The entrance is recessed with a painted concrete porch on the south corner beneath an eave overhang. The front façade has been extended forward beneath the eave on the north half of the building to create additional living space; the picture window and its opening likely date to an alteration made within the period of significance. A large two-story rear addition projects above the south half of the building; although substantial, this addition is located at the rear and is only minimally visible from the public right-of-way. An interior covered brick chimney with limestone or concrete cap is centered on the volume. A contributing detached garage from 1955 is in the northeast corner of the lot.

Integrity: The dwelling retains its original side-gabled form, deep eaves, exposed rafter tails, and a triangular knee brace at the south end of the façade, which together continue to express the modest Craftsman cottage subtype present in the district. Although the front façade has been extended beneath the eave on the north half of the building and fitted with a picture window, this alteration likely occurred within the period of significance and reflects typical mid-century modernization patterns found elsewhere in the additions. These changes diminish the clarity of the building's Craftsman stylistic expression but do not eliminate its ability to convey its historic architectural character. A large two-story rear addition projects above the south half of the building; this later alteration is only minimally visible from the public right-of-way and does not dominate

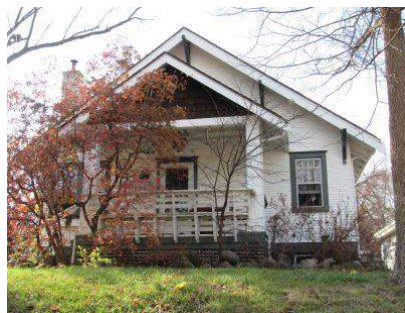
Description: Located on the west side of Ridgewood Avenue, facing east, this is a one-story Craftsman bungalow with nested front gables constructed in 1916 according to Ames City Assessor data. The foundation material is brick, and the roof is covered with composition shingles. The exterior cladding is made of narrow clapboards with some wood shingles beneath the porch gable. The extended fascia boards cap the gables and triangular brackets, and rafter ends are housed in the

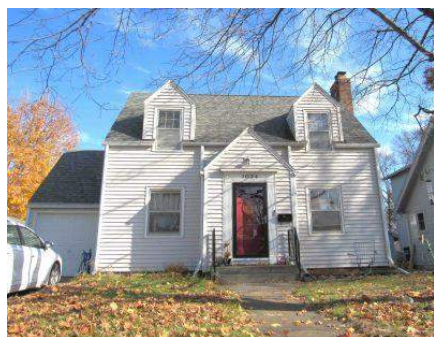
Description: Located on the east side of Ridgewood Avenue, facing west, this is a one and a half-story Minimal Traditional home with Colonial Revival influence. Constructed in 1940 according to Ames City Assessor data and Inspection Division permit files, this house has a side gable, with projecting front-gabled entrance vestibule and two front dormers. The foundation material is brick, and the roof is covered with composition shingles. The exterior cladding is vinyl with flushed eaves characteristic of the Minimal Traditional

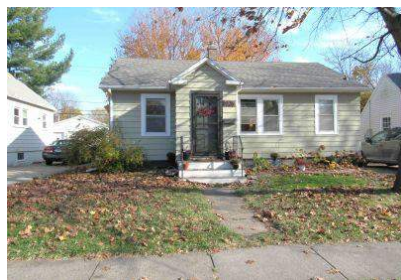
**Contributing House; 1 Contributing Garage**

Description: Located on the east side of Ridgewood Avenue, facing west, this is a one-story vernacular cottage with a side-gabled roof and a front-gabled entrance vestibule. This house was constructed in 1929 according to Ames Inspection Division permit files. The foundation material is concrete, and the roof is covered with composition shingles. The exterior cladding is aluminum, has extended eaves with returned cornices on the side

and vestibule gables. The entrance vestibule is offset to the north and concrete steps with metal railings lead up to the door. A one-over-one double-hung window is on the north side of the façade and three one-over-one windows are on the south, two of which are paired. The windows are surrounded by flat boards. An interior centered brick chimney is behind the roof ridge. A contributing detached garage from 1930 is on the south property line. This home is an interesting bridge between Minimal Traditional and Craftsman stylings, retaining a few subtle Craftsman characteristics from the previous decade's trends.

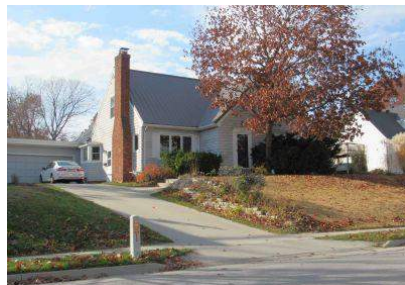
**Contributing House**

**Description:** Located on the west side of Ridgewood Avenue, facing east this is a one and a half-story Minimal Traditional home constructed in 1940 according to Ames City Assessor data and Inspection Division permit files. The house has a side gable roof, a projecting front-gable wing, rear dormer, rear addition, and an attached garage. The foundation material is brick, and the roof is covered with composition shingles. The home is clad in clapboard

with narrow vergeboard at the gables and decorative shutters. The front gable is on the north side of the façade and the entrance vestibule is housed within a layered, projecting gable near the center of the façade. The door trim is Colonial Revival influenced engaged pilasters with a molded entablature. The door is preceded by a small concrete stoop and stairs with a metal railing, oriented to the south. Set of three single-pane casement replacement windows on the south side of the façade, paired six-over-one double-hung windows on the north side. A one-over-one double-hung window is on the gable at the half story level. An added skylight is on the side gable roof north of the front gable. A brick chimney is on the south elevation. A contributing attached garage built in 1940 is on the southwest corner of the home.

**Integrity:** The storm windows, replacement windows and skylights are alterations. This property still retains its original massing, materials, workmanship, and character-defining features. The property retains the feeling and association of a Minimal Traditional home and is contributing to the historic district.

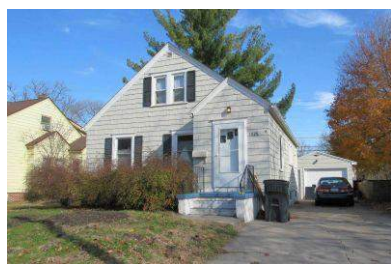
**Contributing House; 1 Contributing Garage**

**Description:** Located on the east side of Ridgewood Avenue, facing west, this is a one and a half-story inter-war period vernacular Minimal Traditional cottage constructed in 1929 according to Ames City Assessor data and Inspection Division permit files. The home has a front-gable roof with a projecting front-gabled vestibule. The foundation is brick, and the roof is covered with

composition shingles. The home is clad in asbestos-cement shingles, with decorative shutters and simple gable-end trim at the flush eaves. The entrance is offset to the south, housed in a front-gabled vestibule, door framed in flat boards. Two windows on the first level and paired windows under the gable are one-over-one double-hung, all with flat board and molded lintel trim. Painted concrete steps and a stoop with metal railings reach the front door. A contributing detached garage from 1929 is at the southeast corner of the lot. This home is stylistically caught between Craftsman and

Integrity: The storm windows, replacement windows and shutters are alterations. This property still retains its original massing, materials, workmanship, and character-defining features. The property retains the feeling and association of a Minimal Traditional home and is contributing to the historic district.

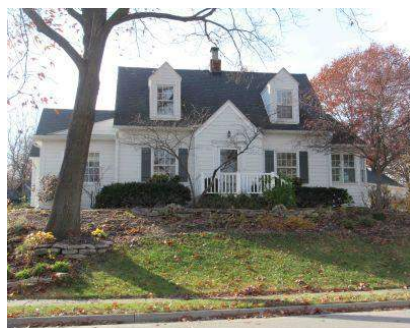
Description: Located on the west side of Ridgewood Avenue, facing east, this is a one and a half-story Minimal Traditional home constructed in 1936 according to Ames City Assessor data and Inspection Division permit files. The house has a side-gable roof and multiple additions. The foundation material is concrete block, and the roof is covered with composition shingles. The exterior cladding is vinyl siding with corner boards and decorative shutters and has flush eaves with narrow

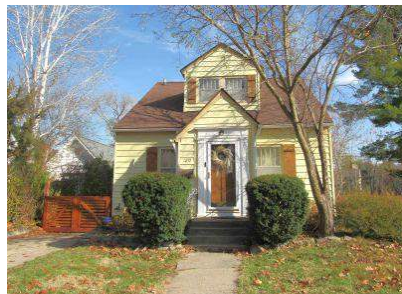
**Contributing House; 1 Contributing Garage**

Description: Located on the east side of Ridgewood Avenue, facing west, this is a one and a half-story cottage constructed in 1922 according to Ames City Assessor data. The house has side-gable roof with a front-gable dormer, two layered side-gabled additions on the south elevation, and an asymmetrical front-gabled entrance vestibule. The foundation material is concrete, and the roof is covered with composition shingles. The exterior

cladding is aluminum siding, an alteration whose installation date is not documented, with simple gable-end trim at the flush eaves and decorative shutters. The entrance vestibule is centered on the façade within an asymmetrical Tudor Revival inspired front gable and the door is surrounded by Colonial Revival influenced engaged pilasters and entablature. Concrete steps with metal railings lead to the centered entrance door. Two first level windows are situated on either side of the projecting entrance volume and are Craftsman- style five-over-one double-hung, with paired windows of the same configuration in the front-gabled central dormer. An interior centered brick chimney is behind the roof ridge. A contributing detached garage built in 1940 is at north corner of the property. This home is stylistically caught between Craftsman, Minimal Traditional, and Tudor Revival, likely due to modifications made in the late 1930s or early 1940s. Entrance vestibule is likely a historic addition from this time, influenced by the surrounding Minimal Traditional and Tudor Revival homes, while the windows and front-gable dormer reflect Craftsman aesthetics, showing the transition between these significant architectural trends.

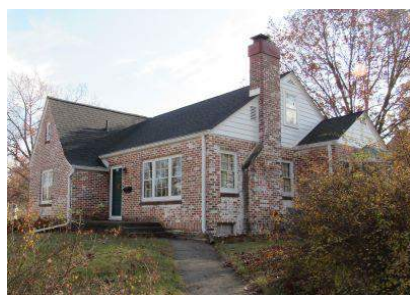
**House; 1 Contributing Garage**

Description: Located on the west side of Ridgewood Avenue, facing east, this is a one and a half-story Minimal Traditional home with Tudor Revival influences. Constructed in 1935 according to Ames Inspection

Division permit files, the house has an overlapping side gable roof with a projecting front gable. The foundation is brick, and the roof is covered with composition shingles. The home is clad in brick with a white-textured treatment

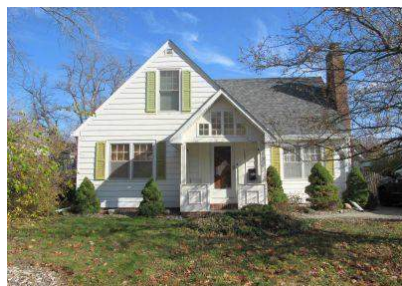
**Contributing House; 1 Contributing Garage**

**Description:** Located on the east side of Ridgewood Avenue, facing west, this is a one and a half-story Minimal Traditional home Constructed in 1938 according to Ames Inspection Division permit files. The house has a cross-gable roof and a front-gable porch. The foundation material is brick, and the roof is covered with composition shingles. The exterior cladding is aluminum with simple vergeboards at the flush eaves, decorative shutters around façade windows. The central entrance is within the front gable on the north side of the façade, covered by a porch roof addition with multi-light windows beneath the gable supported by thin columns, and paneled knee-walls frame the brick porch. The newer gable is layered onto the original shallow gable that houses the front door. The door is framed by Colonial Revival influenced pilasters and entablature. Windows of the first level on the north side of the façade are paired six-over-one double-hung, with similar paired windows on the south side. The window beneath the front gable is a nine-over-one double-hung, likely altered and is larger and with a replacement window. A small vent tucked in the apex of the main gable. Brick chimney on the south elevation. A contributing detached garage built in 1936 is on the southeast corner of the property.

**Integrity:** The covered porch is an alteration. This property still retains its original massing, materials, workmanship, and character-defining features. The property retains the feeling and association of a Minimal Traditional home and is contributing to the historic district.

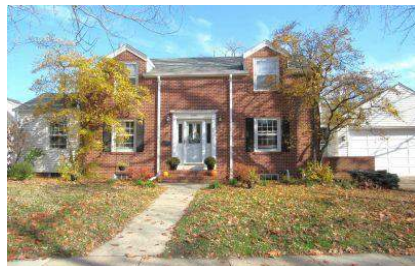
**Contributing Building**

**Description:** Located on the east side of Ridgewood Avenue, facing west, this is a one and a half-story side-gable Minimal Traditional home with Colonial Revival influence, with an attached garage and north elevation addition. The house was constructed in 1938 according to Ames Inspection Division permit files. The foundation material is brick, and the roof is covered with composition shingles. The exterior cladding is brick with vinyl siding

on the north elevation addition, the garage, and beneath the side gable on the upper level; vergeboards at the flush eaves, and decorative shutters flanking first-level windows. The entrance is centrally located on the original building, notable in relation to the surrounding Minimal Traditional homes due to the breadth of the entranceway, including sidelights between the door and the engaged pilasters. Entrance is capped with a molded entablature. Short brick steps lead to the front door. The first level fenestration is made up of two eight-over-eight double-hung windows, one either side of the door. The half-story has two of the same style of window, housed in front-gabled wall dormers. Brick chimney with subtly decorative coursework at the top is situated on the north side. An attached two-car garage is on the south side connected with a hyphen. This garage is recorded as being constructed in 1939.

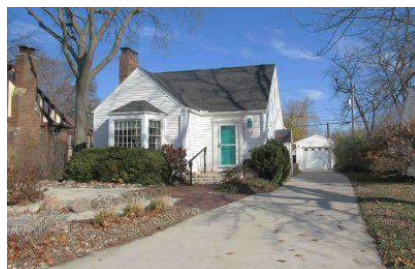
**Contributing Building; 1 Noncontributing Garage**

**Description:** Constructed in 1941 according to Ames City Assessor data and Inspection Division permit files, this house is located on the east side of Ridgewood Avenue, facing west. This house is a one-story Minimal Traditional cottage with a steep side gable roof, projecting front gable, and rear shed-roofed addition. The foundation is a concrete block, and the roof is covered with composition shingles. The exterior cladding is vinyl

with simple vergeboard at the flush eaves. Limestone steps with a metal rail leads to the concrete stoop, the entrance is on the south side of the façade, and framed with Colonial Revival influenced engaged pilasters and entablature. The projecting front gable is on the north side and houses a hip-roofed bay window, featuring a large 30-light fixed window, flanked by six-over-nine double-hung windows on either side. A brick chimney with subtly detailed coursework at the top is on the north elevation. An arched

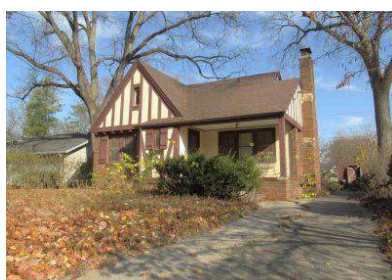
**House**

**Description:** Located on the east side of Ridgewood Avenue, facing west, this is a one and a half-story Tudor Revival cottage constructed in 1932 according to Ames City Assessor data and Inspection Division permit files. The house has intersecting front and layered side gable roofs. The foundation is brick, and the roof is covered in composition shingles. The exterior cladding is stucco and decorative half-timbering in the gables and the southern

half of the front façade, the north half and the north and south elevations on the first level are clad in brick. Layered vergeboards at the flush eaves and exposed rafters beneath the slight front gable overhang. The intersecting line of the side gable roof covers the south-oriented entrance vestibule, while a larger portion of that roof covers the inset brick porch supported by a square post. A set of three six-over-six double-hung windows at the first-level inset façade, paired windows of the same configuration under the front gable on the north side of the façade. A narrow vertical window with diamond leaded panes centered in the gable. Windows and doors are surrounded by flat boards. Brick chimney with limestone detailing on the south elevation. This is one of three Tudor Revival homes designed by architect Carl V. Johnson of Des Moines, on Ridgewood Avenue. At first glance this home is a rather unassuming Tudor Revival cottage, but closer inspection finds consistent stylistic details that add up to the quintessential “charming” quality Tudor Revivals can affect.

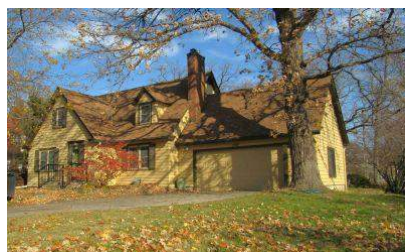
**Gustave L. Luglan House**

**Description:** Located on the east side of Ridgewood Avenue, facing west, this house was constructed in 1939 according to Ames City Assessor data and Inspection Division permit files. It is a one and a half-story front-and-side gabled Minimal Traditional with an attached garage. The foundation material is brick, and the roof is covered with composition shingles. The exterior cladding is

clapboard with molded frieze boards lining the gables and returned cornices at the gable corners, decorative shutters. The front gable on the north side of the façade projects from the side gable, a front gable dormer sits at the half-story on the side gable, and the attached side-gabled garage is set back slightly on the south elevation. Three concrete steps and a stoop with metal railing leads to the centered entrance door That is trimmed with Colonial Revival influenced engaged pilasters and entablature. Paired windows to the north of the entrance are six-over-six double- hung, another pair of the same on the south side of the façade. Single six-over-six double-hung windows within the main gable and the dormer. A brick chimney is on the south elevation partially covered by the non-historic garage addition built in 1979.

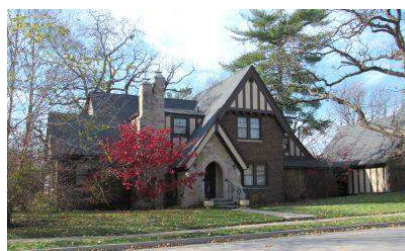
**House 1930**

**Description:** Located on the west side of Ridgewood Avenue, facing east, this is a two-story Tudor Revival home constructed in 1930 according to Ames City Assessor data and Inspection Division permit files. The house has overlapping steep front and side gables, a north elevation addition and an attached garage. The foundation material is brick, and the roof has composition

shingles. The exterior is decorative half-timbering with stucco in the gables, uncoursed limestone, and brick. The Gables overhang has exposed rafters, and the main volume

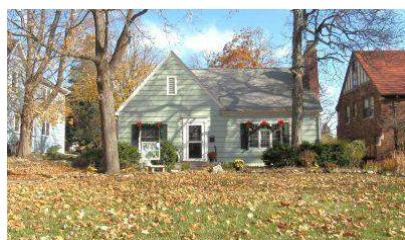
**1216 Ridgewood Ave                      Hollis Judson Nordyke    House    1937                      1**  
**Contributing House; 1 Noncontributing Garage**

**Description:** Located on the east side of Ridgewood Avenue, facing west, this is a one-story frame front-and-side gable Minimal Traditional cottage constructed in 1937 according to Ames City Assessor data and Inspection Division permit files. The foundation material is brick, and the roof is covered with composition shingles. The exterior cladding is asbestos-cement shingles with vergeboards where the nearly flushed eaves meet the walls. The front gable is on the north side of the façade while the side gable faces south. The entrance is offset to the north beneath the front gable, and the door is surrounded by Colonial Revival influenced engaged pilasters and entablature. Small concrete stoop with metal railing. The window on the north side of the first-level façade is eight-over-eight double-hung, while the set of three windows on the south side are six-over-six double-hung with three light transoms. Fenestration openings flanked by decorative shutters. A vent is beneath the gable. The brick chimney is on the south elevation. A noncontributing detached garage built in 2001 is at the north rear of the property.

**Integrity:** This property retains its original massing, materials, workmanship, and character-defining features feeling and association to a Minimal Traditional cottage and is contributing to the historic district.

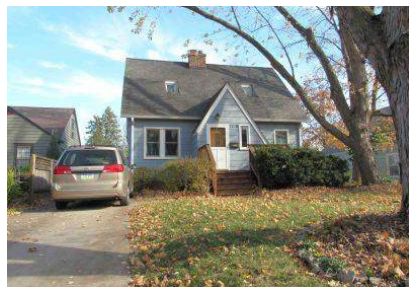
**Contributing House; 1 Noncontributing Garage**

Description: Located on the east side of Ridgewood Avenue, facing west, this is a one-story side-gable Tudor Revival cottage with a steeply pitched, asymmetrical front gable vestibule. Constructed in 1928 according to Ames City Assessor data and Inspection Division permit files. The foundation material is brick, and the roof is covered with composition shingles. The exterior cladding is aluminum with narrow vergeboards at the entrance

vestibule gable. Wood stairs and deck lead to the door, offset to the north within the gable, flanked by a narrow, single-paned window to the south. Paired one-over-one double-hung windows on the north side of façade, single one-over-one double-hung window on south side. Inset dormers with small, square windows. Fenestration is framed by flat boards. An interior centered brick chimney is in front of the roof ridge. A noncontributing detached two-car garage built in 2015 is at the rear of the property. The home was likely originally influenced by Craftsman aesthetics, with the entrance vestibule added in the 1930s or 1940s. In that sense, this home shows the transition between architectural trends and fashions in the district as later construction influences the design of alterations to earlier buildings.

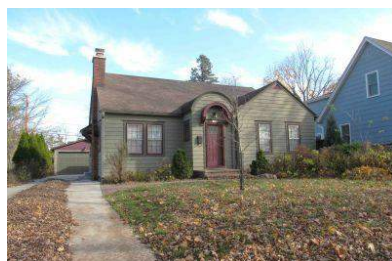
**Contributing House; 1 Noncontributing Garage**

Description: Located on the east side of Ridgewood Avenue, facing west, this is a one-story Minimal Traditional home with a side gable roof, a projecting front gable, and rear addition. Constructed in 1934 according to Ames City Assessor data and Inspection Division permit files. The foundation material is brick, and the roof is covered with composition shingles. The exterior cladding is clapboard

with molded vergeboards. The front gable is on the south side of the façade and the side gable is oriented north. An arch-roofed central entrance vestibule with secondary decorative arch mold over the door and a small, square four-light window is on its north wall. A small brick stoop and steps precede the door. Four windows on façade, all six-over-six double-hung, north side paired, south side separated. The door and window openings are trimmed with flat boards with molded lintels. Brick chimney with limestone or concrete cap on the north elevation. A detached noncontributing garage from 1977 is located at the rear of the property.

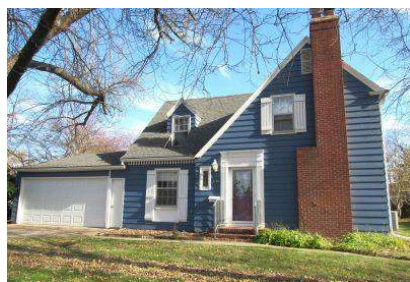
**Contributing House**

**Description:** Located on the east side of Ridgewood Avenue, facing west, this is a one and a half-story Minimal Traditional home with Tudor Revival influence, with a front-and-side gable roof with a steep, asymmetrical front gable. Constructed in 1940 according to Ames City Assessor data and Inspection Division permit files. The foundation is made with concrete block and the roof is covered with composition shingles. Clad in

clapboard, with vergeboard at the flushed eaves, decorative shutters, and dentils beneath the side-gable roofline. The front gable takes up the south two-thirds of the façade and the side gable is oriented north. Brick steps with metal railing lead to the front door, trimmed with pilasters and double entablature. A small diamond leaded window directly sits north of the door. First level with eight-over-eight double-hung window on the north side of the façade with wood paneling beneath. Two half-story windows, one beneath the main gable, the second within a front-gabled inset dormer, both of which are six-over-six double-hung. The brick chimney is prominently on the façade, to the right side and extending beyond the apex of the front gable. A non-historic two-car garage addition from 1984 is attached to the north elevation. This home is a combination of styles, with fenestration and door details speaking to the Minimal Traditional while the front chimney, diamond leaded window, and steep asymmetrical gable reference the nearby Tudor Revival homes.

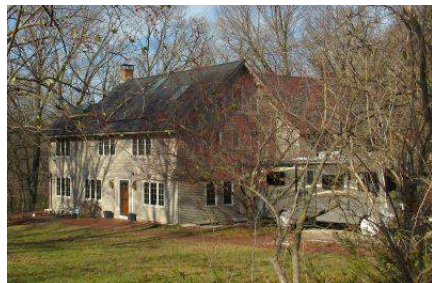
**Description:** Located down a small hill on the outer curve of Brookridge Avenue, roughly on the west side of the road, this house lacks an identifiable architectural style from the early 1900s since it has a contemporary appearance. Constructed in 1907 according to Ames City Assessor data, the building is considered noncontributing based on previous documentation and the multiple additions, and material replacements to the home. This is a three-cc house with a cross-gable roof

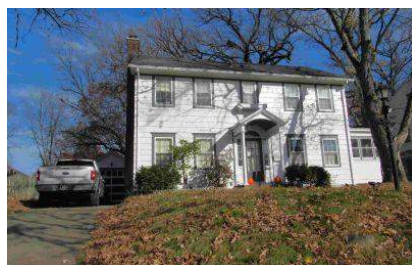
**904 Brookridge Ave Walter H. Root House 1924 1**  
**Contributing House; 1 Contributing Garage**

**Description:** Located on the east side of Brookridge Avenue, facing west, this is a two-story Colonial Revival home constructed in 1924 according to Ames City Assessor data. The house has a side gable roof and a one-story enclosed wing. The foundation material is brick, and the roof is covered with composition shingles. The exterior cladding is wood shingles with vertical boards on the wing enclosure, molded cornice with

cornice returns at the corners of the gables. The small brick porch is covered with a small gabled roof with an arched pediment and molded entablature on the sides, supported by thin columns and engaged pilasters near the door. Sidelights with paneled wood at the bottom are between the pilasters and the door, and a fan transom is capped with a small keystone. Fenestrated with six-over-six double-hung windows, four on the first level with two on either side of the entrance. The second level has five windows, the center of which is slightly smaller with a planter box below. The second level windows about the cornice and lack the molded lintels of the first-level fenestration, though all windows are framed in flat boards. The south elevation wing is covered with a flat roof. It is unclear if this wing is a historic addition, however the enclosure is likely not original but historic. A brick chimney bisects the gable on the north elevation. A contributing garage built in 1924 with strong stylistic details is at the rear of property.

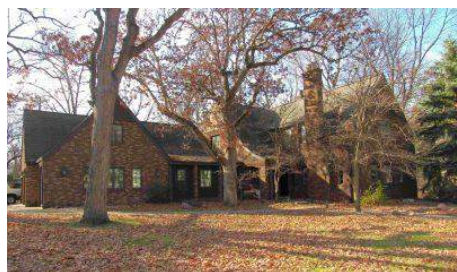
**Description:** Constructed in 1929 according to Ames City Assessor data and Inspection Division permit files, the home is on the southwest side of Brookridge Avenue facing northeast. This Tudor Revival house is a one and a half-story with a cross-gable roof with sweeping rooflines, and a large addition on the southeast elevation. The foundation material is poured concrete, and the roof is covered with composition

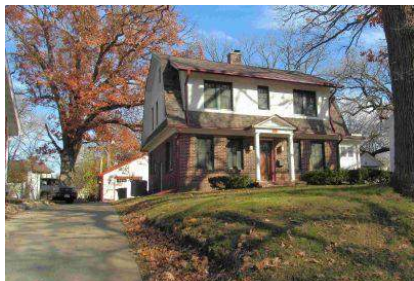
**Contributing House; 1 Noncontributing Garage**

Description: Located on the east side of Brookridge Avenue, facing west this is a two-story Dutch Colonial Revival home constructed in 1924, according to Ames City Assessor data. The house has a side gambrel roof, central dormer, and a south elevation wing. The foundation is brick, with a brick soldier course at the top of the foundation. The roof is covered with composition shingles and the exterior cladding is brick and stucco.

Frieze boards beneath the eaves. Entrance pediment is supported by two columns with subtle molded decoration, covering a small brick porch. Pediment entablature seems to extend around the building, becoming a molded belt course beneath the gambrel eaves. A typical window for this home is six-over-one double-hung with brick rowlock course sills. The first-level has four evenly spaced windows, two on either side of the door. Five windows are on the second level façade in the central shed-roofed dormer, with two pairs flanking a center single window. The second level has original stucco as noted on the original plans of the house. The right-side porch is original and covered with a flat roof supported by columns similar to the entrance. An interior centered brick chimney is at the roof ridge. A noncontributing detached garage built in 2023 is located at the rear north corner of the property. This home is one of a subset of uncommon Dutch Colonial Revival homes that falls within the umbrella of Colonial Revival, notable for their side-gambrel roofs and front dormers.

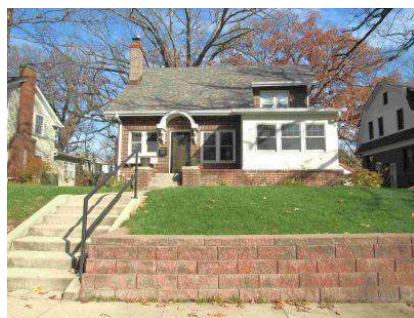
Description: Located on the east side of Brookridge Avenue, facing west, this is a one and a half-story Craftsman home constructed in 1923 according to Ames City Assessor data. The house has a side gable roof and projecting pergola. The foundation material is brick, and the roof is covered with composition shingles. The exterior cladding is brick and stucco, and wide barge boards line the gables. The entrance is offset to the north beneath a semicircular arch supported by wood brackets.

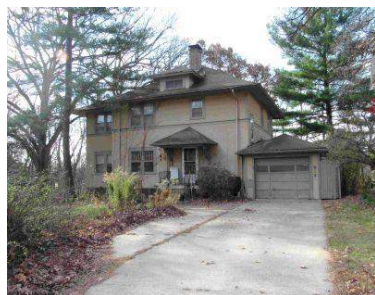
**917 Brookridge Ave**  
**House**

**Description:** Located on the west side of Brookridge Avenue, facing east, this is a two-story Craftsman home. Constructed in 1925 according to Ames City Assessor data. The house has a hip roof, a two-story wing, and an attached garage. The foundation material is brick, and the roof is covered with composition shingles. The exterior cladding is stucco with a molded belt course at the height of the second-level windowsills. The door is offset to the north and is covered by a hip roof supported by triangular knee

braces. Concrete steps with flared metal railings lead to the door. The two-story hip-roofed wing is set back somewhat on the south elevation. A typical window for this home is four-over-one double-hung with vertical panes in the upper sash. Paired windows sit to the south of the door and on the south elevation wing on the first level. A single window is on the north side of the second level with paired windows on the south side and on the wing. A small central dormer with a hipped roof projects above the second level and houses a pair of two-light windows. All windows with flat board and molded lintel trim. An interior brick chimney is centered on the main volume. The attached garage from 1925 is on the north elevation.

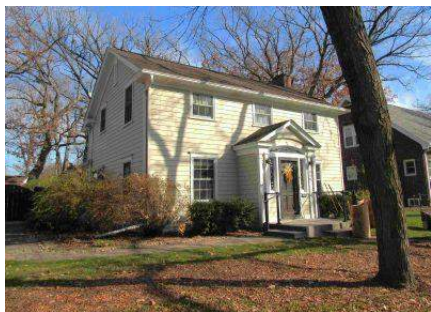
Description: Located on the east side of Brookridge Avenue, facing west, this is a two-story Colonial Revival home constructed in 1925 according to Ames City Assessor data. The home has a side gable roof and a two-story rear addition. The foundation is brick, and the roof is covered with composition shingles. The home is clad in vinyl with a molded cornice and cornice returns in the gable corners. The entrance door is centered on the façade within an enclosed foyer to

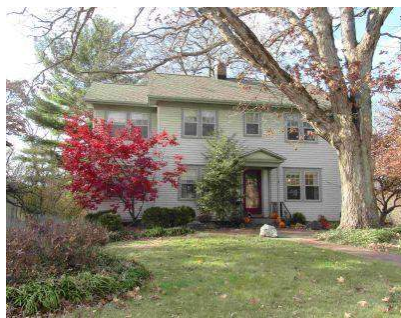
**921 Brookridge Ave Ernst M. Mervine House 1916 1 Contributing**  
**House; 1 Noncontributing Garage**

Description: Located on the west side of Brookridge Avenue, facing east, this is a two-story Colonial Revival home constructed in 1916 according to Ames City Assessor data. The house has a side gable roof and two-story wing. The foundation is brick, and the roof is covered with composition shingles. The home is clad in clapboard with corner boards. The roof is lined with molded cornice and frieze boards, with returned cornices in the gable corners. The door and small concrete porch

are covered by a projecting pediment with molded entablature supported by thin columns, and the door is framed by flat boards. A typical window is six-over-one double-hung. Paired windows on the first level on either side of the entrance with matching paired windows on the second level, central single window above the entranceway. A two-story wing is a historic addition, possibly where there was previously a style-typical

**Integrity:** The storm windows are alterations. This property still retains its original massing, materials, workmanship, architectural design, and character-defining features. The property retains the feeling and association of a Colonial Revival home and is contributing to the historic district.

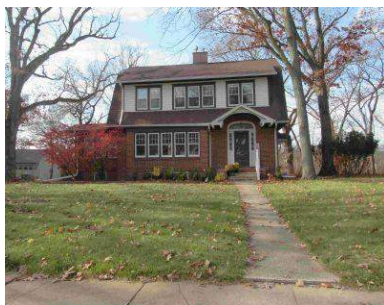
**927 Brookridge Ave                      A. M. O'Neal House                      1918                      1**  
**Contributing House; 1 Contributing Garage**

**Description:** Located on the west side of Brookridge Avenue, facing east, this is a two-story Dutch Colonial Revival home constructed in 1918 according to Ames City Assessor data. The house has a side gambrel roof, a one-story enclosed wing, and a large central dormer. Originally built as a duplex (according to Helen Jensen of 929 Brookridge Ave) and later converted to a single-family home. The foundation material is brick, and the roof is covered in composition shingles. The exterior cladding is brick on the first level and clapboard on the second, with a belt of soldier course bricks at the foundation level and a molded belt course abutting the eaves roofline. The entrance is offset to the north and is covered by an open bed pediment supported by paired extended rafters. Limestone and brick steps lead to the door with a wood railing. The door trim is made up of an elliptical brick arch over the elliptical transom fanlight, four-pane sidelights flanking the door. First level fenestration in a ribbon of five six-over-one double-hung windows, the widened opening a historic alteration to the slightly projected façade. The second level dormer has seven of the same style of windows, two pairs flanking a central set of three. The upper-level windows have flat boards and molded lintel trim, the first level has narrow flat boards. The wing enclosure is historic and made up of typical windows spanning the space between brick piers. Interior brick chimney is centered on the volume. A contributing detached brick garage from 1920 is at the rear south property line. This home is one of a subset of uncommon Dutch Colonial Revival homes that falls within the umbrella of Colonial Revival, notable for their side-gambrel roofs and nearly full-width front dormers.

**Integrity:** This property still retains its original massing, materials, workmanship, architectural design, and character-defining features. The property retains the feeling and association of a Dutch Colonial Revival home and is contributing to the historic district.

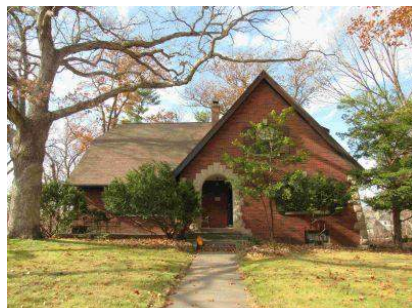
**Contributing House**

**Description:** Located on the west side of Brookridge Avenue, facing southeast, this is a one and a half-story Tudor Revival home constructed in 1936 according to Ames Inspection Division permit files. The house has a steep front and side gable roof. The foundation is brick the roof is covered in composition shingles. The exterior cladding is brick with rough-hewn limestone quoins and decorative shutters. The front gable is peaked and on the southeast side of the façade, and the side gable clipped

into a jerkinhead facing the southwest. The central door and porch are covered under the front gable roof with an arch of rough-hewn limestone framing the entrance. Concrete steps lead up to the covered porch. The first level with paired eight-over-one double-hung windows north of the entranceway and paired eight-over-one double-hung windows to the south. Single eight-over-one window at the half-story in the front gable. All windows with limestone sills and soldier course lintels with limestone keystones. A small dormer is visible on the north side of the front gable roof is original to the home according to current property owner, Helen Jensen. Interior brick chimney is centered on the volume. A contributing garage is located beneath the home accessible by a drive leading to the rear of the building.

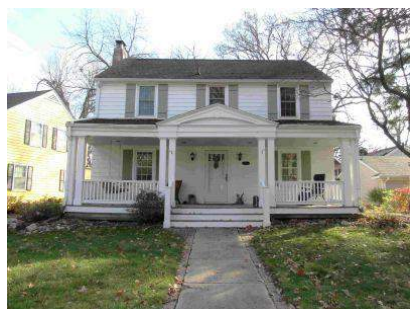
**Contributing House; 1 Noncontributing Garage**

**Description:** Located on the east side of Brookridge Avenue, facing northwest, this is a two-story Colonial Revival home constructed in 1939 according to Ames Inspection Division permit files. The house has a side gable roof, and full-length shed-roof porch. The foundation material is brick, and the roof is covered in composition shingles. The exterior cladding is clapboard with decorative shutters. The front porch appears to be a later addition or a porch remodel. It is supported by four

pairs of evenly spaced square columns with molded capitals. Wide steps span the distance between the two center pairs of columns, and directly above is a projecting front-gabled pediment, sitting atop a double width entablature. Wood railing wrap around the rest of the porch. The door is centered and framed by the style-typical

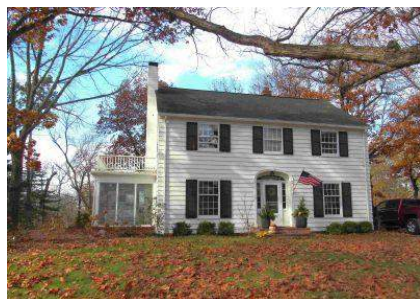
**1001 Brookridge Ave**  
**Contributing House**

Description: Located on the northwest side of Brookridge Avenue, facing southeast, this is a two-story Colonial Revival home constructed in 1939 according to Ames City Assessor data and Inspection Division permit files. The house has a side gable roof, one-story wing, and an attached garage. The foundation material is brick, and the roof is covered with composition shingles. The home is clad in clapboards with a narrow cornice

that is returned in the gable corners and decorative shutters. A molded belt course runs along the foundation level. The recessed entrance door centered on the façade has an elliptical arch transom framed by slender pilasters. The door is flanked by four-pane sidelights and topped with an elliptical fanlight. Brick stoop and steps precede the door. The first-level windows are eight-over-twelve double-hung placed on either side of the entrance. The second-level windows are eight-over-eight and evenly spaced. Windows are framed by flat boards. A one-story wing on the southwest elevation is a historic addition that has been converted to a sunroom, with railing lining the edges of the flat roof. An interior central chimney and exterior chimney are on the southwest elevation partially covered by the side porch wing. An attached garage on the right-side rear was built in 1939 and is on the northeast elevation, set back with a side-gabled roof.
