United States Department of the Interior  
National Park Service**National Register of Historic Places Registration Form**

**1. Name of Property**Historic name: Chautauqua Park and Ridgewood Historic DistrictOther names/site number: N/A

A Home for Science and Technology: Ames, Iowa, 1864–1941 (NRIS 64500871)

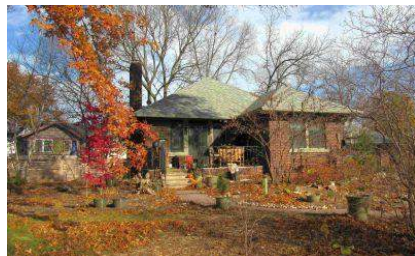
**Contributing House**

**Description:** Located on the southeast side of Brookridge Avenue, facing southwest. The one-story Craftsman cottage was constructed in 1927 according to Ames City Assessor data. The house has a multi-hipped roof and an attached rear garage. The foundation material is brick, and the roof is covered with composition shingles. The home is clad in brick. The entrance is oriented southwest with a brick and concrete porch. The door is flanked by wood panels and wide sidelights. Double-hung paired windows exist on various elevations with limestone windowsills. Large, rough stones line the driveway, and the later addition garage from 1972 uses similar materials to the house and has a harmonious hipped roof. The rear garage is attached by a hyphen at the rear of the property.

**Integrity:** The storm windows are alterations. This property still retains its original massing, materials, workmanship, and character-defining features. The property retains the feeling and association of a Craftsman cottage and is contributing to the historic district.

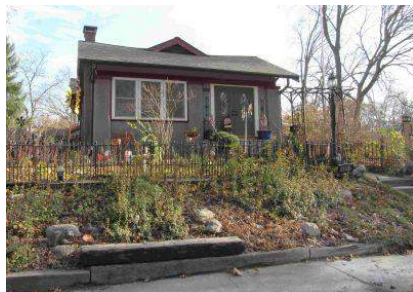
**1010 Brookridge Ave David P. Weeks House 1920 1**

**Description:** Located on the southeast side of Brookridge Avenue, facing northwest, this is a one-story Craftsman cottage Constructed in 1920 according to Ames City Assessor data. The house has a side gable roof, an enclosed half-width porch, and a rear addition. The foundation is brick, and the roof is covered in composition shingles. The exterior cladding is stucco with a molded belt course at the window lintel height. Fascia boards line the gables and a few triangular knee braces remain beneath the eaves. A small front gable decoration protrudes from the middle of the front roof and an enclosed porch framed by wide stucco piers sits on the northeast side of the façade, with an altered double door entrance on the southwest side of the façade. Doors flanked by sidelights and louvered panels. Concrete steps lead to the doors. Brick chimney on the northeast elevation with stucco covering the lower two-thirds. A noncontributing garage built in 1972 is located on the east property line directly behind the home.

**Integrity:** The storm windows are alterations. This property still retains its original massing, materials, workmanship, and character-defining features. The property retains the feeling and association of a Craftsman cottage and is contributing to the historic district.

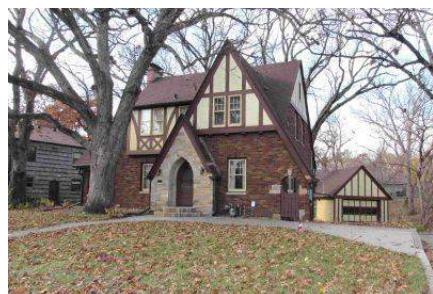
**1011-13 Brookridge Ave Elmer G. Hart House 1931 1 Contributing House; 1 Contributing Garage**

**Description:** Located on the northwest side of Brookridge Avenue, facing southeast, this is a two-story Tudor Revival two-family home Constructed in 1931 according to Ames City Assessor data and Inspection Division permit files, converted from a single-family home. The house has a steep front and side layered gable roof, one-story enclosed wing, and rear addition. The foundation is brick, and the roof is covered with composition shingles. The exterior cladding in brick and limestone on the first level and decorative half-timbering with stucco on the second, gables lined with flat vergeboards at the nearly flush eaves. The main front gable is situated on the northeast side of the façade and extends nearly to the ground on both sides, housing a decoratively arched gate on at the northeast corner and the layered gable of the projecting entrance vestibule at the southwest corner. The wing on the southwest elevation has a side-gabled roof. The entrance vestibule is roughly centered on the façade, with its own steep gable over the rough-hewn uncoursed limestone lancet arch and original diamond-leaded windowed door. Half-circle brick steps lead to the slightly inset door. A

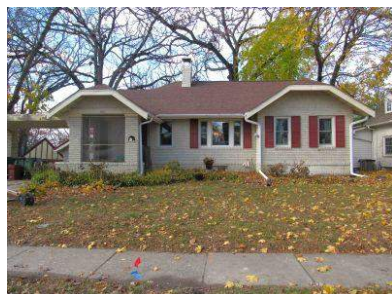
**Contributing House; 1 Contributing Garage**

**Description:** Located on the northwest side of Brookridge Avenue, facing southeast, this is a one-story Craftsman home, constructed in 1926 according to Ames City Assessor data. The house has a side gable jerkinhead roof with a front-gabled bay and an enclosed porch. The foundation material is brick, and the roof is covered with composition shingles. The exterior cladding is cream brick with stucco in the gables, with a rowlock belt course at the

foundation level and soldier courses separating the stucco and brick cladding. Decorative shutters flank windows and wide fascia boards line the gables. The enclosed porch is on the southwest side of the façade, with a front jerkinhead gable supported by brick piers and a molded entablature, spanned by screening material. The concrete steps and porch door are oriented to the southwest while the inner double-door entrance is recessed and faces the street. Small half-circle newspaper or mailbox hole built into one of the piers. Slightly projecting front gable located on the northeast side of the façade. Fenestration is made up of two one-over-one double-hung windows beneath the front gable, a set of three windows with two one-over-one double-hung narrow windows flanking a larger fixed pane at the center of the façade, and one one-over-one double-hung window next to the entrance. Flat boards frame the windows with rowlock sills below. Internal covered brick chimney. A carport is attached directly southwest of the porch, with a contributing detached brick garage from 1953 is behind the carport. The garage is harmonious with the house using the same brick materials and a front gable jerkinhead roof.

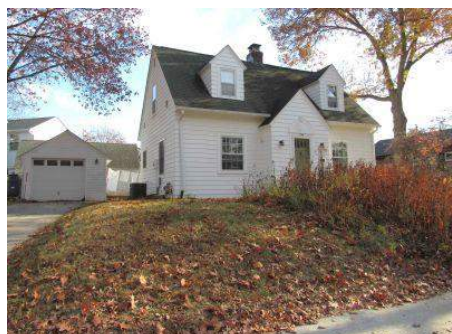
**Russell M. Meads House 1935**

Description: Located on the southeast side of Brookridge Avenue, facing northwest, this is a one and a half-story Minimal Traditional home in the Cape Cod Revival style constructed in 1935 according to Ames Inspection Division permit files. The house has a side-gable roof. The foundation material is poured concrete, and the roof is covered in composition shingles. The exterior cladding is wood clapboard with narrow verge boards at the gable eaves. A front-gabled entrance vestibule projects from the center of the façade, the

entrance door is capped with a molded fan transom. Concrete steps from the sidewalk and stoop with curved metal railings lead to the front door. Two first level windows flank the entrance volume and are eight-over-eight. Two symmetrically placed front-gable dormers have six-over-six double-hung windows. Flat boards frame all the windows. Internal centered brick chimney. A contributing detached garage from 1936 is at the northeast corner of the property.

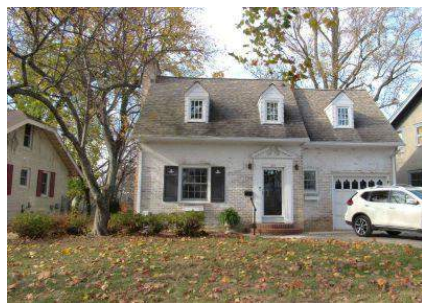
**Contributing House**

Description: Located on the northwest side of Brookridge Avenue, facing southeast, this is a one and a half-story Minimal Traditional home with Colonial Revival influences, built in 1936 according to Ames City Assessor data and Inspection Division permit files. The house has a nested side-gable roof. The foundation material is brick, and the roof is covered with composition shingles. The exterior is clad in brick textured with paint or plaster, with wide clapboard in the

gables and dormers. The eaves are nearly flush with the gables. The layered side gable on the northeast side is slightly set back and houses the garage and a half story of living space above. Three front-gabled dormers evenly spaced at the half story. Brick semi-

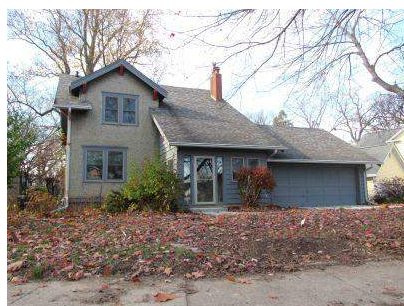
**1**

**Description:** Located on the west side of Brookridge Avenue, facing east, this is a two-story Craftsman home constructed in 1920 according to Ames City Assessor data. The house has a side gable roof, front-gable wall dormer, enclosed porch, and an attached garage. The foundation material is brick, and the roof is covered with composition shingles. The exterior cladding is stucco and clapboard with fascia boards lining the gables, corner boards, and a molded belt course at the foundation level.

Triangular knee braces beneath the gables. The enclosed half-width porch is covered by an extended section of the side-gabled roof which comes down to the molded entablature above the door. Façade fenestration is made up of paired one-over-one double-hung windows, a set southwest of the porch and a set within the front-gabled wall dormer. Windows are framed with flat boards and molded lintels. A garage from 1960 is attached on the northeast elevation, covering part of the external brick chimney. The porch enclosure is likely historic and has clapboard siding.

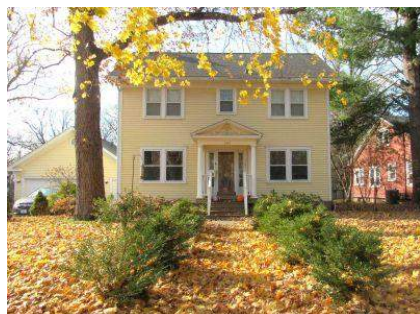
**Contributing House**

Description: Located on the west side of Brookridge Avenue, facing east, this is a two-story Colonial Revival home with a side gable roof and rear additions. This house was constructed in 1922 according to Ames City Assessor data. The foundation material is brick, and the roof is covered with composition shingles. The exterior cladding is narrow clapboard, cornice returns at the corners of the gables. The door and small, wooden

porch sit beneath the projecting front-gabled pediment with a molded entablature and an ornate wood carving. A turned wood railing encloses the porch behind the columns with molded capitals and engaged columns beside the door. The front door is flanked by four-pane sidelights. The typical window for this home is six-over-one double-hung with flat board and molded lintel trim. Paired windows are on either side of the entrance and two pairs are mirrored above in the second story. A single window is centered above the door on the upper story and roof has lintels and a cornice frieze board. The stucco-covered brick chimney is on the south elevation. A garage from 1993 is attached with a small hyphen near the southwest corner of the building.

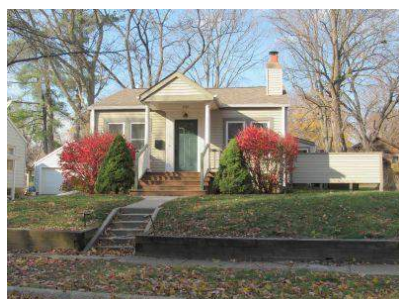
**1115 Orchard Dr C. W. Kimler House 1925 1**  
**Contributing House; 1 Noncontributing Garage**

Description: Located on the inner side of the Orchard Dr loop, facing southeast, this is a one-story inter-war period vernacular cottage with Colonial Revival influence. Constructed in 1925 according to Ames City Assessor data, the house has a side gabled roof, and rear additions. The foundation is poured concrete, and the roof is covered with composition shingles. The exterior cladding is aluminum with fascia boards at the flush eaves. A

centered projecting pediment entrance porch covers the small wood deck leading up to the front door and is supported by two thin columns. The original door is surrounded by pilasters and an entablature. Paired windows on either side of the entrance porch are one-over-one double-hung with flat board trim. An interior chimney is covered with aluminum siding and is offset to the northeast. The house has a rear addition visible on the right side. A noncontributing detached garage from 1969 is located at the rear west of the property.

Integrity: The storm windows and aluminum siding are alterations. This property retains its original massing, workmanship, materials, and character-defining features. The property maintains the feeling and association of a Colonial Revival cottage and is contributing to the historic district.

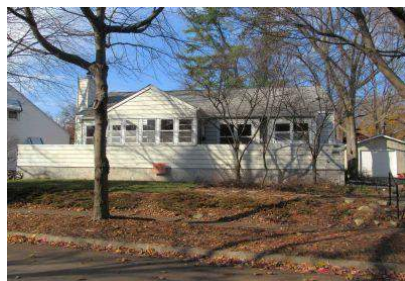
**1119 Orchard Dr Roger H. Williams House 1923 1**  
**Noncontributing House; 1 Noncontributing Garage**

Description: Located on the inner side of the Orchard Dr loop, facing southeast. The house was constructed in 1923 according to Ames City Assessor data. This one-story inter-war period cottage has a side gable roof and a centered front-gable porch. The foundation material is stucco-covered brick, and the roof is covered in composition shingles. The exterior cladding is vinyl siding with narrow fascia boards at the flush eaves. alterations

**Integrity:** Due to incompatible façade additions to the house such as the low wall addition across the entire façade, an enclosed front porch with a portion of the roof open (cut out), and vinyl siding it is considered a noncontributing property.

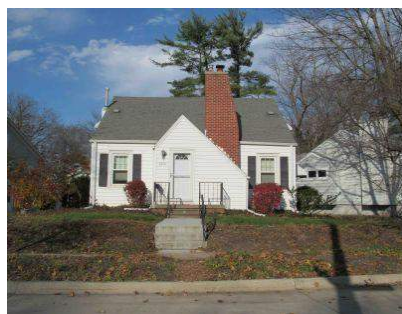
**1201 Orchard Dr Charles E. Allen House 1928 1 Contributing House**

**Description:** Located on the inner side of the Orchard Dr loop, facing southwest, this is a one-story Tudor Revival cottage with a side gable and a front-gabled entrance vestibule. The house was constructed in 1928 according to Ames City Assessor data and Inspection Division permit files. The foundation material is poured concrete, and the roof is covered with composition shingles. The exterior cladding is aluminum with narrow vergeboards at the flush eaves. The entrance vestibule is centered with

an asymmetrical gable extending to the southeast side of the façade. Concrete steps and stoop with metal railing leads to the door. Wide façade chimney partially covered by the southeast side of the entrance vestibule. One window is on either side, each is a six-over-six double-hung, framed by flat boards and flanked by decorative shutters. This home sits on a split lot and shares a contributing detached garage from 1928 with the property next door, 1207 Orchard Dr.

**Integrity:** The aluminum siding is an alteration. This property retains its original massing, workmanship, materials, and character-defining features. The property maintains the feeling and association of a Tudor Revival cottage and is contributing to the historic district.

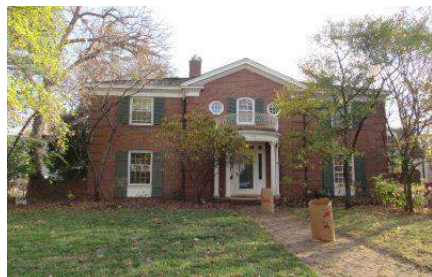
**1204 Orchard Dr Clinton Jay Adams House 1940 1 Contributing House**

**Description:** Located on the outer side of the Orchard Dr loop, facing north, this is a two-story Colonial Revival home Constructed in 1940 according to the Ames Inspection Division permit files. The house has a hipped roof and front gable, in a distinctly three-bay structure. The foundation materials are brick and concrete and the roof is covered with slate tiles. The exterior cladding is brick with quoins at the corners of the bays, cornice with

**Integrity:** The storm windows are alterations. This property stands out for its scale and use of a different style of Colonial Revival themes, it is a good example of a Colonial Revival home designed by architect Henry L. Fisk with a high degree of integrity. This property retains its original massing, materials, workmanship, architectural design, character-defining features, feeling and association, and is contributing to the historic district.

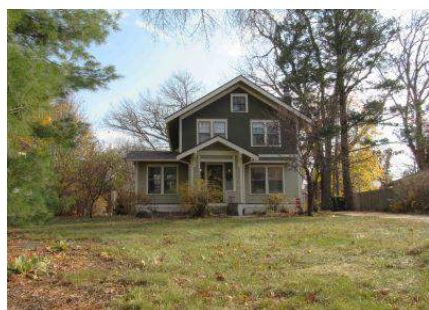
**1206 Orchard Dr Thomas F. Vance House 1921 1 Contributing House; 1 Noncontributing Garage**

**Description:** Located on the outer side of the Orchard Dr loop, facing north, this is a two-story Craftsman home constructed in 1921 according to Ames City Assessor data. The house has a front gable, side-gabled one-story wing, and a rear addition. The foundation material is brick, and the roof is covered with composition shingles. The exterior cladding is narrow clapboard on the first level and stucco on the second with molded belt courses at the foundation and second level levels. The

gables are lined with wide fascia boards, projecting eaves house two layered frieze boards and rafter tails. The front porch is offset to the east under a small gable with knee braces and a molded entablature. The porch is partially enclosed with clapboard. Stone steps align with the doorway, original door likely behind the storm door. A typical window for this home is six-over-one double-hung, paired within flat board and molded lintel trim. A pair of windows sits on the west side of the first level, one pair on the east elevation wing façade, and two pairs evenly placed fenestrate the second level. A smaller window tucked in the gable is eight-over-eight double-hung. A stucco-covered chimney is on the west elevation. A noncontributing detached garage built on 2018 is at the west rear of the property.

**Integrity:** The storm windows are alterations. This property retains its original massing, materials, workmanship, architectural design, and character-defining features. The property maintains the feeling and association of a Craftsman style home and is contributing to the historic district.

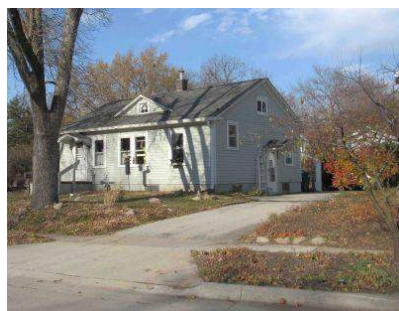
**1207 Orchard Dr Albert T. Mighell House 1927 1 Contributing House; 1 Contributing Garage**

**Description:** Located on the inner side of the Orchard Dr loop, facing southwest, this is a one and a half-story inter-war Craftsman-influenced cottage with a side gable roof. The house was constructed in 1927 according to Ames City Assessor data and Inspection Division permit files. The foundation is poured concrete, and the roof is covered with composition shingles. The exterior cladding is clapboard with narrow returned cornices at the gable corners, frieze boards, and corner boards. A small front-

gabled dormer with a fanlight window is centered in the front roof and the northwest-offset entrance is covered by a small open pediment supported by curved brackets. The entrance door is trimmed with flat boards and a molded lintel partially covered by the bracketed pediment. Concrete steps lead to the front door. The façade windows are one-over-one double-hung, two single windows flanking paired windows. Internal centered brick chimney. A contributing detached garage from 1928 is shared with the neighboring property, 1201 Orchard Dr.

**Integrity:** The replaced windows and storm windows are alterations. This property retains its original massing, materials, and character-defining features and is contributing to the historic district.

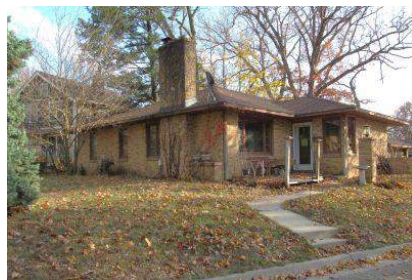
**1208 Orchard Dr Harlan H. Harper House 1951 1 Contributing House**

**Description:** Located on the outer side of the Orchard Dr loop, facing north, this is a one-story Ranch home with multi-hipped roof. The house was constructed in 1951 according to Ames City Assessor data. The foundation is made of concrete block and the roof is covered with composition shingles. The home is clad in textured cream and red brick and has a recessed front open terrace enclosed with a wood deck. The front door is on the right-

side projecting volume and has a storm door that is not original. The house has original windows typical of the Ranch style homes of the time including a picture window and casement windows with multiple horizontal lights. A wide brick chimney is on the left

**Integrity:** The storm door is an alteration. This property retains a high degree of integrity its original massing, materials, windows, workmanship, architectural design, and character-defining features. The property maintains the feeling and association of a Ranch house and is contributing to the historic district.

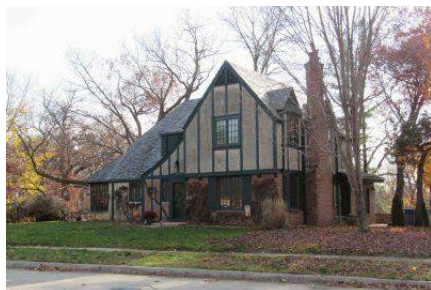
**1210 Orchard Dr    Robert M. Bailie House    1933    1 Contributing House; 1 Contributing Garage**

**Description:** Located on the outer side of the Orchard Dr loop, facing north, this is a two-story Tudor Revival home (**Figure 6**) constructed in 1933 according to Ames City Assessor data. The house has a cross-gable roof, sunroom addition, and a rear addition. The foundation material is brick, and the roof is covered with irregularly sized slate tiles. The exterior cladding is brick and limestone on the first level and decorative half-

timbering with stucco on the second, with irregularly cut clapboard on the shed-roofed dormer. Flat vergeboards line the flush eaves. The front gable is located on the west side of the façade, and the inner roofline sweeps down over the entrance. The side gable faces east and is deeply clipped with a small dormer balcony, and the sunroom addition is attached to this elevation. Shed-roofed dormer extends from the side gable roof and intersects with the front gable. Entrance is roughly centered on the façade within a shallow elliptical arch, with the original door behind the storm door. Diamond-lead sidelight and herringbone brickwork extend the entrance vestibule area to the end of the flared eave. The gable overhangs on the first level slightly with exposed rafters beneath. The first level has paired fifteen-light casement windows beneath the front gable framed by shutters and paired nine-light casement windows to the east of the entrance. The second-level houses paired twelve-light casement windows in the gable, and paired diamond-lead windows in the dormer framed by small shutters. Two chimneys, one internal and one brick on the west elevation. The 1931 contributing garage is located below the home and is accessed through Blackwood Circle.

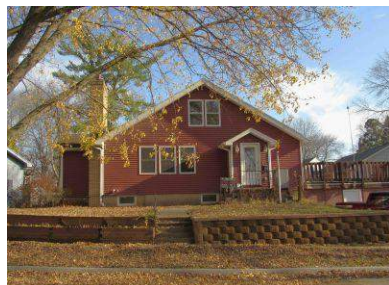
**1214 Orchard Dr Dwight Smithson Jeffers House 1923 1**

**Description:** Located on the inner side of the Orchard Dr loop, facing northwest, this is a one and a half-story home, likely original Craftsman house constructed in 1923 according to Ames City Assessor data. The building has a front gable roof, side-gabled wing, and a basement addition. The foundation material is stucco-covered brick, and the roof is covered with composition shingles. The exterior cladding is vinyl and faux stone. Fascia boards line

the enclosed eaves. A small concrete stoop with steps oriented to the northeast precedes the entrance within a slightly projecting front-gabled vestibule. A basement-level storage addition lacks date of construction and is on the right-side elevation has a non-usable deck on top, gabled wing on the northeast elevation according to the Story County Assessor. The façade fenestrations are made up of one-over-one double-hung windows, three are on the first level to the northeast of the entrance and two at the half-story gable. Alterations to fenestration openings and windows are replacements. A large cream brick chimney is on the northeast elevation of the front gable.

**Integrity:** The replaced windows eave fascia, siding and entrance door are alterations. Due to significant modifications, such as the basement-level addition with deck this home is considered noncontributing to the historic district because the massing and façade have changed.

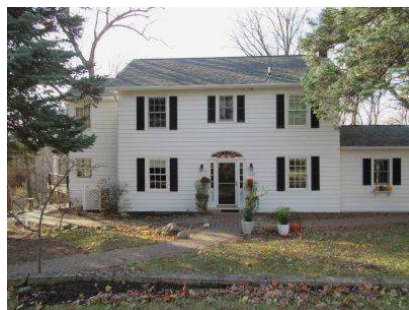
**1215 Orchard Dr Stewart N. Smith House 1925 1 Contributing House**

**Description:** Located on the outer side of the Orchard Dr loop, facing east, this is a two-story Colonial Revival home constructed in 1925 according to Ames City Assessor data. The house has a side gable roof, a two-story side-gabled wing, and an attached garage by way of a connector. The foundation material is brick, and the roof is covered with composition shingles. The exterior cladding is clapboard with decorative shutters and returned cornices in the corners of the gables. The south

elevation has a two-story wing projecting volume. The centered front door is flanked by four-pane sidelights and capped with an elliptical transom fanlight, with thin pilasters on the outside of the sidelights. The window for this home is six-over-six double-hung typical of the Colonial Revival style. One window is on either side of the entrance and three evenly spaced windows are on the second level, the center of which is somewhat smaller. The left side volume has six-over-six and eight-over-eight double-hung windows. All windows were trimmed with flat boards and molded lintels. The garage

**Integrity:** The storm door is an alteration. This property retains its architectural design, workmanship, materials, and character-defining features. The property maintains the feeling and association of a Colonial Revival home and is contributing to the historic district.

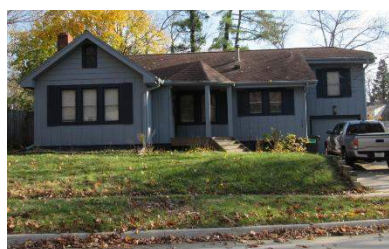
**1224 Orchard Dr Frank E. Buck House 1923 1 Contributing House**

**Description:** Located on the inner side of the Orchard Dr loop, facing northwest, this is a one and a half-story Craftsman home constructed in 1923 according to Ames City Assessor data. The house has a cross-gable roof with the front-gabled wing on the left-side of the façade and an attached garage on the right side. The foundation material is brick, and the roof is covered with composition shingles.

The exterior cladding is vertically ribbed with board and batten siding and clapboard beneath the gables and has decorative shutters. The side-gabled roof has been extended on the right-side to cover an attached garage with a story above, ending in a clipped gable. The enclosed eaves are capped with fascia boards. The front porch is centered on the façade and has a wood deck with three sides covered by a hipped-pyramid roof supported by molded columns. The windows are one-over-one double-hung trimmed with flat boards with molded lintels. A set of three windows is beneath the gable, two paired sets inside the porch and on the right side of the porch. A single one-over-one double-hung window is above the original garage and a small window is in the front gable.

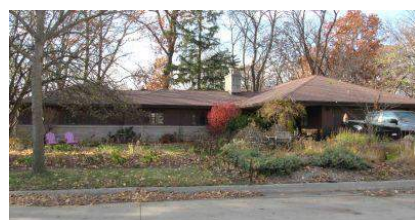
**1225 Orchard Dr R. G. Pasley House 1948 1 Contributing House**

**Description:** Located on the outer side of the Orchard Dr loop, facing east, this is a Ranch home constructed in 1948 according to Ames City Assessor data. The L-shaped house has a multi-hipped roof and has an attached front garage on the right side. The foundation material is likely poured concrete, and the roof is covered

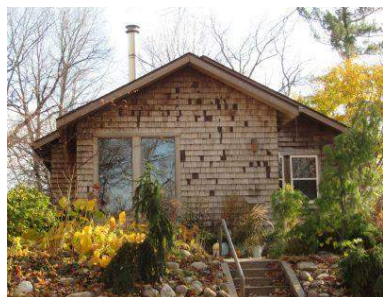
**Noncontributing Garage**

**Description:** Located on the inner side of the Orchard Dr loop, facing northwest, this is a one-story Craftsman bungalow constructed in 1928 according to the Ames City Assessor data. The house has an overlapped front gable roof and an enclosed half-width porch. The foundation material is brick, and the roof is covered with composition shingles. The exterior cladding is wood shingles with fascia board lining the wood-enclosed eaves. The added porch gable is asymmetrical, and the front door is on the west

elevation of the porch, and the porch windows are large, fixed single panes in a pairing. The windows beneath the main gable are one-over-one double-hung with unfinished wood board Trim. A noncontributing detached garage from 1992 is at the rear west of the property. This home is part of a subtype of Craftsman bungalows in the additions, distinctive for their one-story, overlapping front-gabled design and enclosed half-length porches.

**Integrity:** The storm windows, porch enclosure, and the siding are alterations. While this type of home is characteristically found with an enclosed porch, the porch enclosure to this home is a significant façade change of wood shingle siding with an asymmetric window placement that alters the historic feeling and association of the property. These changes and the modifications to the porch gable roof render this home noncontributing to the district.

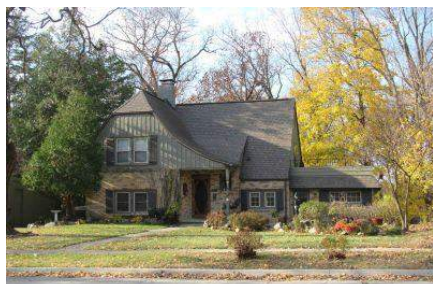
**1231 Orchard Dr John L. Powers House 1931 1**

**Description:** Located on the outer side of the Orchard Dr loop, facing southeast, this is a one and a half-story Tudor Revival home constructed in 1931 according to Ames Inspection Division permit files. The house has a cross-gable roof and one-story wing on the right side. The foundation material is brick, and the roof is covered with composition shingles. The exterior cladding is multi-color brick on the first level and board and batten siding on the gable. Rowlock course bricks line the

base of the gable and provide windowsills for the first-level windows. The front gable is located on the southwest side of the façade and the steep side gable faces northeast. The small concrete porch is covered by the extended sweep of the front gable, which is supported by a turned wood column. A small art glass sidelight sits to the east of the door. The front gable has a jerkinhead, with small decorative trim fans in the corners. A historic one-story wing on the northeast elevation has a deck on the roof. The windows are paired six-over-six double-hung on the southwest side and paired six-light casement windows to the east of the door. Paired six-over-one double-hung windows are in the half-story gable. The side wing has a door and paired six-light fixed windows. An interior covered brick chimney is at the cross-gable ridge. A contributing detached garage from 1931 is directly west of the house.

**Integrity:** The replacement windows and the gable siding are alterations. This property retains its original massing, workmanship, architectural design, materials, and character-defining features. The property maintains the feeling and association of a Tudor Revival home and is contributing to the historic district.

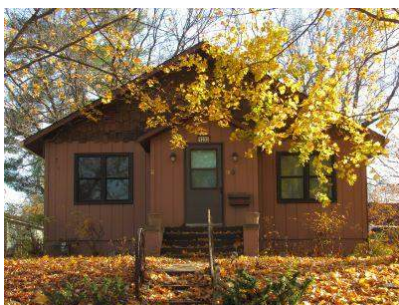
**1232 Orchard Dr W. E. Hoffman House 1935 1**

**Description:** Located on the inner side of the Orchard Dr loop, facing northwest, this is a one-story Craftsman bungalow constructed in 1935 according to Ames Inspection Division permit files. The house has a front gable roof, and a front-gable projecting entrance vestibule centered on the façade with stucco-covered railing flanking the concrete front steps. The foundation material is brick, and the roof is covered with composition shingles. The exterior cladding is vertical hard boards typical of the

1960s and wood shingles on the gable. The paired one-over-one double-hung windows are on either side of the entrance with a hexagonal porthole-style window beneath the gable. A noncontributing detached garage from 1992 is at the rear east of the property.

**Integrity:** The replacement windows, storm windows siding and the gable siding are alterations. This property still retains its original massing, workmanship, and character-defining features. The property maintains the feeling and association of a Craftsman bungalow and is contributing to the historic district.

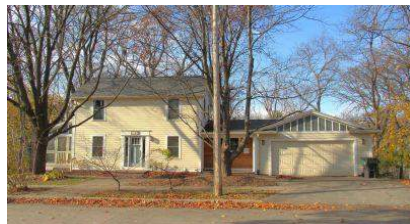
**Contributing House**

**Description:** Located on the outer side of the Orchard Dr loop, facing southeast, this is a two-story Colonial Revival home that was constructed in 1923 according to Ames City Assessor data. The house has a side gable roof, side porch, rear addition, and an attached garage by an opened breezeway. The foundation is made of concrete block and the roof is covered with composition shingles.

The exterior cladding is clapboard, with corner boards, returned cornices, and vertical boards in the gables. The entrance door is centered on the main volume including a molded entablature and full-length-pane sidelights. Four evenly placed one-over-one double-hung windows fenestrate the façade. An added shed-roofed wrap-around porch addition is on the southwest elevation. A rear addition and screen porch from 1989 alter the massing but is mostly viewed from the back. The contributing garage is from 1923 according to the Story County Assessors and the one-story connecting volume alters the façade however of the original house volume is still legible since the connecting volume is recessed.

**Integrity:** The replacement windows are alterations. This property still retains its original materials, workmanship, and character-defining features. The additions change the façade, but the historic elevation is still legible. The property maintains the feeling and association of a Colonial Revival home and is contributing to the historic district.

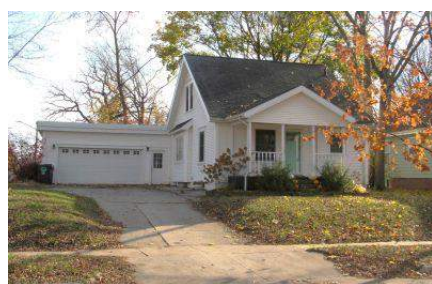
**Contributing House**

**Description:** Located on the inner side of the Orchard Dr loop, facing northwest, this is a one and a half-story Craftsman home was constructed in 1920 according to the Ames City Assessor. The house has a side gable roof, and a centered front gabled porch is supported by thin wood columns and enclosed by turned wood railings. The foundation material is stucco-covered brick, and the roof is covered in composition shingles.

The exterior cladding is vinyl, with molded fascia lining the enclosed eaves and corner boards. Rough-hewn stone steps lead to the porch entrance and a centered front door. A six-over-six double-hung window on the west side of the primary façade, eight-over-eight double-hung window directly east of door. East elevation fenestrated with a central shallow bay with a shed roof and a set of three single-pane casement windows on the first level, with a six-over-six double-hung window to the south and an eight-over-eight double-hung window to the north. A paired six-over-six double-hung windows in the gable at the half-story. All windows have flat

**Integrity:** The replacement windows are alterations. This property still retains its original massing, materials, workmanship, and character-defining features. The property maintains the feeling and association of a Craftsman home and is contributing to the historic district.

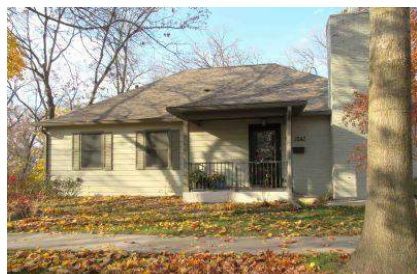
**1247 Orchard Dr Harry Hall House 1925 1 Noncontributing House**

**Description:** Located on the outer side of the Orchard Dr loop, facing southeast, this is a one-story inter-war period vernacular home constructed in 1925 according to Ames City Assessor data. The house has a hipped roof with a rear addition and an attached garage. The foundation is brick, and the roof is covered with composition shingles. The exterior cladding consists of vinyl siding on the primary elevations, limestone veneer,

and brick elements associated with mid-twentieth-century alterations, and a stucco-clad southwest elevation. Decorative shutters frame the front windows. The entrance is roughly centered on the façade, beneath a pyramid hip roofed supported by square columns on the slightly raised concrete porch. Large thin-cut limestone clad chimney just northeast of the entrance. Two one-over-one double-hung windows to the southwest of the entrance. An attached hip-roofed garage built in 1979 is on the northeast elevation.

The replacement windows, shutters, front chimney, siding, and garage addition are alterations. Due to significant alterations to the façade including cladding materials, chimney, attached garage, and fenestration openings that alter the original massing, materials, feeling and association, this home is considered noncontributing.

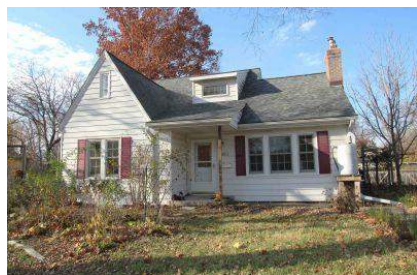
**1253 Orchard Dr Frank Spedding House 1933 1 Contributing House; 1 Noncontributing Garage**

**Description:** Located on the outer side of the Orchard Dr loop, facing southeast, this is a one-story Minimal Traditional cottage constructed in 1933 according to Ames City Assessor data and Inspection Division permit files. The house has a cross-gable roof with a steep front gable on the left side of the façade and layered side gables. The foundation material is brick, and the roof is covered with composition shingles. The exterior cladding

**Integrity:** The storm windows, replaced windows, side balcony, and dormer are alterations. This property still retains its original massing, materials, workmanship, and character-defining features. The property maintains the feeling and association of a Tudor Revival cottage and is contributing to the historic district.

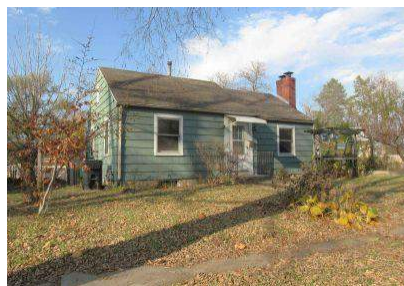
**1257 Orchard Dr. Clarence Hartley Covault House 1941 1**  
**Contributing House**

**Description:** Located on the outer side of the Orchard Dr loop, facing southeast, this is a one-story Minimal Traditional cottage was constructed in 1941 according to Ames City Assessor data and Inspection Division permit files. The house has a nested side gable roof. The foundation is made of concrete block and the roof is covered with composition shingles, and the siding is wood shingles according to the Story County Assessor. A small concrete stoop with metal railing leads to the centered front door with flat board trim that is covered with a metal awning. A one-over-one double-hung window is on either side of the entrance door. A brick chimney on the northeast elevation with subtly decorative coursework at the top. This cottage is one of the simplest Minimal Traditional homes in the district.

**Integrity:** The replacement windows and storm windows are alterations. This property still retains its original massing, materials, workmanship, and character-defining features. The property maintains the feeling and association of a Minimal Traditional cottage and is contributing to the historic district.

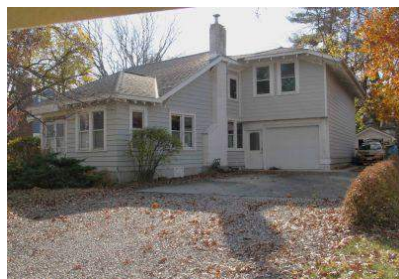
**Noncontributing House**

**Description:** Located on the south side of Park Way, facing northeast, this is a one-story Craftsman cottage constructed in 1926 according to Ames City Assessor data. The home has a side gable roof on the main volume, a hip-roofed front wing, and one and a half-story attached garage addition on the right-side rear. The foundation is covered with brick and the roof is covered in composition shingles. The exterior cladding is clapboard, with wide fascia boards at the roofline, and molded frieze boards, rafter tails, and triangular knee braces beneath the projecting eaves. The gables are jerkinhead. The roof extends from its south side covering the centered front door accessed by a small concrete porch, supported by a wood column on the left corner. The original door is flanked by four-pane sidelights, the door is behind the storm door. Fenestrations include a paired one-over-one double-hung replacement windows on the north wing and a set of three four-over-one double-hung windows on the south side of the entrance. Windows are trimmed with flat boards and molded lintels. A painted brick chimney is on the north elevation. An attached from 2002 garage with half-story addition is a recent alteration with compatible materials, however it affects the massing of the original volume and the facade. A contributing detached garage from 1926 is located behind the addition, on the north side of the property.

fascia boards at the roofline, and molded frieze boards, rafter tails, and triangular knee braces beneath the projecting eaves. The gables are jerkinhead. The roof extends from its south side covering the centered front door accessed by a small concrete porch, supported by a wood column on the left corner. The original door is flanked by four-pane sidelights, the door is behind the storm door. Fenestrations include a paired one-over-one double-hung replacement windows on the north wing and a set of three four-over-one double-hung windows on the south side of the entrance. Windows are trimmed with flat boards and molded lintels. A painted brick chimney is on the north elevation. An attached from 2002 garage with half-story addition is a recent alteration with compatible materials, however it affects the massing of the original volume and the facade. A contributing detached garage from 1926 is located behind the addition, on the north side of the property.

**Integrity:** The replacement windows and storm windows and door are alterations. This property does not retain its original massing, due to the attached garage addition and has lost integrity of feeling and historic association, and is not contributing to the historic district.

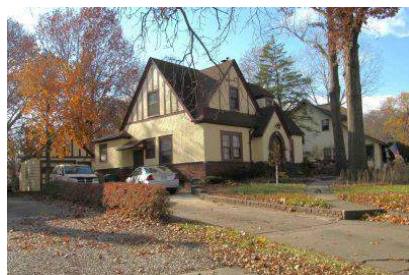
**1208 Park Way (10th St) Edgar S. Jacobson House 1924 1 Contributing House; 1 Contributing Garage**

**Description:** Located on the south side of Park Way, facing northeast, this is a two-story Tudor Revival home constructed in 1924 according to Ames City Assessor data. The house has a side gable roof, front gables, and hip-roofed elements. The foundation material is brick, and the roof is covered with composition shingles. The exterior cladding is brick along the lower half of the first level and highly textured stucco with decorative half-

timbering in the gables, cladding materials separated by a rowlock course of bricks with limestone corner pieces. Molded vergeboards line the gables near the flush eaves. The front gable is located on the east side of the façade, with a slightly projecting hip roof beneath, hip-roofed dormer in the side gable roof on the west side of the façade. The

**Integrity:** The storm windows and door are alterations. This property has high integrity and retains its original massing, workmanship, architectural design, materials, windows and door, and many character-defining features. Therefore, this property maintains the feeling and association of a Tudor Revival home and is contributing to the historic district.

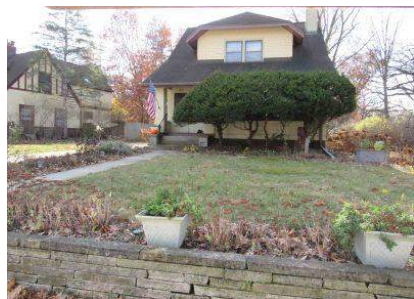
**1212 Park Way (10th St) William G. Gaessler House 1921 1 Contributing House; 1 Contributing Garage**

**Description:** Located on the south side of Park Way, facing north, this is a one and a half-story Craftsman home (**Figures 7 to 10**) constructed in 1921 according to Ames City Assessor data. The house has a steep side gable roof and a large front dormer with deeply set jerkinhead. The foundation is brick, and the roof is covered in composition shingles. The exterior cladding is wood shingles, with molded fascia board lining the gables. The front roof extends at a secondary angle to

cover the partially enclosed porch. An open porch is on the east side of the façade, creating a recessed entrance, with concrete steps leading toward the front door trimmed with flat boards. The porch roof is supported by large, tapered columns. The porch enclosure is a stucco low wall. Paired windows in the dormer are recessed from the roofline, with six-over-one double-hung windows within flat board trim. Stucco-covered chimney on the west elevation. A contributing detached garage built in 1921 is located at the rear east corner of the property with a brick and concrete patterned drive. This home is part of a subtype of Craftsman homes in the district that features a steep side-gabled roof with a prominent central dormer.

**Integrity:** The replacement windows and storm windows and door are alterations. This property has a high degree of integrity retaining its original massing, materials, workmanship, design, and character-defining features. The property maintains the feeling and association of a Craftsman home and is contributing to the historic district.

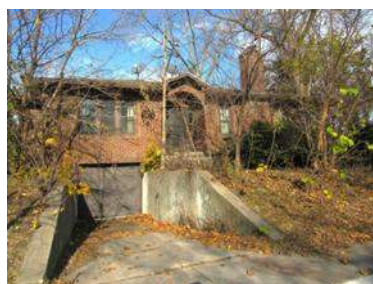
**Noncontributing House**

**Description:** Located on the north side of Park Way, facing south, this is a one-story Craftsman cottage constructed in 1928 according to Ames City Assessor data. The home is brick with a soldier course belt at the foundation level and has a hipped roof. The foundation material is brick, and the roof is covered with composition shingles. A small front gable roof sits above a brick arch framing the recessed porch that is offset to the west. The façade has a brick chimney slightly offset to the east. The original windows are three-over-one double-hung with Craftsman-style vertical panes in the upper sash typical of this style of home. One window is on either side of the chimney, and a further pair at the east end of the façade. Set of three to the west of the entrance. The left-side projecting entrance volume is original to the home. A garage built beneath the home is a later alteration to the basement of the house on the west side with a front entrance, formed concrete retaining walls suggests a construction past the period of significance.

**Integrity:** This property has lost integrity with the basement garage alteration affecting the feeling and historic association, and is consequently noncontributing to the historic district.

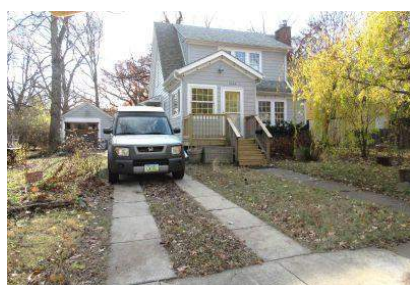
**House; 1 Contributing Garage**

**Description:** Located on the south side of Park Way, facing north, this is a one and a half-story Craftsman home with Colonial Revival-influenced alterations. The house has a steep side gable roof, central shed-roofed dormer, original porch enclosed, and a projecting half-width entrance vestibule addition. Constructed in 1931 according to Ames Inspection Division permit files. The foundation material is brick, and the roof is covered with

composition shingle. The exterior cladding is vinyl with narrow fascia boards, frieze boards beneath the gables, and cornice added beneath the side gable's eaves. Modern wood steps lead to the east-offset entrance vestibule, door flanked by an eight-over-eight double-hung window. The first level windows and the dormer have six-over-six double-hung all with wide board and molded lintel trim. The detached garage built in 1932 at the rear east of the property is considered a contributing structure. This home is part of a subtype of Craftsman homes in the neighborhood that feature a steep side-gabled roof with a prominent central dormer.

**Integrity:** The replacement windows and storm windows and door are alterations. This property retains its original massing, workmanship, materials, and character-defining

features. The property maintains the feeling and association of a Craftsman home and is contributing to the historic district.

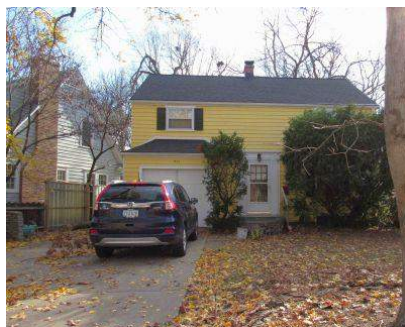
**1228 Park Way (10th St) Abbie Langmaid House 1938 1 Contributing House**

Description: Located on the south side of Park Way, facing northwest, this is a two-story Minimal Traditional home with Colonial Revival influences. Constructed in 1939 according to Ames Inspection Division permit files. The house has a side gable roof, and a rear addition. The foundation material is brick, and the roof is covered in composition shingles. The exterior cladding is clapboard with decorative shutters flanking the windows, narrow cornice with nearly flush eaves. According to the Story County Assessor, the built-in garage is original from

1938. It is on the east side of the first level with a slightly projecting roof lined by a narrow cornice. Concrete steps and stoop lead to the front door, framed by Colonial Revival influenced pilasters and entablature. Two four-over-four horizontally oriented double-hung windows are on the second level, framed by narrow boards and abutting the cornice. An Interior central brick chimney is on the roof ridge.

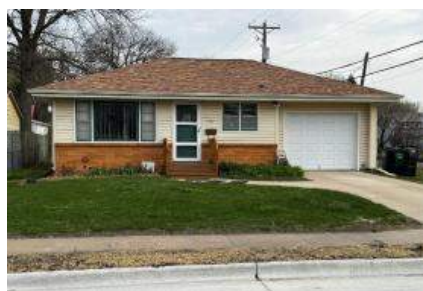
**1107 9th Street Mrs. Arlene Schmidt 1958 1 Contributing House**

Description: Located on the north side of 9th Street, facing south, this is a one-story Ranch style home constructed in 1958 according to Ames City Assessor data and Inspection Division permit files. The house has a hipped roof covered with asphalt shingles, a brick base on the façade, vinyl siding above, and a concrete foundation. The entrance door is accessed by a set of wood stairs and landing with wood railings. A three-part

window on the left side of the façade has one large, fixed glass in the center flanked by narrow double-hung windows. The additional double-hung windows side-by-side are to the right of the entrance door. The integrated garage is on the right side of the façade.

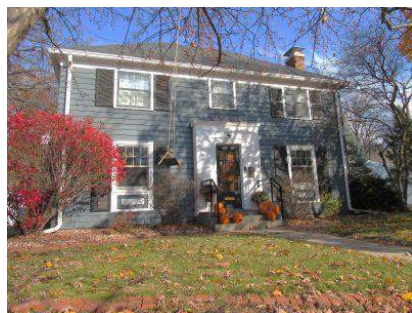
**Contributing House; 1 Noncontributing Garage**

Description: Located on the north side of 9th Street, facing southwest, this is a two-story Colonial Revival home constructed in 1937 according to Ames Inspection Division permit files. The house has a hipped roof and rear addition. The foundation material is brick, and the roof is covered in composition shingles. The exterior cladding is clapboard with decorative shutters, cornice beneath the roofline with a wide flat frieze board. Modern concrete steps with metal railing leads to the centered

entrance framed by three layers of thick boards and capped with a small, hipped roof, with a cornice and lightly flared corners. The first level with two eight-over-one double-hung windows with decorative panels beneath, surrounded by flat boards with molded lintels. Second story with two eight-over-one double-hung windows and a smaller central six-over-one double-hung window, windows framed by flat boards with the frieze board acting as the lintel. Internal centered brick chimney. A noncontributing garage from 1993 at the north rear of the property. This property has a stone retaining wall in the front garden and concrete steps that lead up to the house entrance.

Integrity: The replacement windows and storm windows and entrance door trim are alterations. This property retains its original massing, workmanship, materials, and character-defining features. The property maintains the feeling and association of a Colonial Revival home and is contributing to the historic district.

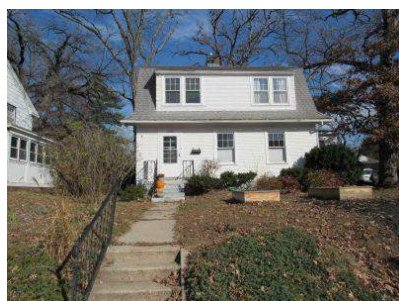
**Contributing House; 1 Noncontributing Garage**

Description: Located on the northeast side of 9th Street, facing southwest, this is a two-story Dutch Colonial Revival home was constructed in 1922 according to Ames City Assessor data. The house has a side gambrel roof, a central dormer, and a one-story wing at the rear. The foundation is covered with brick and the roof is covered with composition shingles. The exterior cladding is narrow clapboard siding, with returned cornices in the gambrel corners, narrow fascia boards in the nearly flush eaves at

the gambrel and frieze boards beneath the side roof eaves. Concrete steps and stoop with metal railing leads to the north-offset entrance which is flanked by decorative shutters. The original door may remain behind the storm door, and the entrance is framed by flat boards with a molded lintel. The windows are six-over-one double-hung, typical for this home style. The first level fenestration has two evenly spaced windows to the south of the door with flat board and molded lintel trim, and the second-level windows are housed in the large dormer in two pairs, one at either end, with flat boards

**Integrity:** The replacement windows and storm windows and storm door are alterations. This property has integrity and retains its original massing, materials, workmanship, architectural design, and character-defining features. The property maintains the feeling and association of a Dutch Colonial Revival home and is contributing to the historic district.

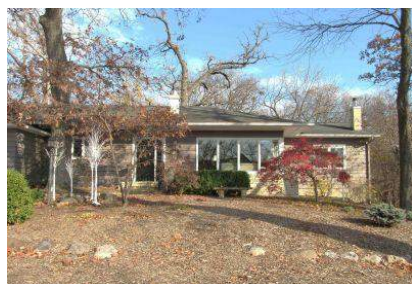
**1024 Blackwood Circle Irene O. Sogard 1950 1 Contributing House**

**Description:** Located on the east side of Blackwood Circle, facing west, this is a one-story Ranch home constructed in 1950 according to Ames City Assessor data and Inspection Division permit files. The house has a multi-hipped roof and attached garage. The foundation material is concrete, the roof is covered with composition shingles and the home is clad in original clapboard siding. A small concrete porch with steps up to the

central door with multipaned sidelight on the south side. A set of three casement windows north of door, ribbon of four large fixed-pane windows south of door. The centered interior chimney is stucco clad. A secondary stucco-clad chimney is on the south elevation addition.

**Integrity:** The replacement windows, and storm door are alterations. This property retains its original massing, materials, materials, workmanship, architectural design, and character-defining features. The property maintains the feeling and association of a Ranch home and is contributing to the historic district.

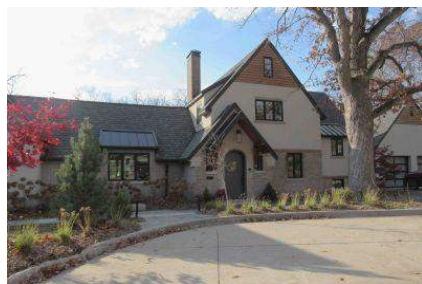
**1101 Blackwood Circle Craig W. Stephenson House 1929 1 Noncontributing House**

**Description:** Located on the west side of Blackwood Circle, facing east, this is a one and a half-story Tudor Revival home constructed in 1929 according to Ames City Assessor data and significantly altered in recent years. The cross-gable roof has a front-gabled addition on the second level and a detached garage with a side-gabled open breezeway on the right side. The foundation material is brick, and the roof is clad in thick composition shingles and standing-seam metal roof

shed dormers. The exterior is brick on the first level with limestone details, paneled stucco on the second level, and un-painted clapboard in the gable. The entrance vestibule has been altered and is roofed with a steeply pitched gable, with layered vergeboard, projecting fascia with second vergeboard supported by curved brackets. The front door is slightly recessed beneath a limestone Roman arch, with a leaded art glass window. Small sidelights recessed from the door have limestone sills. The windows are replacement multi-light casement windows. The house has fenestration alterations and replacements, entrance alterations, side additions and garage additions and siding replacements from 2018.

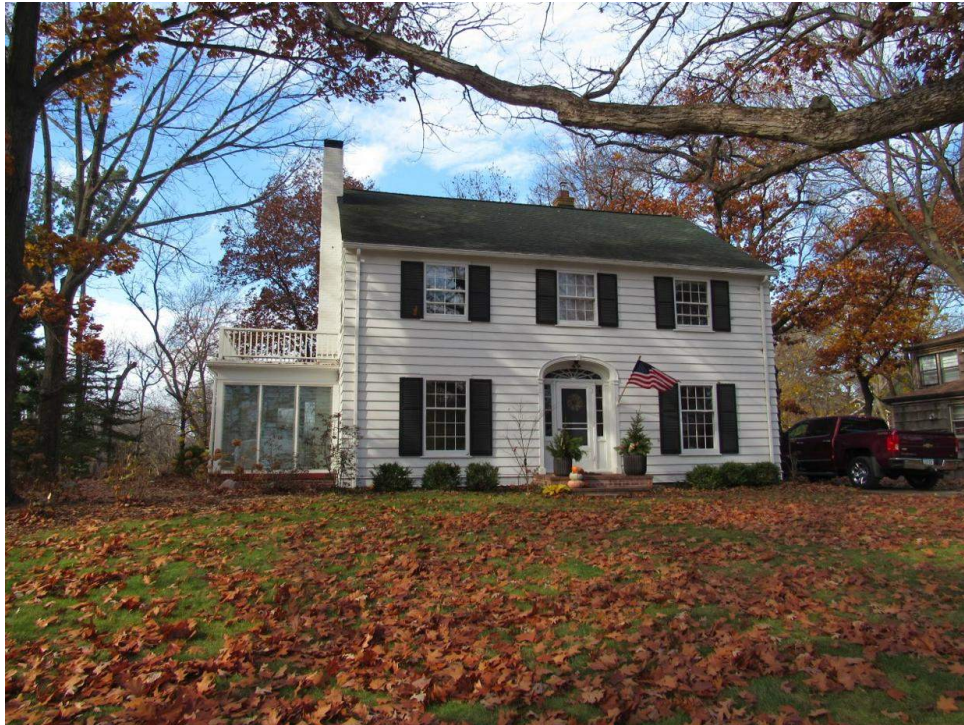
Photo 5. Façade of 1001 Brookridge Avenue, view to the northwest.

Photo 5 of 8 (IA\_Story\_Chautauqua Park and Ridgewood\_0005)  
Façade of 1001 Brookridge Avenue, view to the northwest.

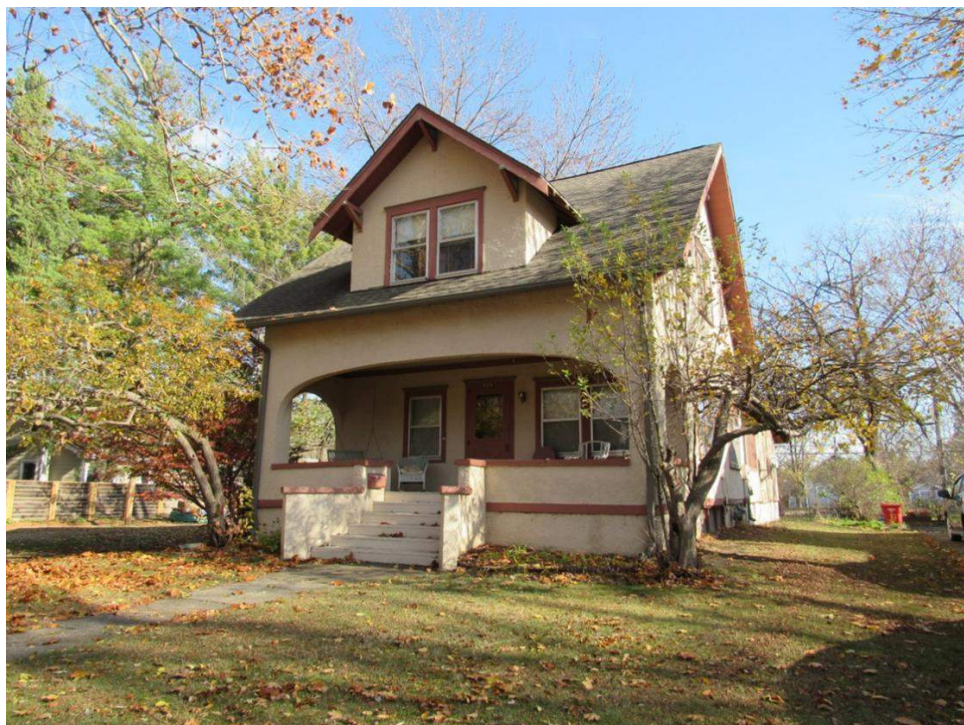
Photo 6. Façade of 926 Ridgewood Avenue, view to the northeast.

Photo 6 of 8 (IA\_Story\_Chautauqua Park and Ridgewood\_0006)  
Façade of 926 Ridgewood Avenue, view to the northeast.

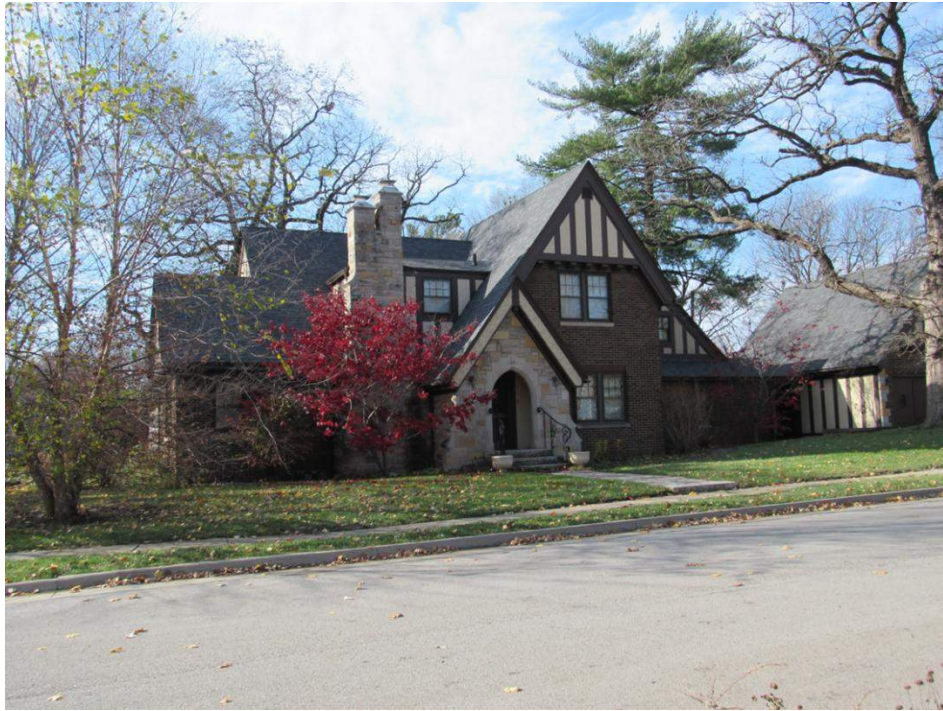
Photo 7. Façade of 1205 Ridgewood Avenue, view to the southeast.

Photo 7 of 8 (IA\_Story\_Chautauqua Park and Ridgewood\_0007)  
Façade of 1205 Ridgewood Avenue, view to the southeast.
