United States Department of the Interior  
National Park Service**National Register of Historic Places Registration Form**

**1. Name of Property**Historic name: Chautauqua Park and Ridgewood Historic DistrictOther names/site number: N/A

A Home for Science and Technology: Ames, Iowa, 1864–1941 (NRIS 64500871)

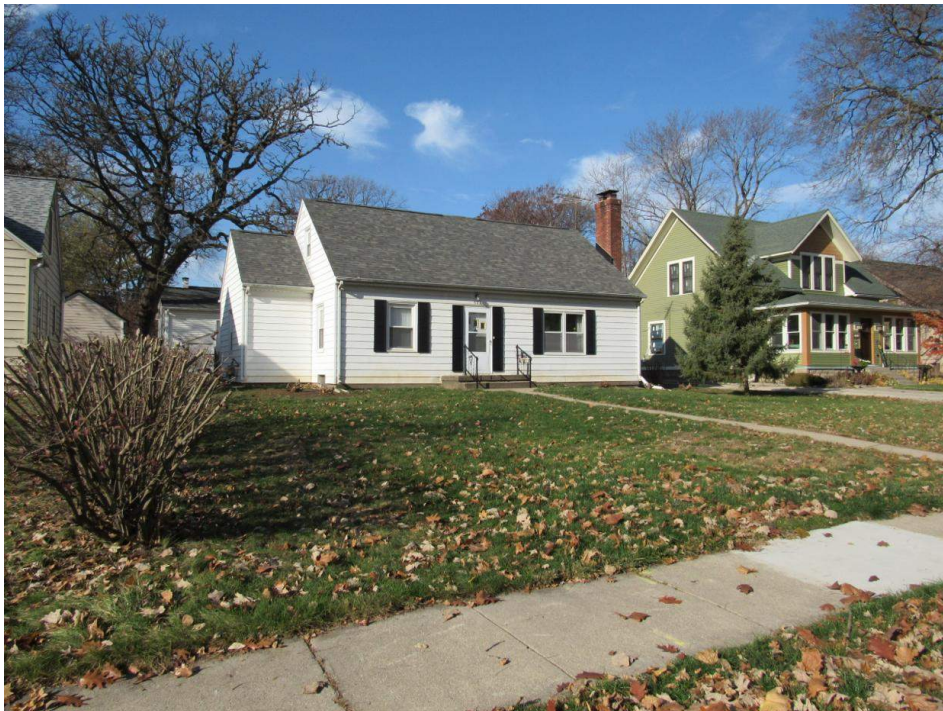
Photo 8. Façade of 627 Ridgewood Avenue, view to the northwest.

Photo 8 of 8 (IA\_Story\_Chautauqua Park and Ridgewood\_0008)  
Façade of 627 Ridgewood Avenue, view to the northwest.

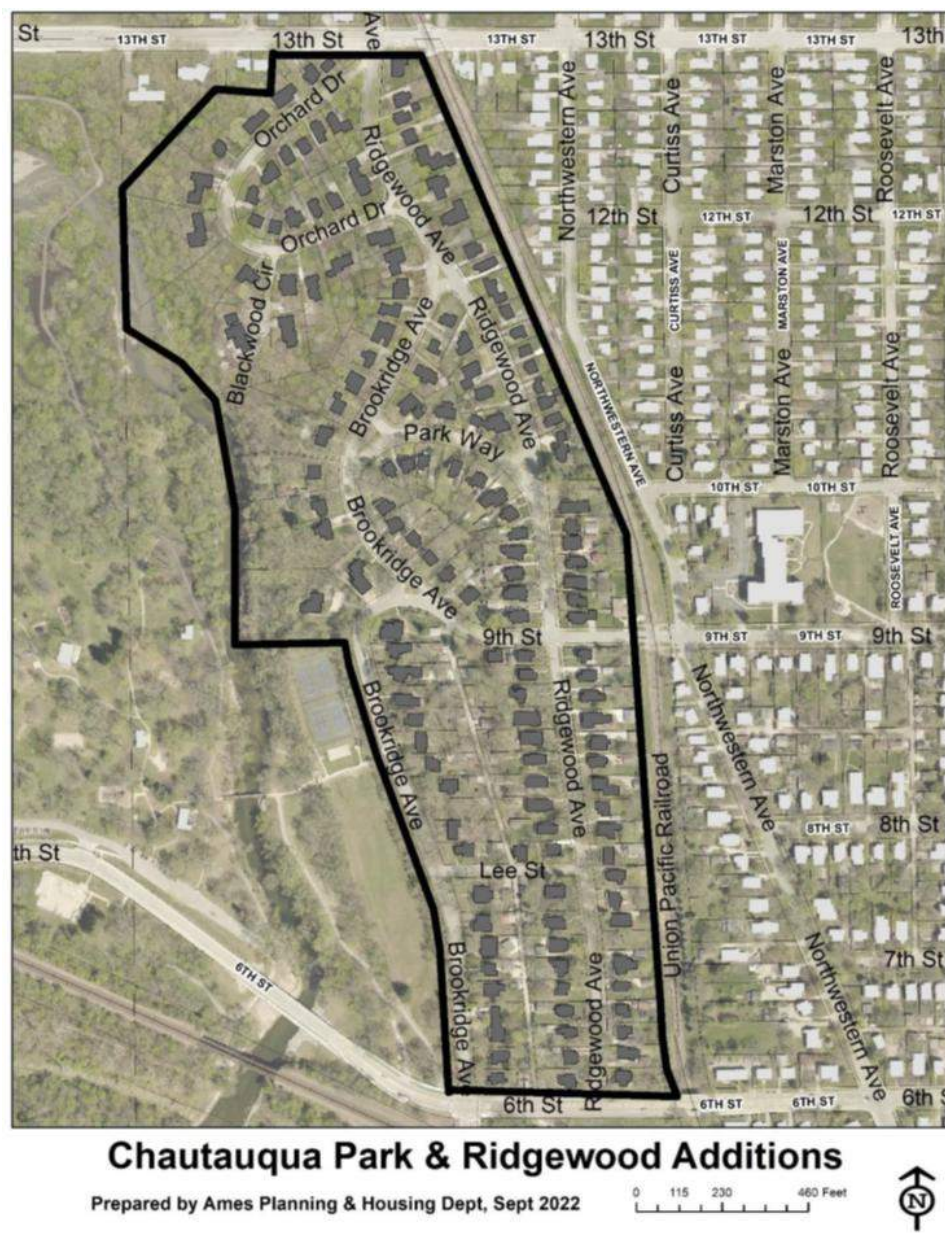
**Figure 1.** Historic District Boundaries, Intensive Survey, 2022.

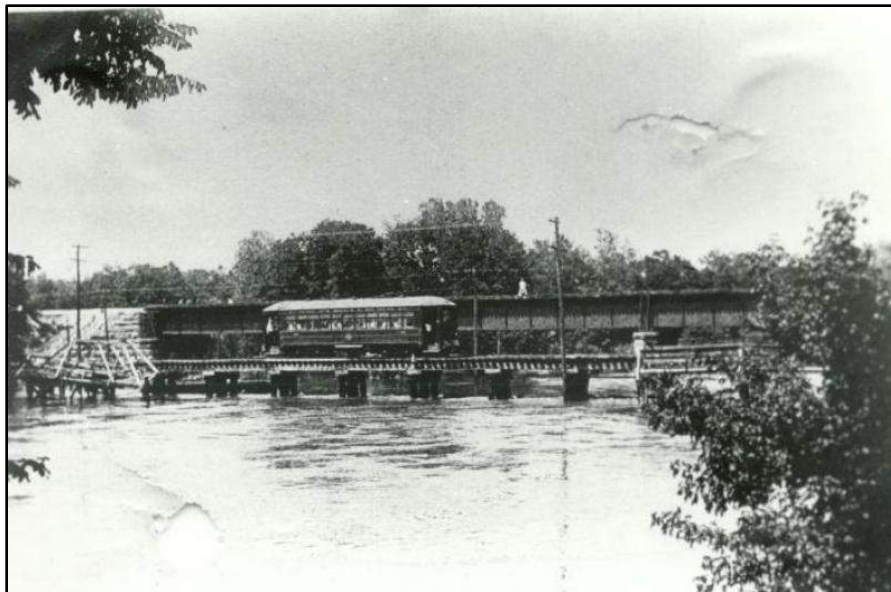
**Figure 13.** Remnant pieces of the foot bridge next to the streetcar on the left side, after it was washed away in the flood waters, 1918.

The FDDM&S replaced the old streetcar line with a new electric powered railway (**Figure 13**). The new service began in September of 1907,<sup>47</sup> three years before the Chautauqua Addition to Ames was platted. While the A&C tracks had run along 5th Street, one block south of what would become the Chautauqua Park Addition, the new tracks built in 1907 were moved another block south, to Main Street.<sup>48</sup> Also in 1907, a cinder paved foot path was built between downtown Ames and the college. The path included a pedestrian bridge over Ioway Creek.<sup>49</sup> To the north, a second pedestrian bridge was constructed by the railroad to dissuade students from using the rail bridge.<sup>50</sup> The bonds between the college and Ames were strengthening (**Figure 14**). In 1916, the same year the Ridgewood Addition was platted, the FDDM&S added a loop around campus.<sup>51</sup> The streetcar line now functioned as an inter-campus line and a vital link between downtown and the campus as well

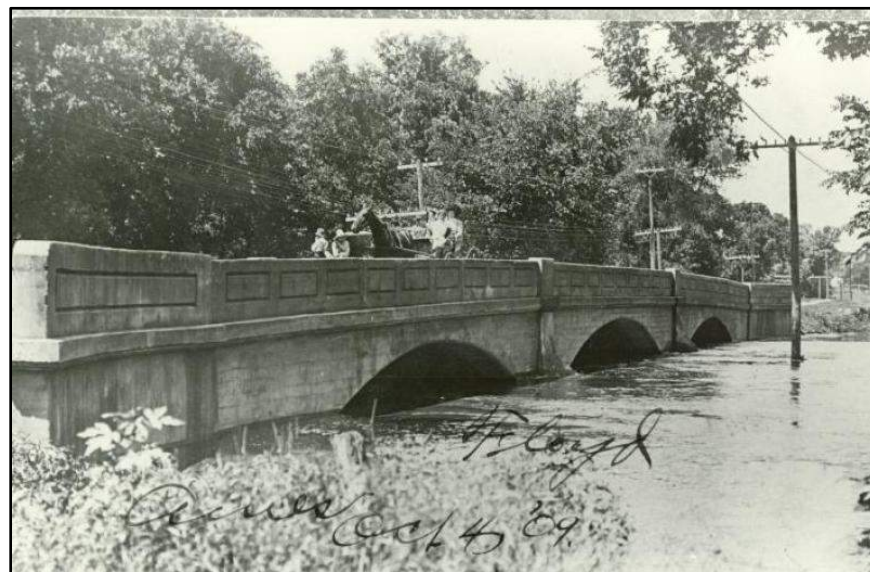
**Figure 15.** Lincoln Highway bridge over Ioway Creek. Within the year of construction, this flood water threatened the stability of the bridge, 1909.
